# ROAD SAFETY AUDIT

Washington Street

Town of Holliston

December 2012

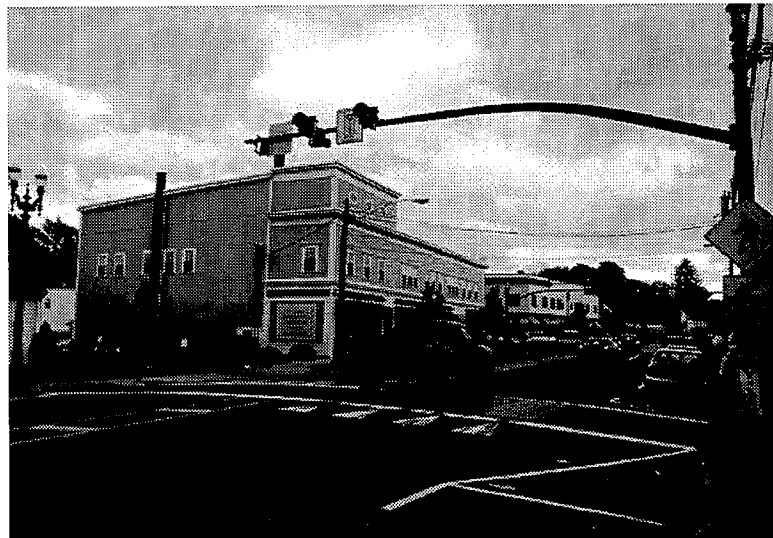
***The raised mid-block crosswalk between Central Street and Hollis Street/ Charles Street. The on-street parking spaces are located close to the crosswalk.***

Site observations determined that several on-street parking spaces were located within a short distance to intersections, crosswalks, and driveways, within 10-15 feet in some cases. The proximity of on-street parking is reducing sight distance for vehicles turning onto Washington Street from the side streets and could be contributing to angle crashes. Further, the proximity of on-street parking spaces to crosswalks is reducing the visibility of pedestrians waiting to cross, even when the flashing beacons are activated. In some cases, a driver must enter a crosswalk in order to maneuver into a parallel on-street space, potentially creating an unsafe condition for pedestrians.

3. Install curb extensions at the three existing crosswalks to shorten crossing distances, prevent motorists from parking too close to the crosswalks, and improve motorists’ visibility of a pedestrian waiting to cross.

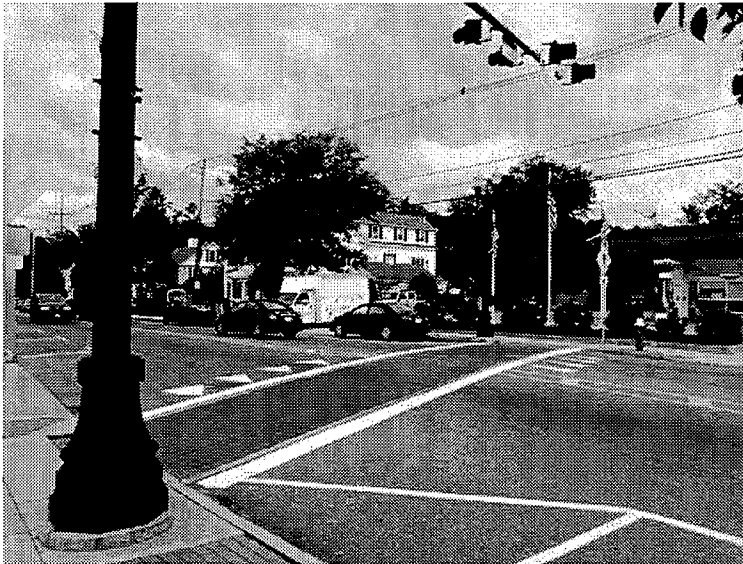
*Looking west at the raised crosswalk located just south of Green Street/Exchange Street.*

This raised crosswalk extends approximately 65 feet from curb to curb across Washington Street. The crosswalk is not perpendicular to Washington Street but instead is skewed, making the crossing distance longer. According to the Holliston Police Department, the crosswalk was located south of the Green Street/Exchange Street intersection to accommodate the Mobil gas station

The crosswalk is approximately 14 feet wide, raised, and marked with a red brick pattern and white outline. Triangular “yield mark” symbols are applied on the inclines up to the crosswalk in both the northbound and southbound directions to alert motorists of the change in grade.

Mast arm mounted flashing yellow beacons are located over the crosswalk and are visible from either direction. Only one mast arm pole, located on the east side of Washington Street, is used to suspend the beacons; as a result, the signal heads facing the Washington Street southbound traffic are not located directly over the Washington Street southbound lane. The flashing beacons are activated by both push button and motion detection. The motion detection at this location appeared to be inactive during the team’s site visit.

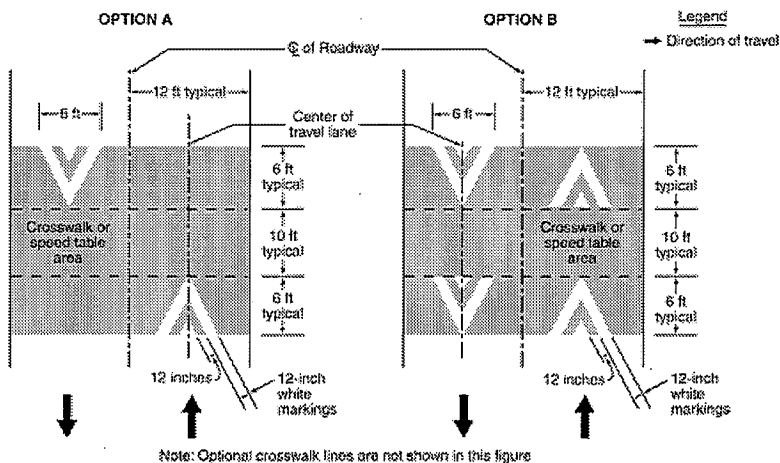
Figure 3B-30. Pavement Markings for Speed Tables or Speed Humps with Crosswalks

It was noted that the pavement markings on the upgrades of the raised crosswalk are not correct according to the MUTCD. The

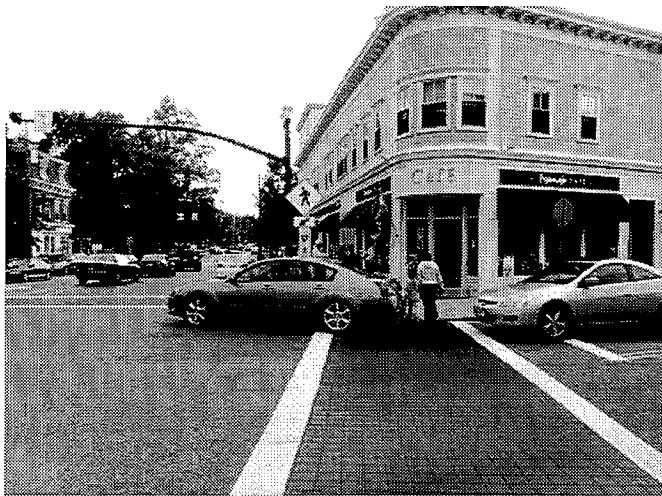
Audit team members expressed concern regarding the safety of pedestrians in the crosswalk across Washington Street. A motorist turning right from Central Street onto Washington Street northbound is looking left to determine whether there is a gap in the northbound traffic, and frequently does not look back to the right to determine whether there is a pedestrian in the crosswalk.

***The stop bar on Central Street is set back from the intersection, forcing a vehicle to creep forward across the crosswalk to have sufficient sight distance.***

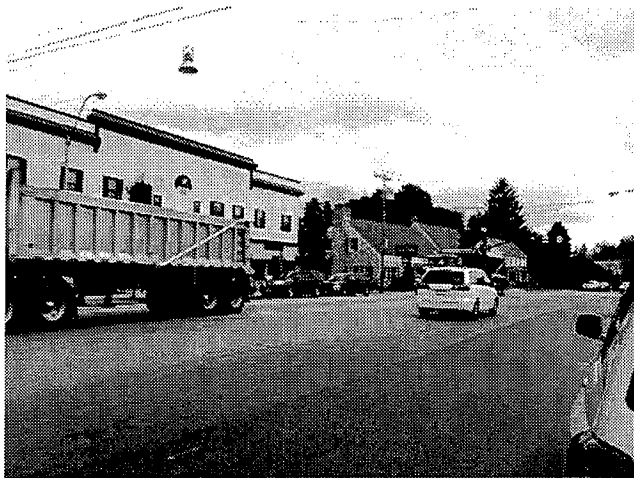
***The wide expanse of unmarked pavement on Washington Street southbound between Green Street/Exchange Street and Central Street.***

A team member noted that the Washington Street southbound lane between Central Street and Green Street/Exchange Street is very wide, possibly more than two lanes wide, with no delineation. It was noted that this wide area may provide a refuge for a vehicle turning left out of Central Street when a vehicle continues to travel southbound on Washington Street after a southbound left-turning driver waves the Central Street driver out onto Washington

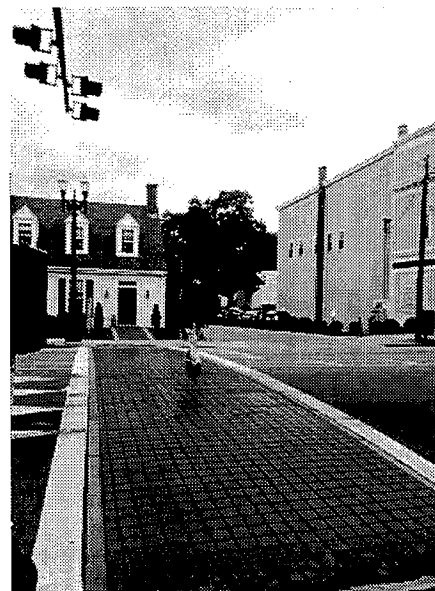
This crosswalk is located approximately halfway between Central Street and Hollis Street/Charles Street. Team members stated that many pedestrians use the crosswalk, but even in the crosswalk they don't feel safe. Pedestrians hesitate in crossing, concerned that a driver may not see the flashing beacons. The flashing beacons can be activated by pedestrian pushbutton or by passive motion detectors. RSA team members noted that occasionally the beacons are activated and drivers cannot see whether a pedestrian is waiting to cross. It was also noted that the passive motion activation sensors may be

***A pedestrian in the mid-block crosswalk between Central Street and Hollis Street/Charles Street.***

giving false calls, causing motorists to disregard the beacons. The crosswalk is very long as Washington Street is very wide at its location. It was also noted during the site visit that the length of time during which the beacons flash may not be long enough. A pedestrian waits to be sure vehicles have stopped, and by the time s/he completes the crossing, the beacons have stopped flashing.

The sign (State Law Yield to Pedestrians) that is mounted between the flashing beacons is too small and doesn't immediately convey the meaning that a pedestrian is likely in the crosswalk. The positioning of the beacons as well as the limited amount of information regarding the beacons' purpose may cause confusion or lack of appropriate response by motorists. Other locations where a beacon is located overhead include a two-way stop controlled intersection. Perhaps drivers are associating the beacons on Washington Street as similar to an intersection with a flashing beacon and aren't expecting a pedestrian but rather a vehicle at a side street.

It was noted that the pavement markings on the upgrades of the raised crosswalk are not correct according to the MUTCD. The marking used to indicate the change in elevation of the raised crosswalk should be a small solid triangle inscribed by a larger triangle, see MUTCD Figure 3B-30, shown previously in this report. If the markings are intended to be yield lines, they should be placed a minimum of four feet from the crosswalk, as outlined in Section 3B-16 of the MUTCD.

There were four crashes of the 65 within the study area at this location. All four crashes were rear-end crashes. There were no injuries. In most of these, the crash report noted that a vehicle was yielding for a pedestrian and was struck by the motorist behind, who was either following too closely or not paying attention.

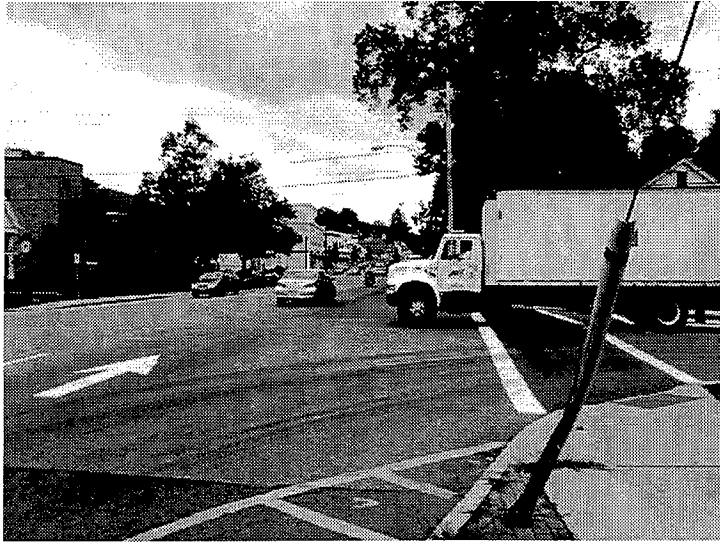
From Hollis Street, left-turns onto Washington Street are challenging given the prevailing speed of traffic and limited gaps in the traffic due to the limited number of traffic controls in this segment of the corridor. RSA team members noted that at around 2:15 PM, a number of buses leave the high school, located west of Washington Street on Hollis Street, and proceed toward Washington Street. Most of the buses turn left onto Washington Street northbound from Hollis Street. Team members also noted during the site visit that a larger vehicle such as an SUV or school bus waiting on Hollis Street to turn left onto Washington Street northbound block sight distance for smaller vehicles waiting to turn right from Hollis Street to Washington Street southbound and vice versa.

Vehicles approaching Hollis Street on Washington Street southbound are perceived to have higher speeds because they are coming from a very wide section of roadway with a higher speed limit. The cross section of Washington Street at Hollis Street/Charles Street is still very wide, approximately 62 feet, including a painted median, a parking lane on each side, a general travel lane in each direction, and opposing left-turn lanes for both directions of Washington Street.

***A box truck waiting to turn left from Hollis Street onto Washington Street northbound.***

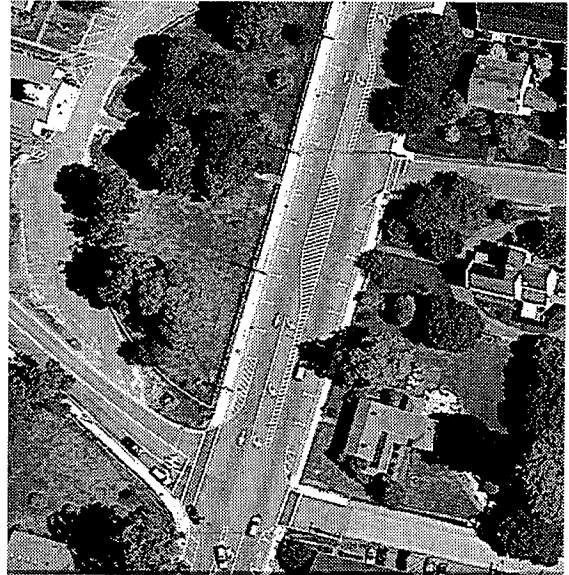
The painted median on the southern leg of Washington Street at Church Street is very wide; it was estimated at wider than 12 feet during the field visit. The painted median opposes an exclusive left-turn lane on Washington Street southbound at Church Street. A team member questioned whether such a median was necessary and what purpose it was serving. Left-turn movements are prohibited from Church Street. Although there is no physical barrier such as a median to prevent motorists from making the illegal left-turn, RSA team members including the Holliston Police Department members reported that most motorists obey the turn restriction.

*An aerial view of the wide painted median at the intersection of Church Street/Washington Street.*

Two of the 65 crashes within the study area occurred at this intersection. One involved an angle collision between a vehicle turning left from Washington Street southbound onto Church Street eastbound and a vehicle that exited an on-street parking space. The other was a rear-end crash on Church Street that had weather and pavement conditions as contributing factors in addition to driver inattention.
