From: James Keast - Facilities Manager

Date: April 8, 2020

Re: **Facilities Review 269 Central Street (DPW Foundry Buildings)**

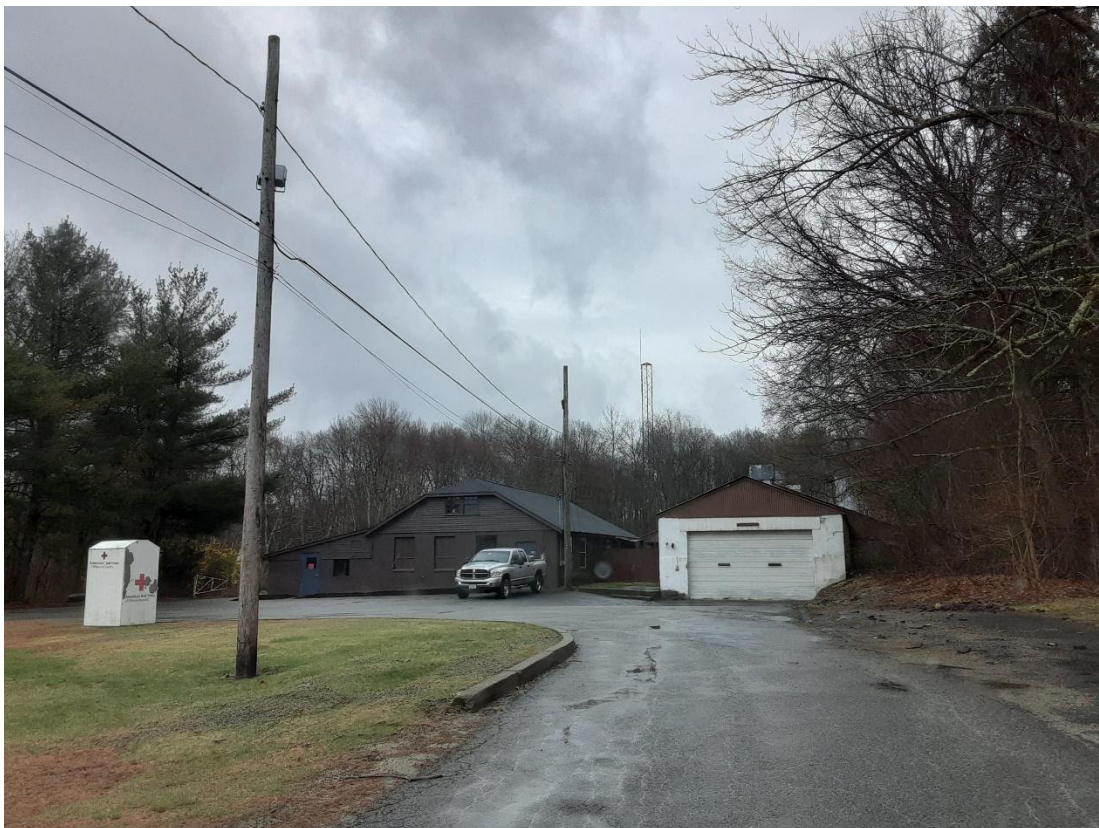
269 Central - Street View

It was noted that there is no lighting in the parking lot with exception of a large single fixture on the back of the Office/Admin building pointing towards the rear Service/Shop entry. There were no designated accessible parking spaces or signage. The pavement surface is cracked and heaved in areas. The overall condition of the landscaping in the front of the buildings (street view) is well kept. Four shipping containers were noted in the rear of the property. There were large piles of scrap metal as well various other mechanical items scattered around the yard. There does not appear to be any wetland areas around the buildings or grounds.

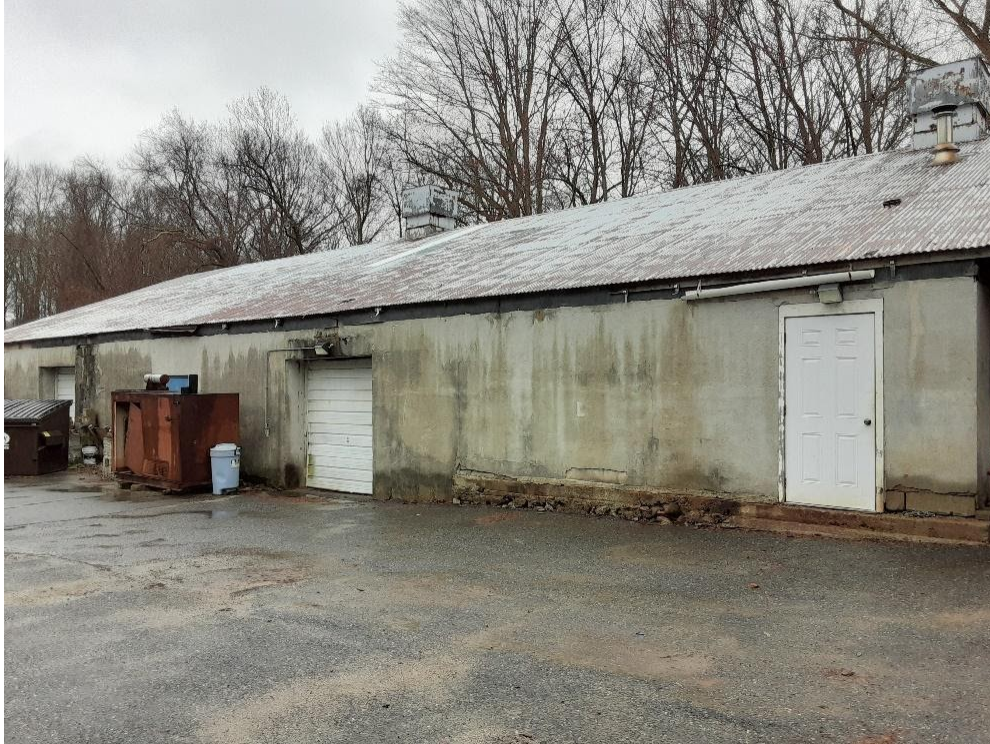
Vehicle Storage east view

The exterior of the Vehicle Storage building is in disrepair with large cracks noted in the block walls. There are sections of the metal and wooden siding coming off above the block walls on the south west gable end.

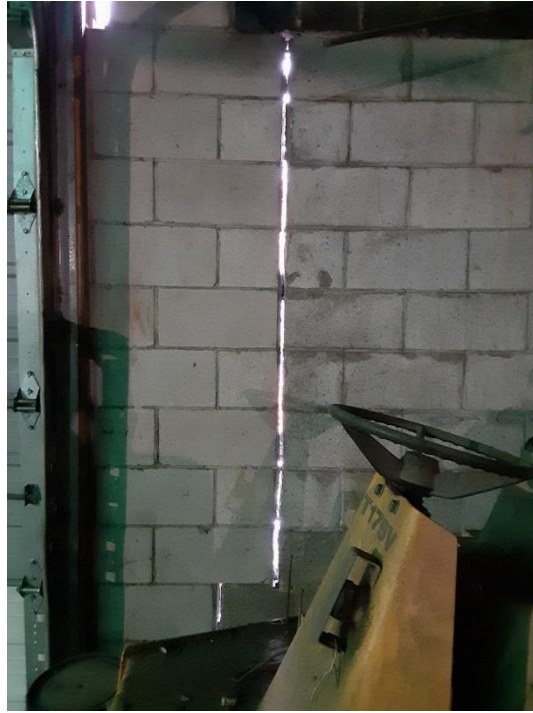
Large crack in wall

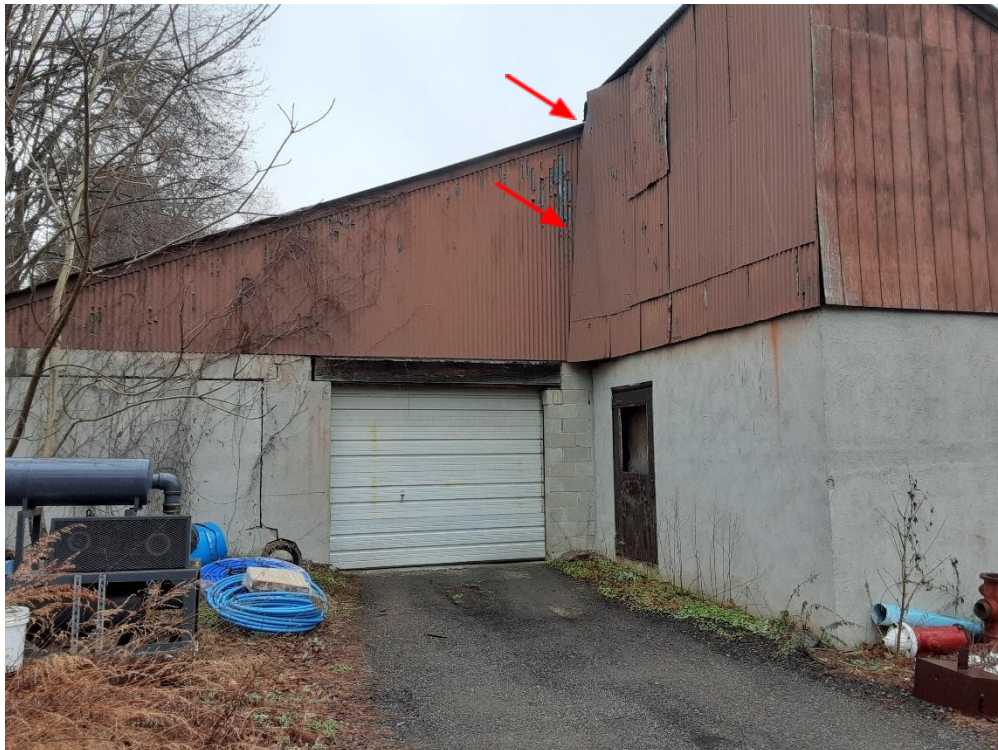
Rear of Vehicle Storage building (Arrow -siding pulling off)

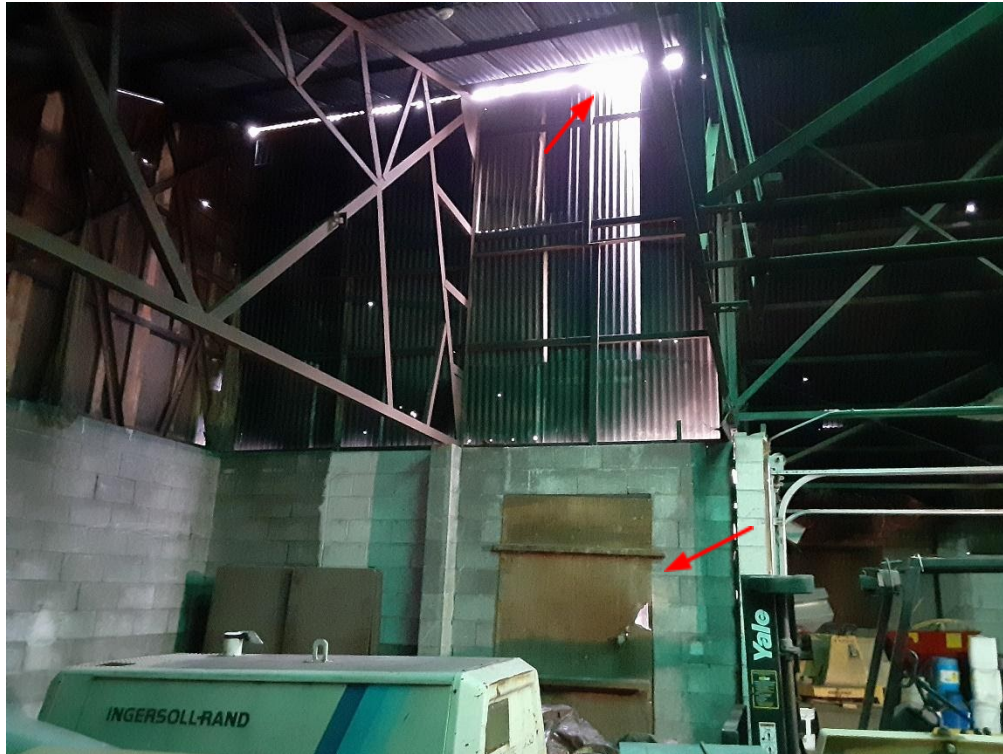
Inside view of failed siding and blocked door

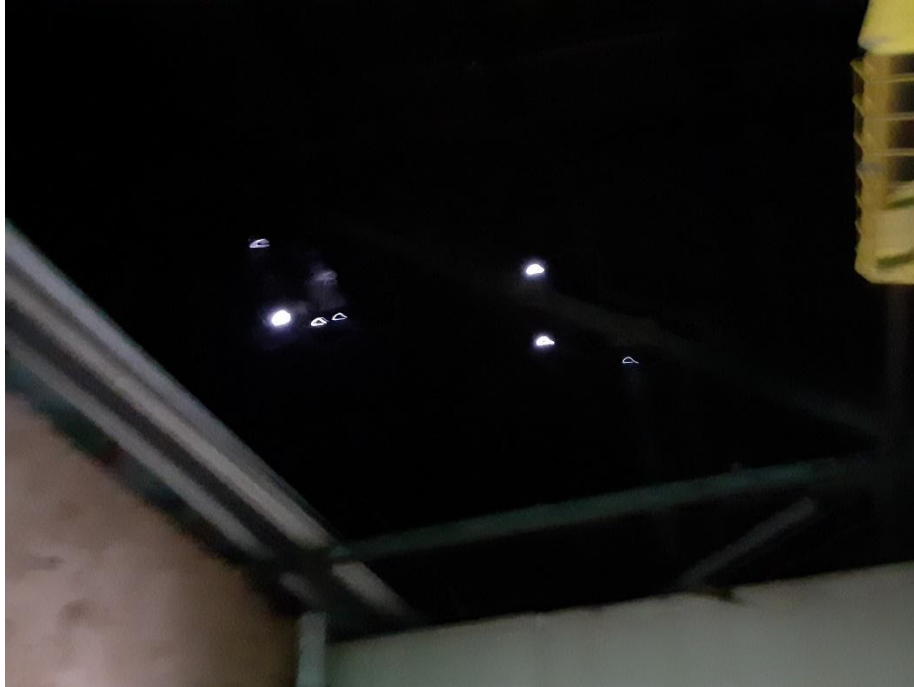
The corrugated metal roof has several holes throughout allowing the elements to enter the building.

Holes in roof

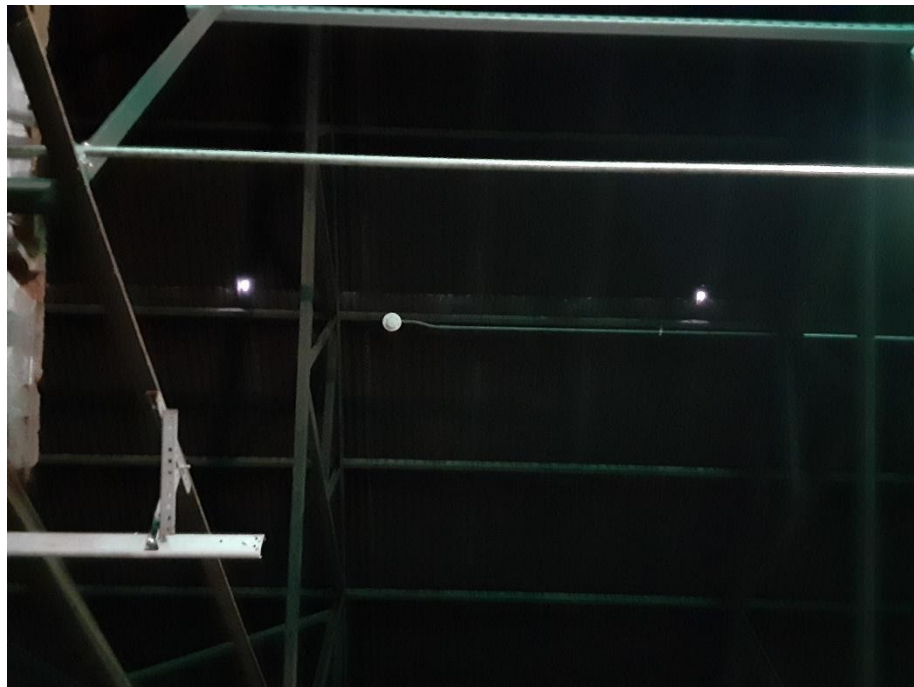
Additional holes in roof

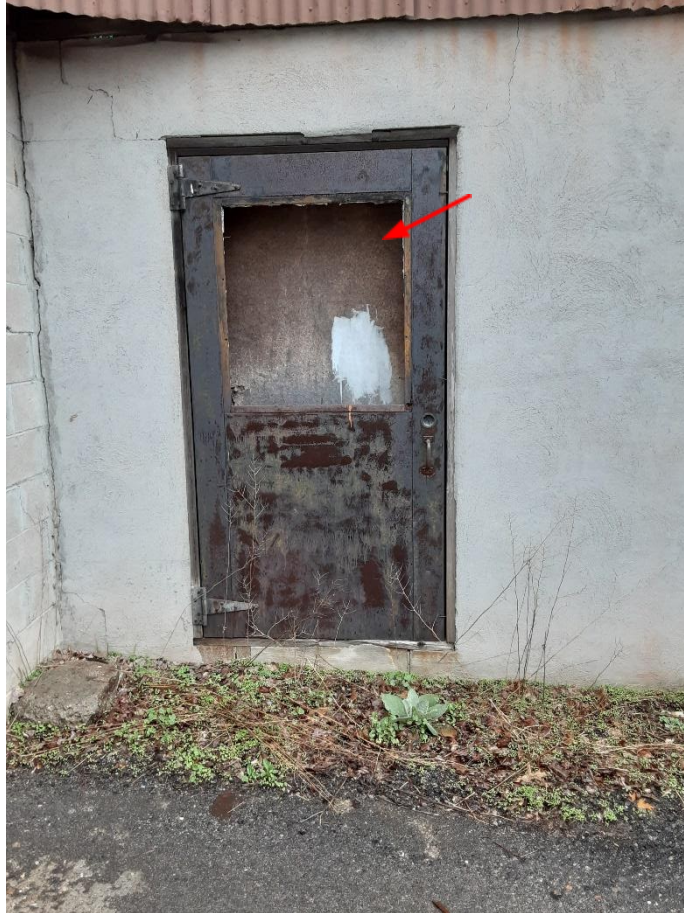
Building 2 Rear door

The rear entry door is blocked off from the inside and the upper section of the window glass is broken out.

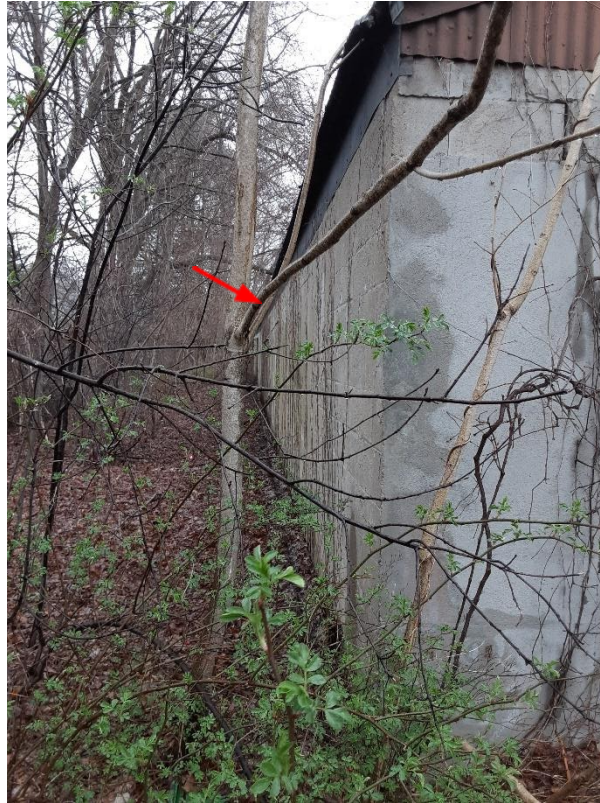
South west wall

The back wall on the west side of the building is buckling-in towards the interior indicating a structural issue with the wall. This is a concern and needs to be addressed.

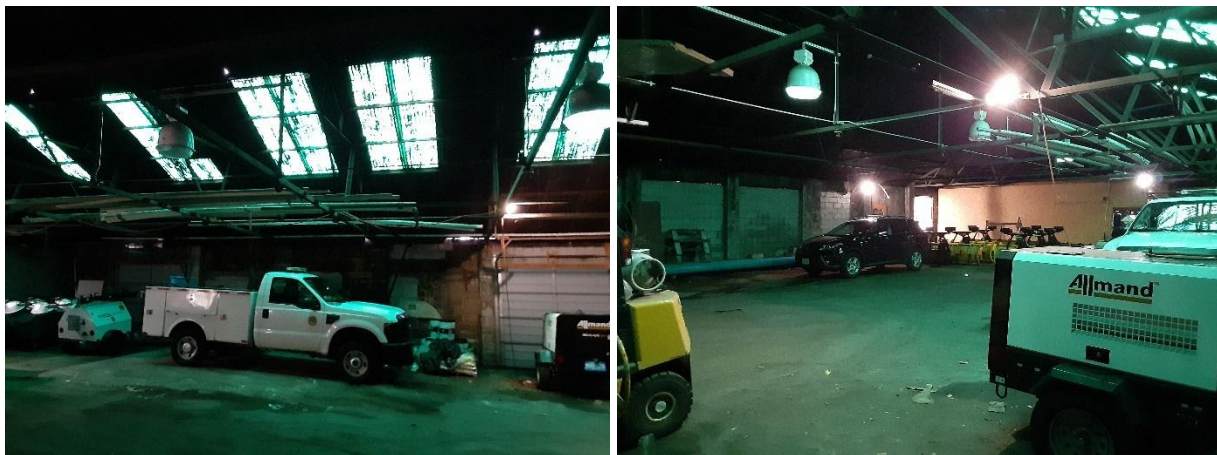
Vehicle Storage Interior

The interior slab is cracked and heaved in several areas presenting a safety concern for occupants and equipment. The lighting is very poor and there did not appear to be any emergency signage. There were no vehicle exhaust fans or vents, eyewash stations or other safety equipment noted in the area.

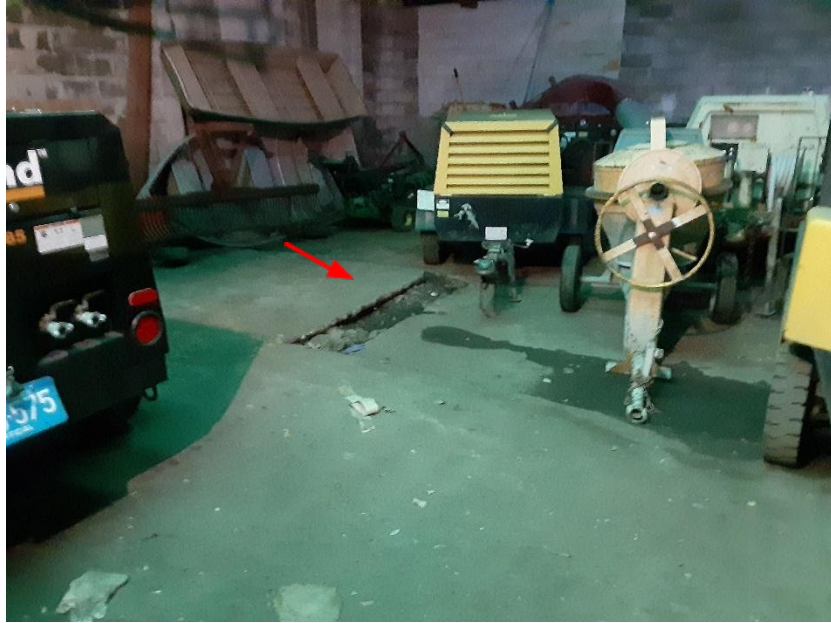
Vehicle Storage Interior- Damaged floor

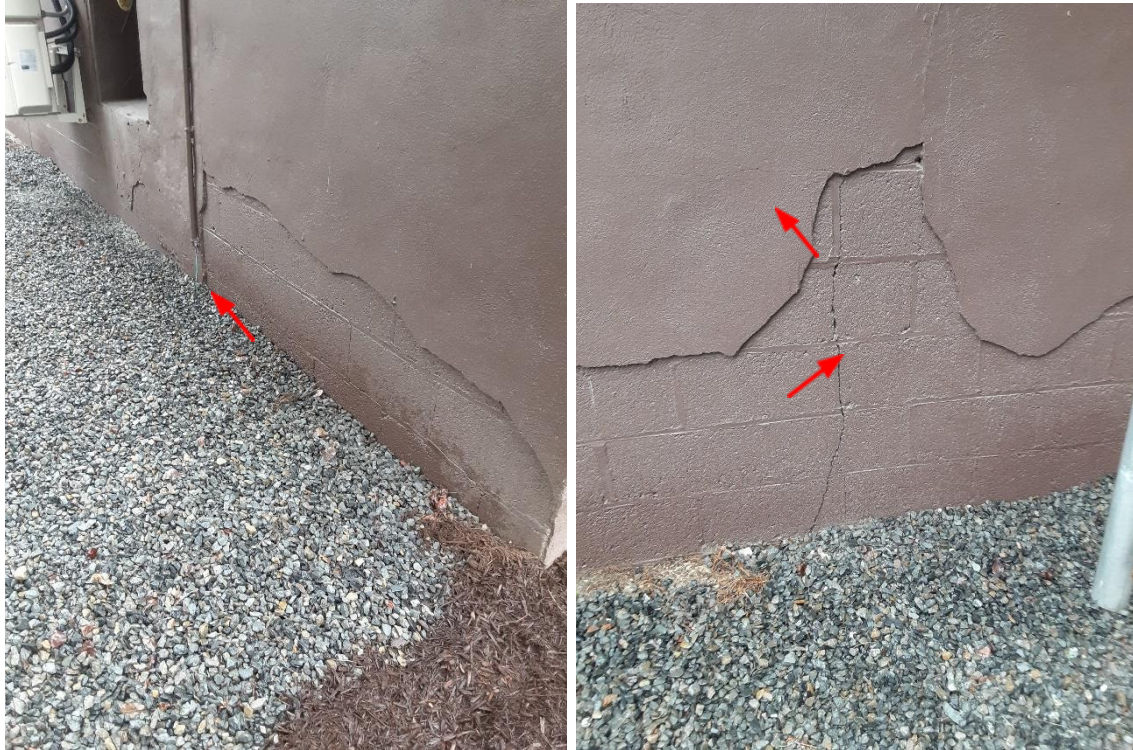
The exterior of the Office/Admin building was recently painted. There are no signs of peeling paint or significant rotting of wooden areas. It was noted that there is a stucco layer added to the exterior block wall. The wall section next to the driveway leading to the rear of the building has large sections of stucco missing and covered up by the recent painting. Some cracking in the block wall is also noted. However, this is not a structural concern.

Damaged Stucco Office/Admin building

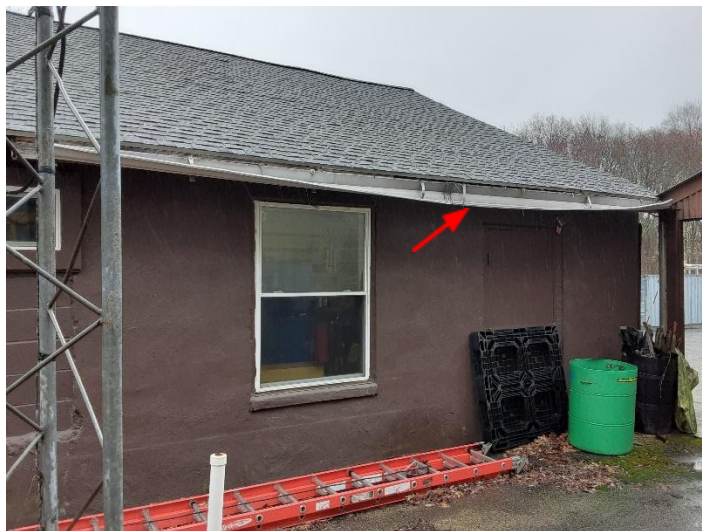
The roof is not showing any signs of significant deterioration. The roof was replaced in 2004. The drip edges, soffits and fascia are sound. It should be noted that on the south west side of the building a rain gutter is pulling away from the building and needs repair. All the windows are double pane vinyl replacements installed in 2000. The entry doors are metal and no rusting was observed. All locks and latches are functioning. The exterior electrical service is in sound condition.

Southwest of Office/Admin building (damaged gutter)

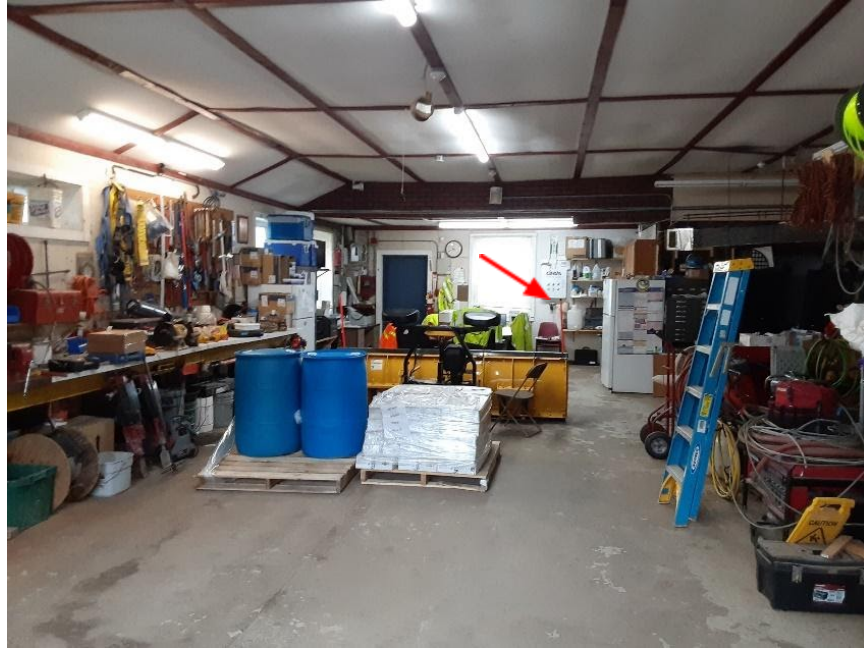
There is no separation between the Service/Shop and the employee kitchen. The kitchen area is exposed to dust, debris and potentially chemicals from the workshop. The Service/Shop is crowded and lacks adequate storage for equipment, tools and chemicals.

Inside Service/Shop; Arrow points to Kitchen
