From: James Keast - Facilities Manager

Date: April 10, 2020

Re: **Facilities Review 63 Arch Street (DPW Highway Buildings)**

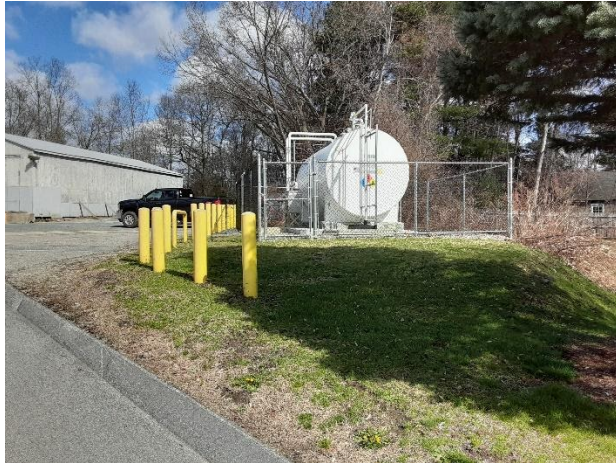
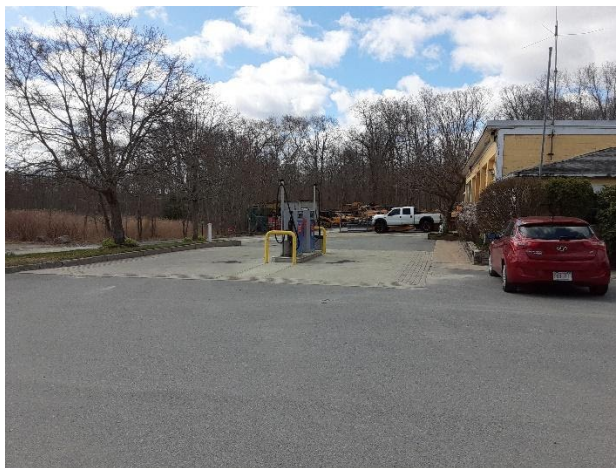
The pavement around the main building is cracked and worn especially around the storage buildings and sides. It was noted that the pavement at the entrance from Arch street is in good condition as well as the pavement around the fuel pumps. The lighting around the buildings appears adequate. The fuel tanks and pumps were relocated and renovated in 2016 and appear in new condition. The fuel tank appears properly protected and secured. A fire suppression system was not observed around the fuel pumps and should be evaluated for necessity.

*Fuel Tank and Pumps*

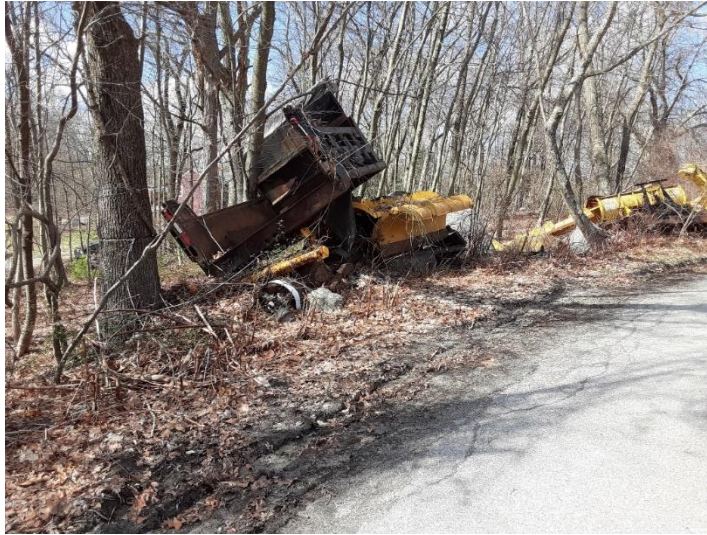
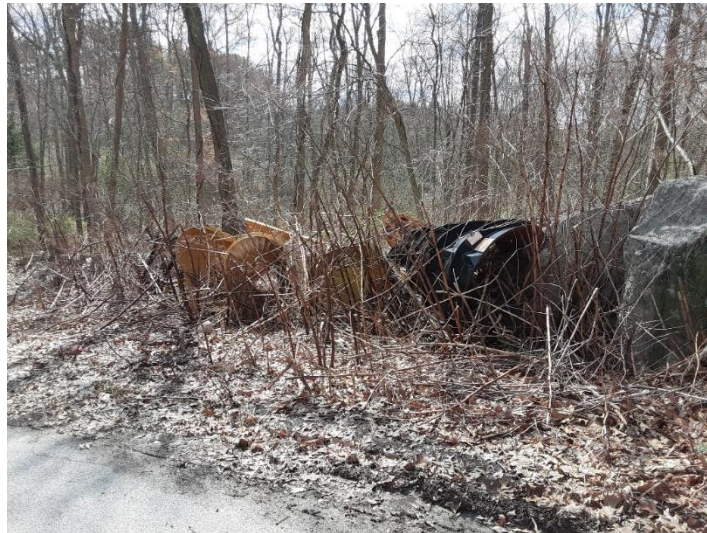
The grounds around the site are cluttered with old vehicles, equipment and scrap metal. An abandoned passenger vehicle was observed behind building Storage 1.

*Grounds with abandoned equipment*

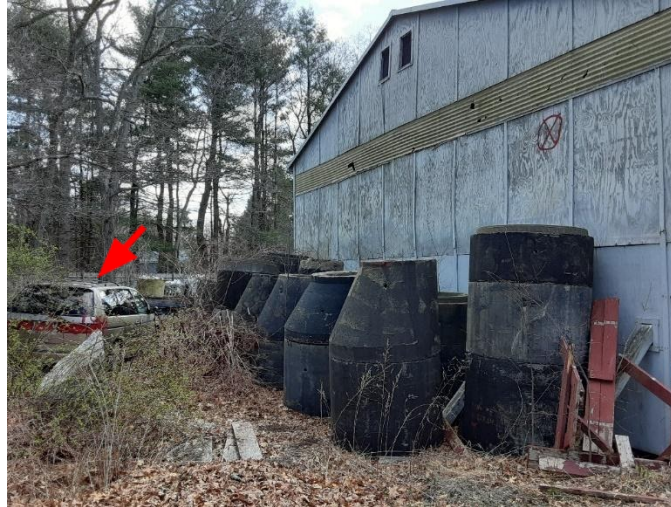
*Grounds (Abandoned vehicle)*

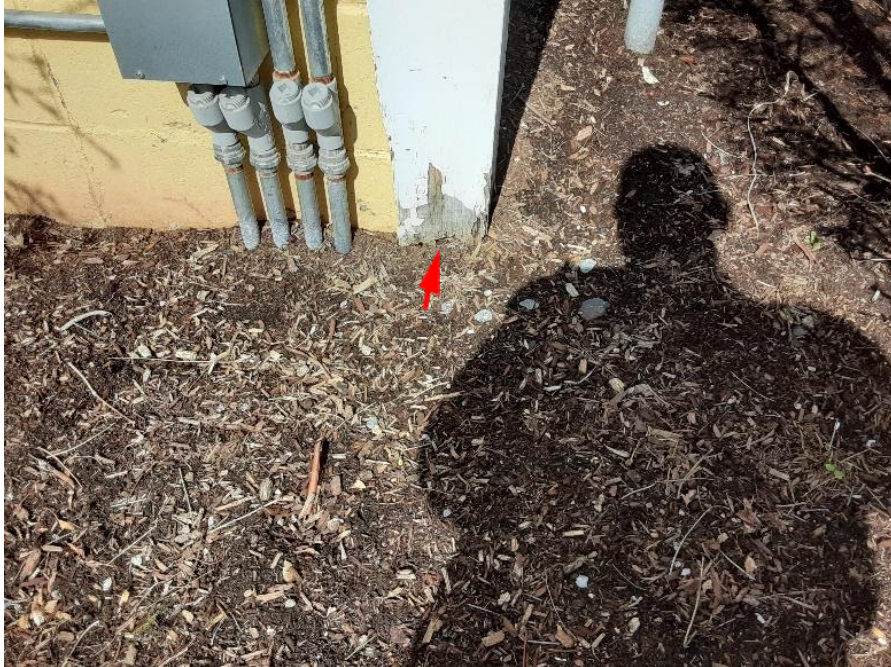
*Rotted trim (Office side)*

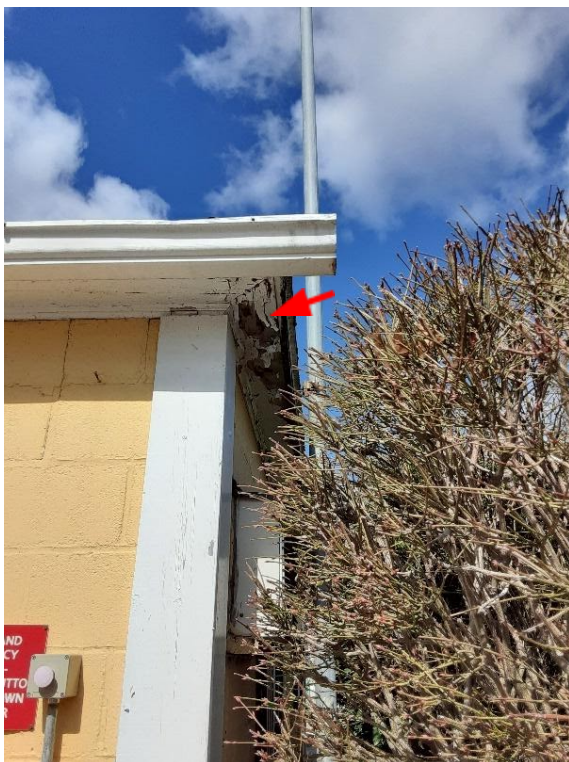
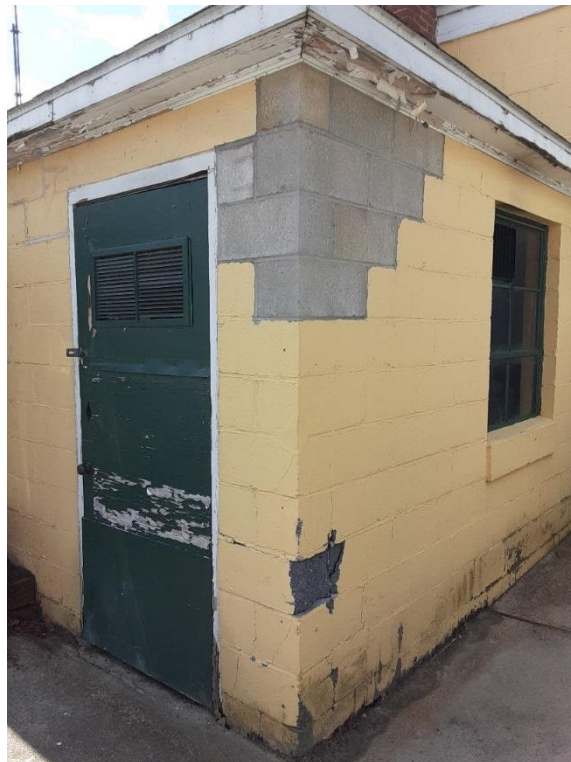
*Damaged Soffit and block walls (Office/admin side)*

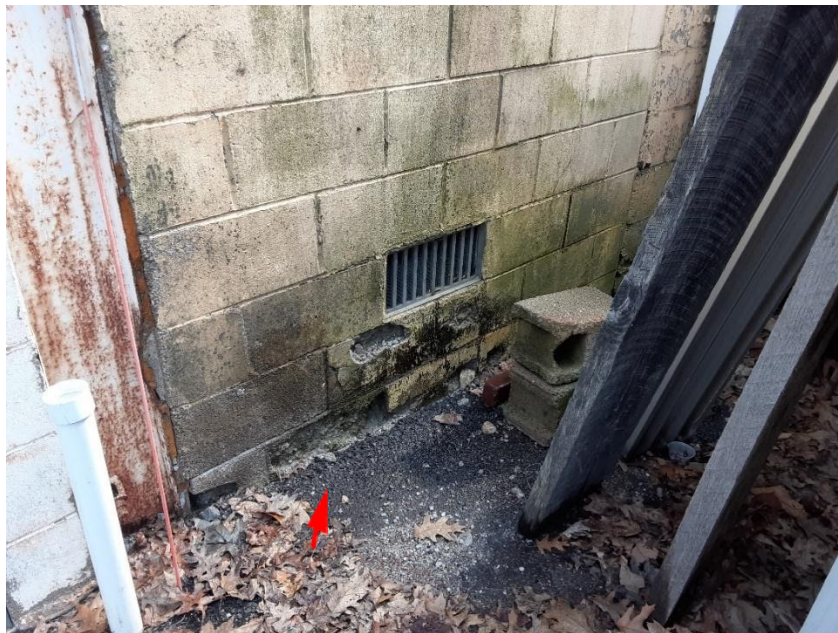
The concrete block walls are damaged in various areas around the building. There is significant damage located at the side entrance to the service shop. This damage is a result of a roof drainage issue. It was noted that the connecting roof area between the original Office/Admin and Service shop and the Vehicle Storage addition collects a significant amount of water from both roofs channeling it to this area of the building.

*Wall damaged at Service Shop side of building*

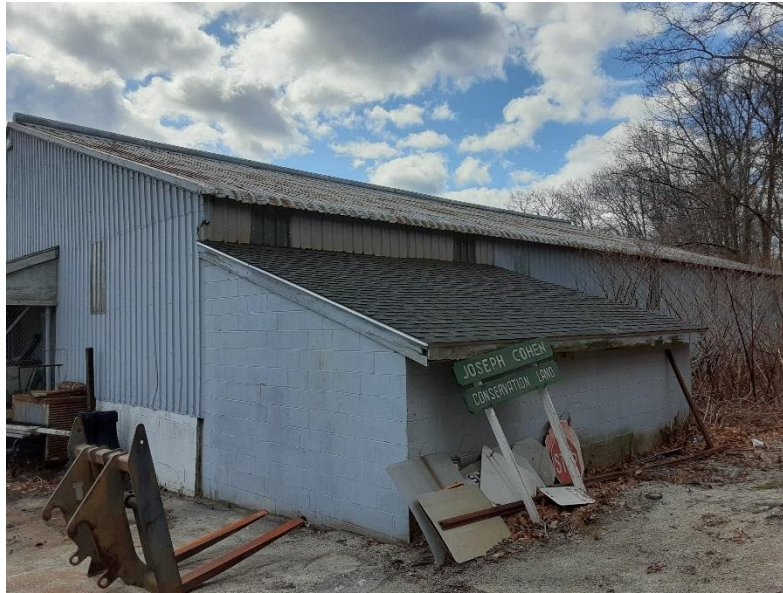
The construction of the Vehicle Storage area of the building is steel and concrete block. The roof is galvanized metal and is in fair condition. There did not appear to be any leaks.

*Roof of Vehicle Storage*

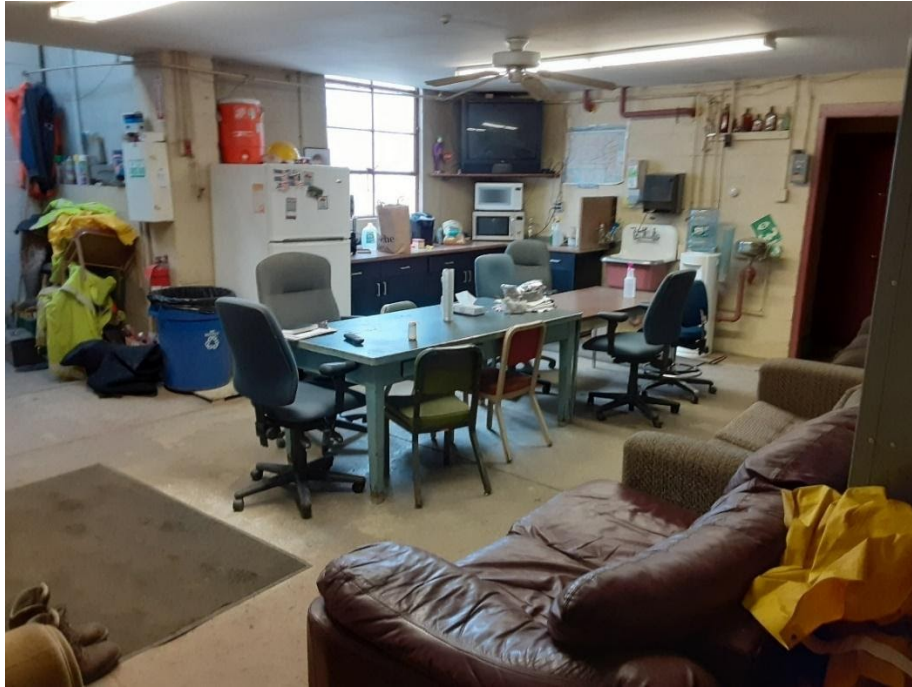
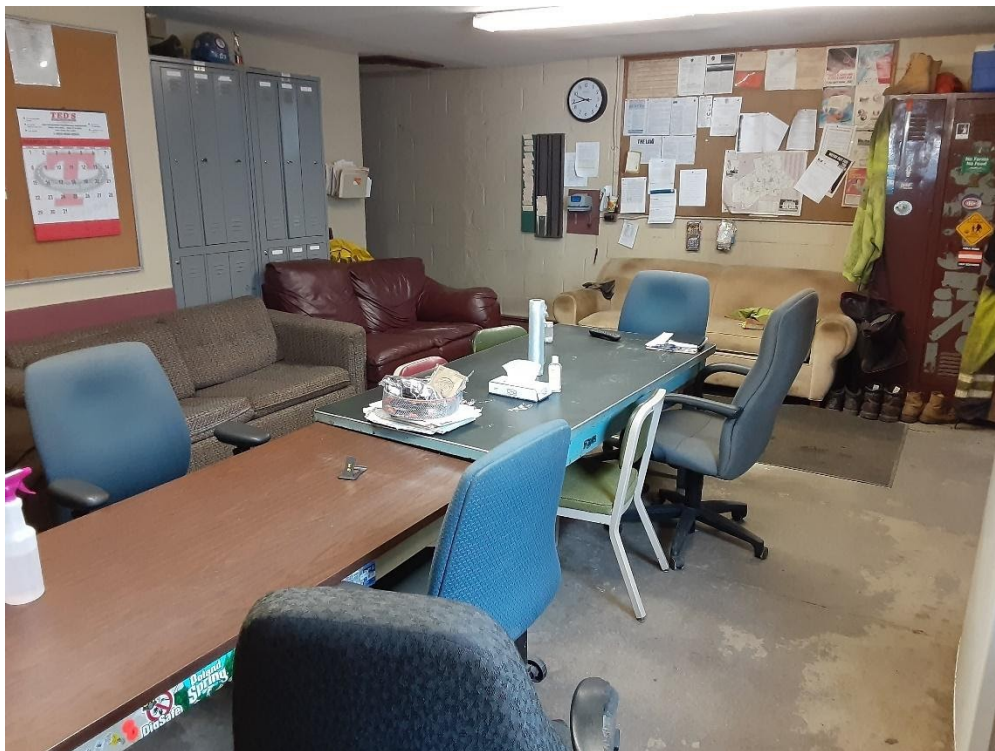
The electric appears in good condition. The employee lounge is worn, has no changing area, cots or showers for workers who need to stay on shift (24 hours or more) due to weather related services.

*Employee lounge*

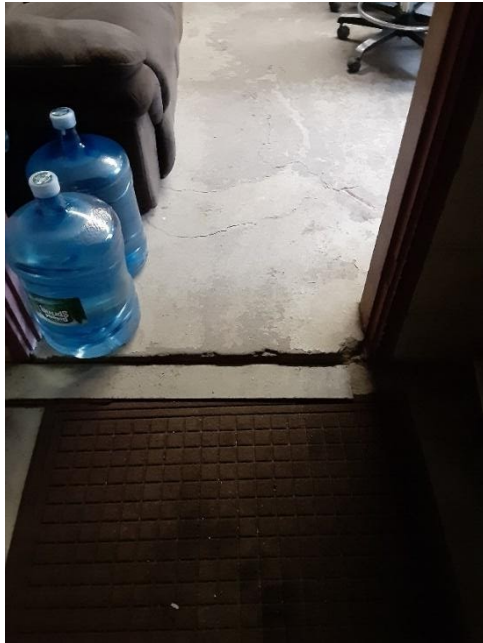
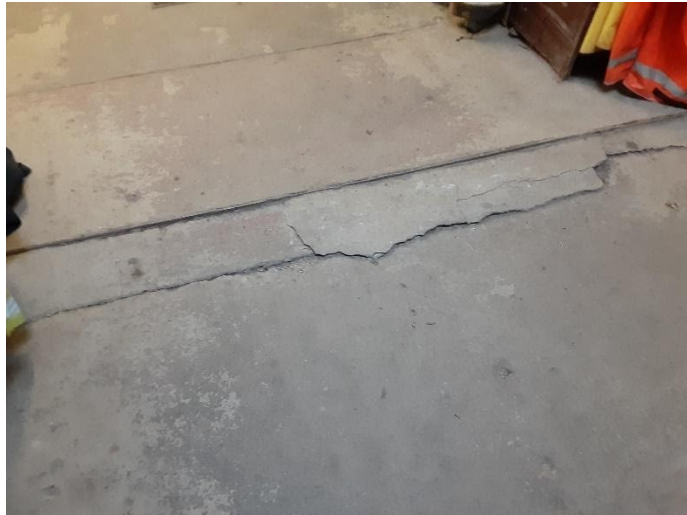
The concrete slab floor in the lounge is cracked and uneven and creates a trip hazard. The ceiling is in fair condition and showing signs of a roof leak around a skylight. Some of the sheet rock has broken away in the area of the leak as well.

*Floor lounge area*

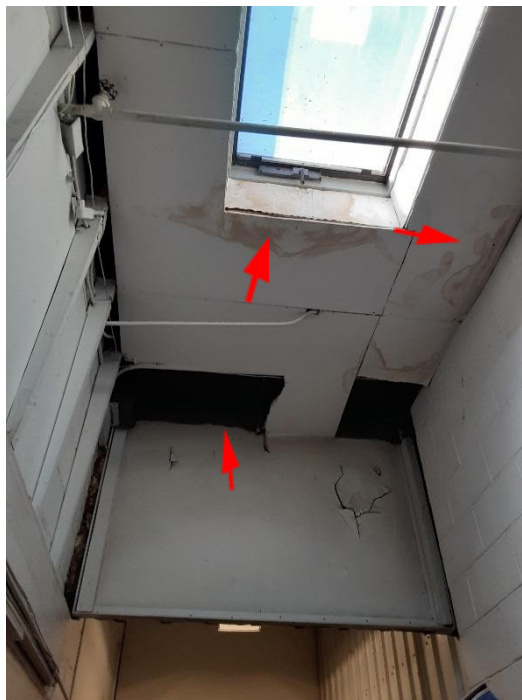
*Ceiling leaks*

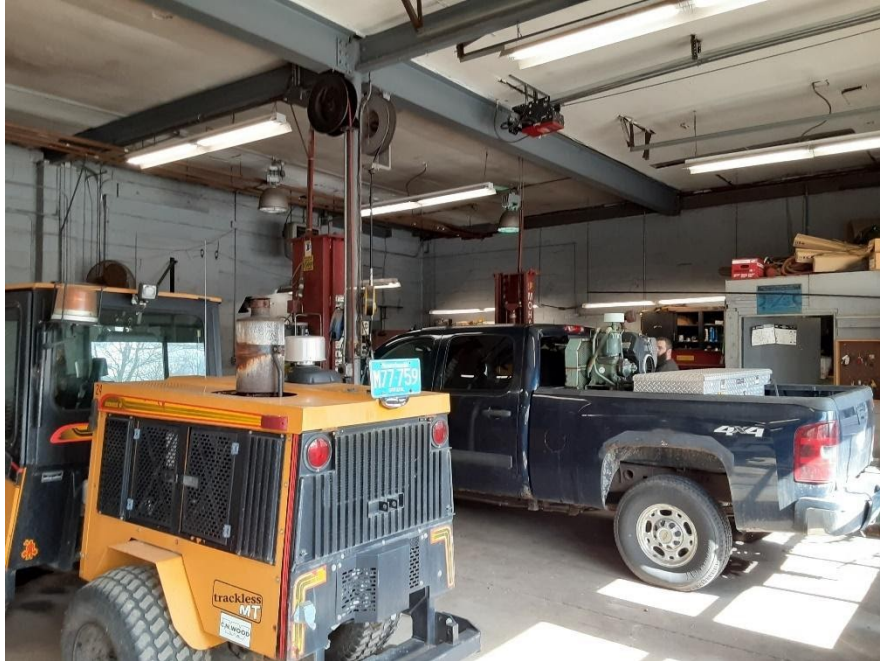
The vehicle/equipment service shop is undersized for the current service demands. There are three bays, but the shop can only accommodate one large vehicle at a time which needs to be placed in the center bay to allow for access. The storage for parts is inadequate and some parts are stored in a storage container outside that has rusted through and leaks rainwater.

*Interior of service shop*

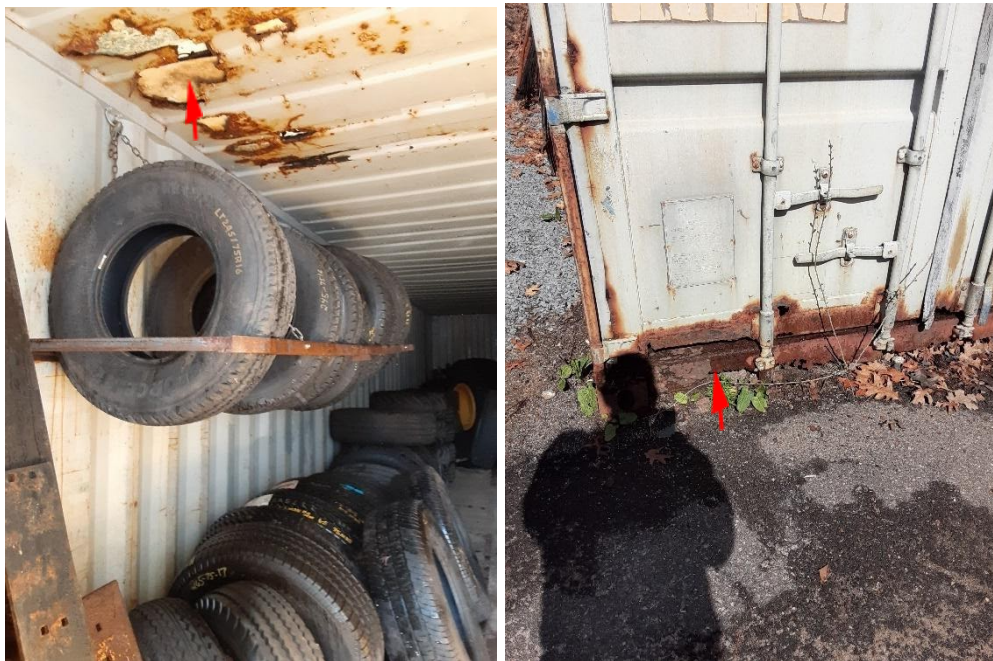
*Parts storage container*

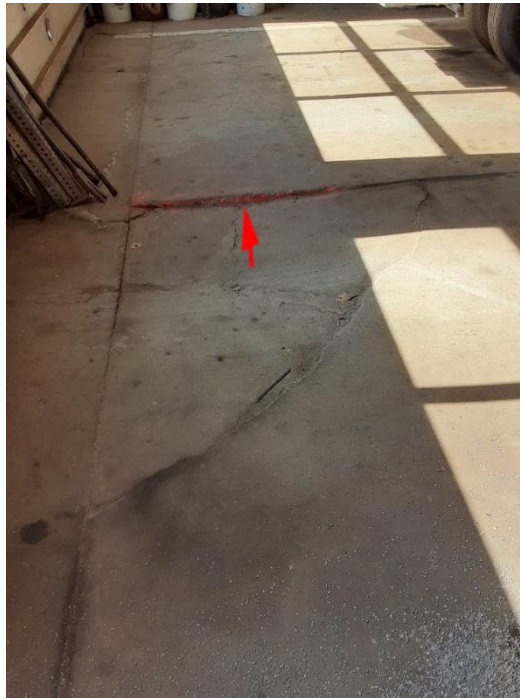
The lack of storage and the small size of the shop requires moving of several items (smaller equipment, supplies, tools, etc.) when things like tire changes, welding, etc. need to take place. This reduces efficiency of the mechanics. The heat in the shop is inadequate and on cold days can not keep up. There does not appear to be an air exchange or venting system in place. The concrete slab floor of the service shop is cracked and heaved in areas.

*Floor of service shop*

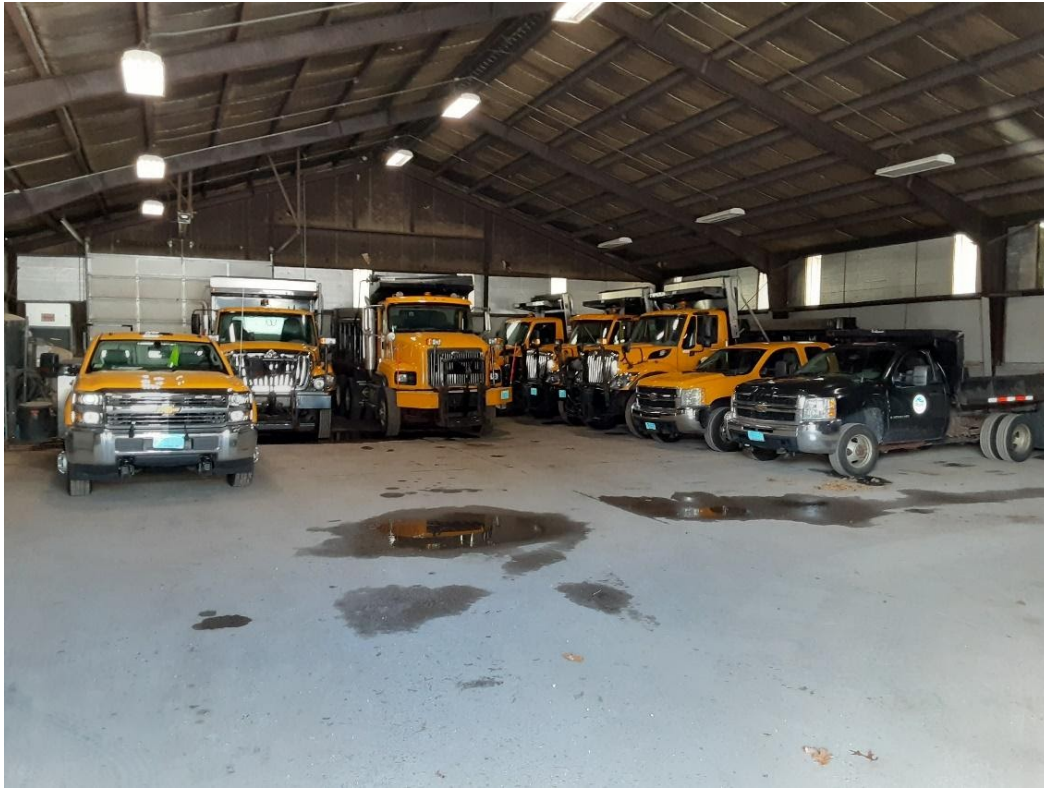
The Vehicle Storage area is the largest square foot area. This area is also too small for the current number of vehicles. Furthermore, the design of the building requires that the vehicles be parked blocking adjacent vehicles. This creates a situation where multiple vehicles need to be moved in order to gain access to a vehicle or piece of equipment. The lighting in this area is inadequate. Vehicles are washed in this area.

*Inside of Vehicle Storage garage*

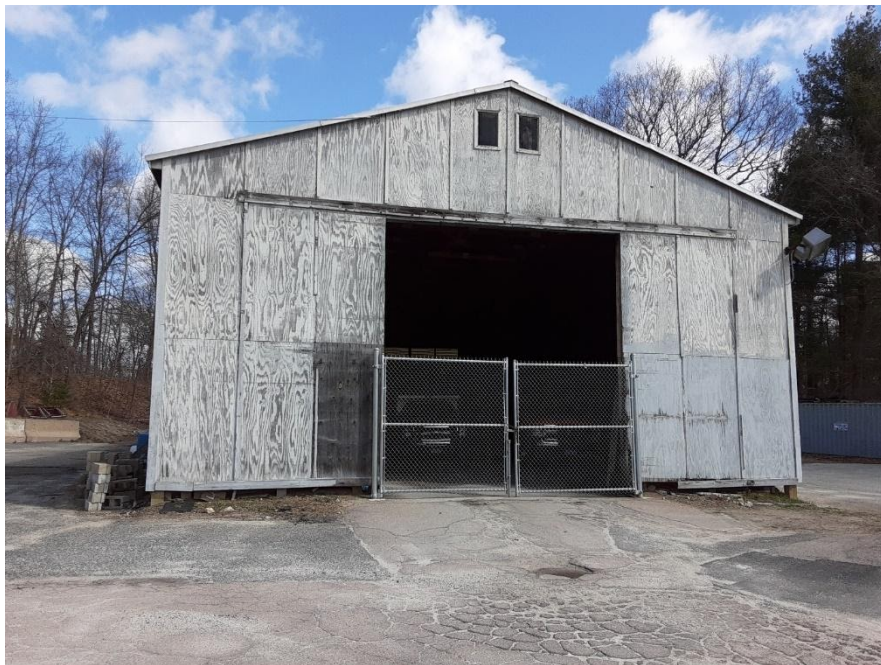
Storage building 1 is unconditioned and constructed of wood with a metal roof. It stores material used to treat roadways in the winter. At the time of my review vehicles were being stored in this space along with the material. This building was secured with a gate. This building is in poor condition with the side bowing out from the road-treating material piled against the interior walls. Side bracing is installed on the outside parameter of the building.

*Storage 1*

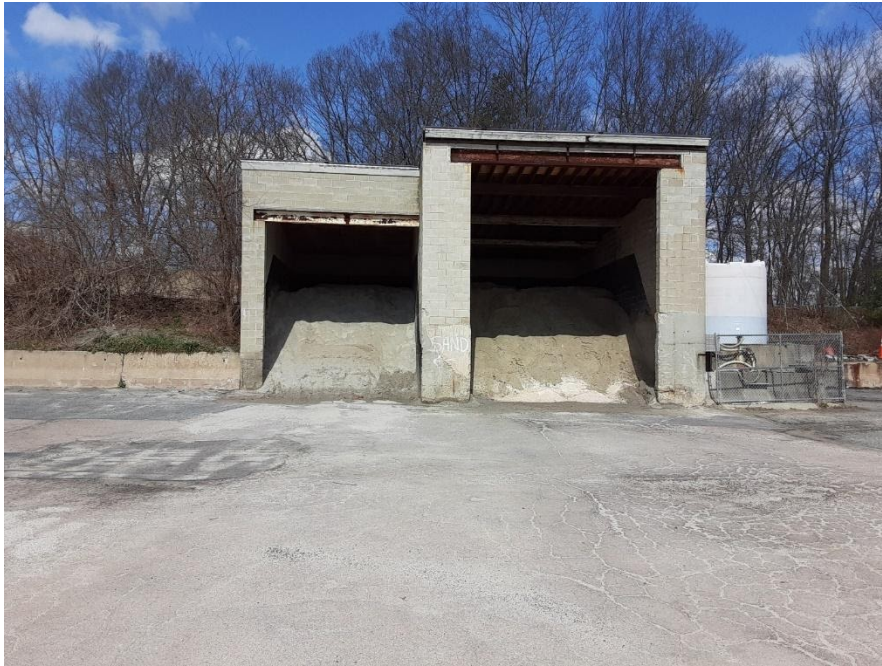
Storage building 2 is unconditioned and stores material used to treat roadways in the winter. This building is open in the front and not secured. This building is constructed from concrete block with a wooden roof structure and rubber roof. This building is in fair condition.

*Storage 2*

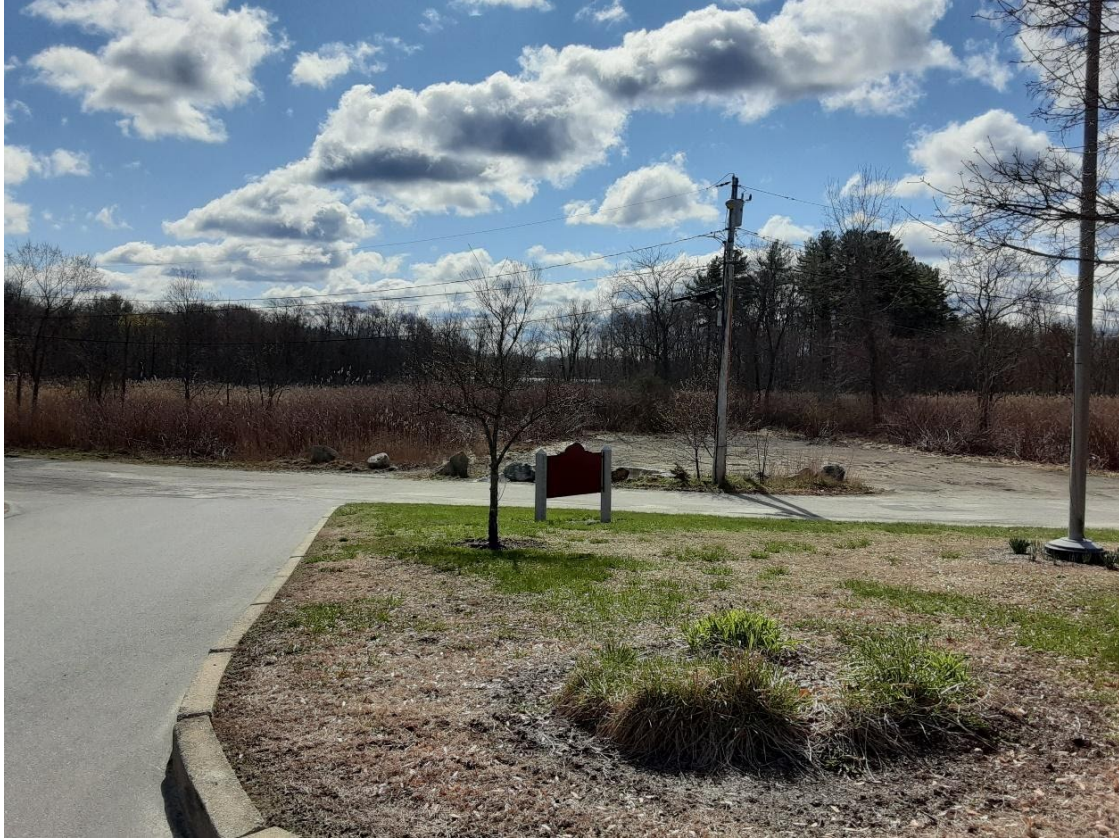
On the eastern side of the property is a wetland area that abuts Lake Winthrop. It is unclear what the impact of storing road treatment supplies and metal equipment has on the wetland area. The grade of the area would direct some run-off from the main site to the wetland area and no diversion barriers were noted.

*Wetland eastern edge of property*
