From: James Keast - Facilities Manager

Date: Aug 18, 2023

Re: **Facility Condition Assessment - Holliston High School 370 Hollis Street**

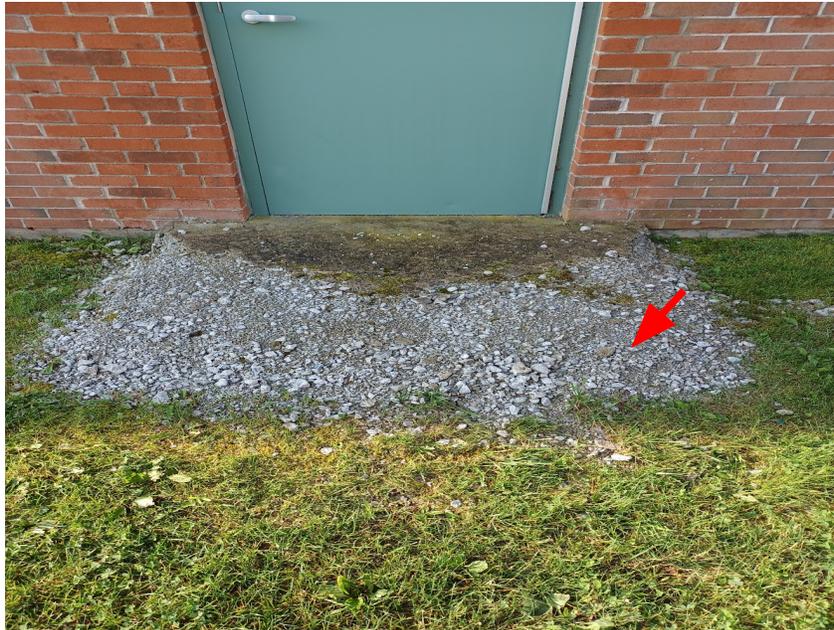
Sidewalks and Pavement- Some sidewalks are in critical condition and are a safety hazard to users. Many sidewalks have shifted at the joints resulting in a raised edge which creates a tripping hazard. Some of the surfaces have deteriorated so much that the concrete has broken apart as shown below. Other sidewalks have a deteriorated surface which traps water, ice and debris further accelerating the deterioration process.

Critical Door Landing Area

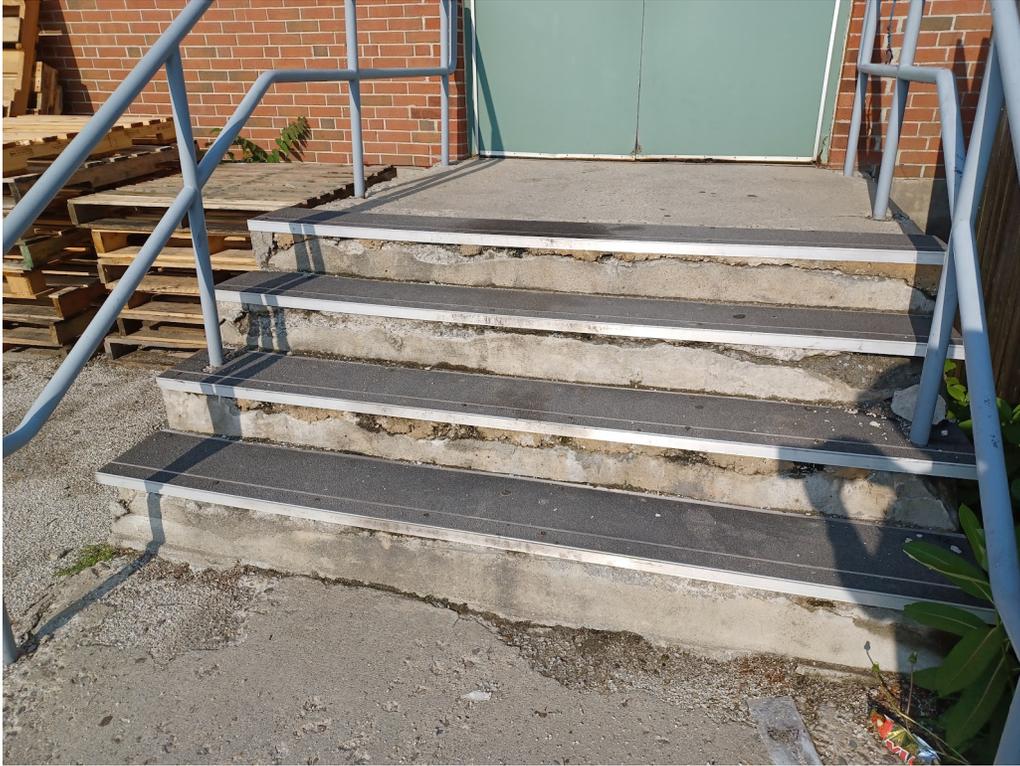
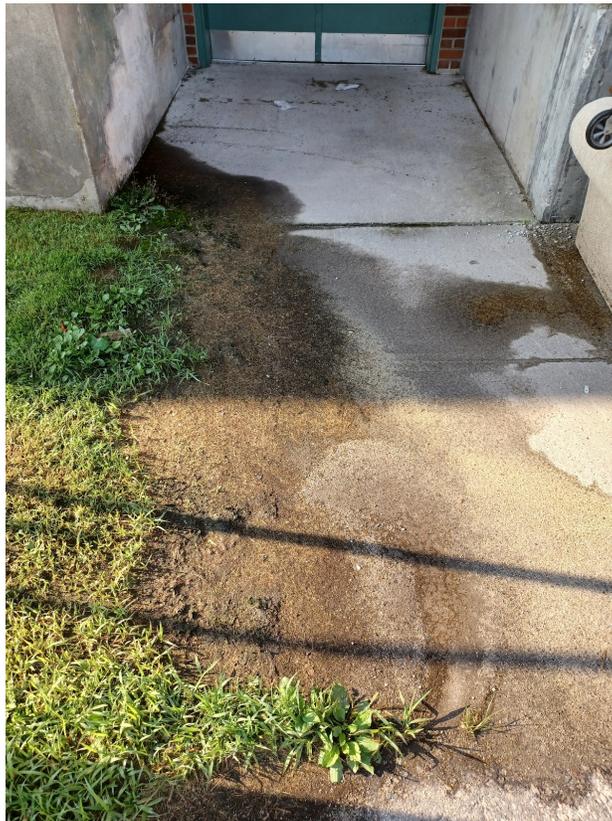
Critical Side Entrances

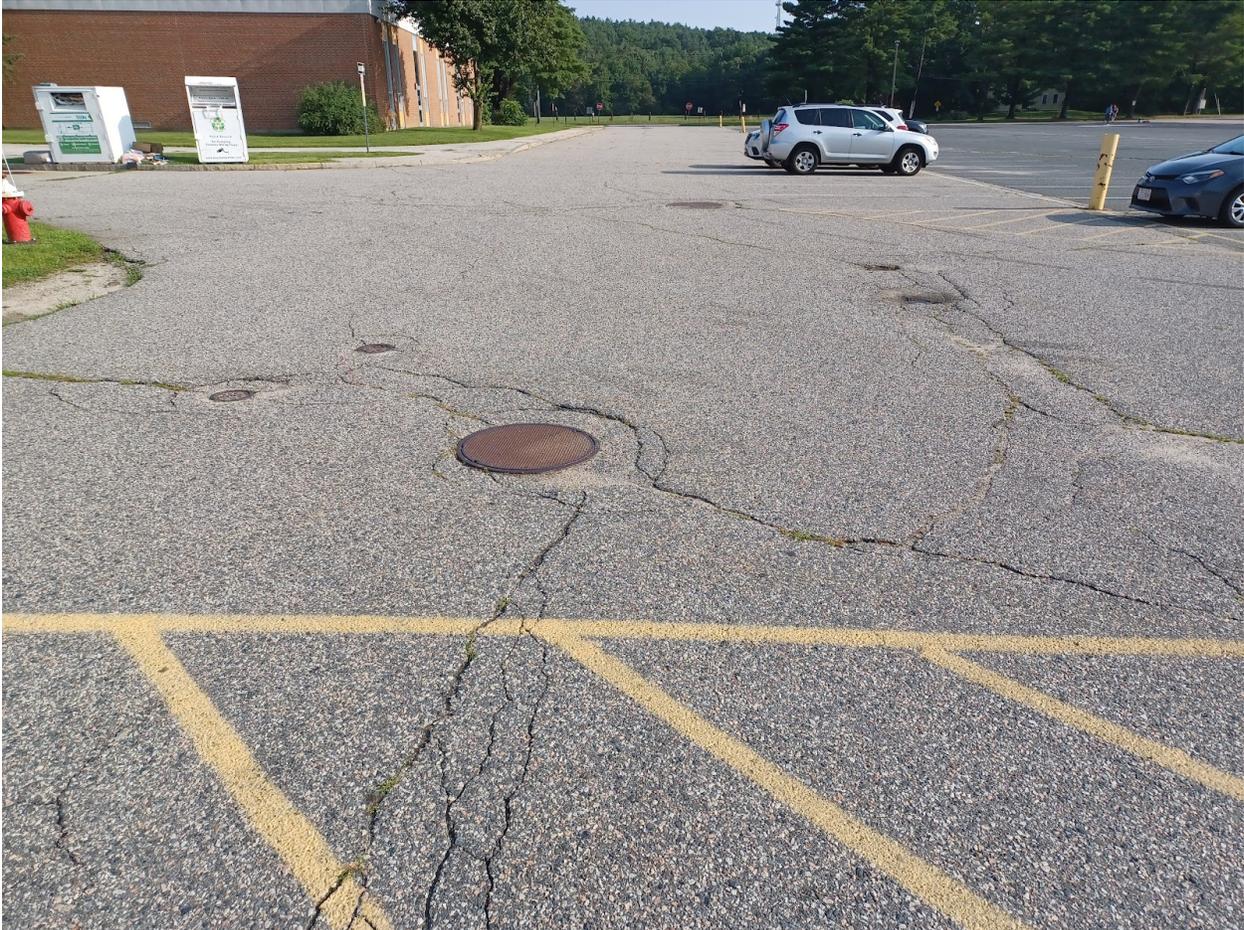
The driveways and paved asphalt surfaces are all in poor condition with various cracks, breaks and openings throughout the campus.

Poor Pavement Condition

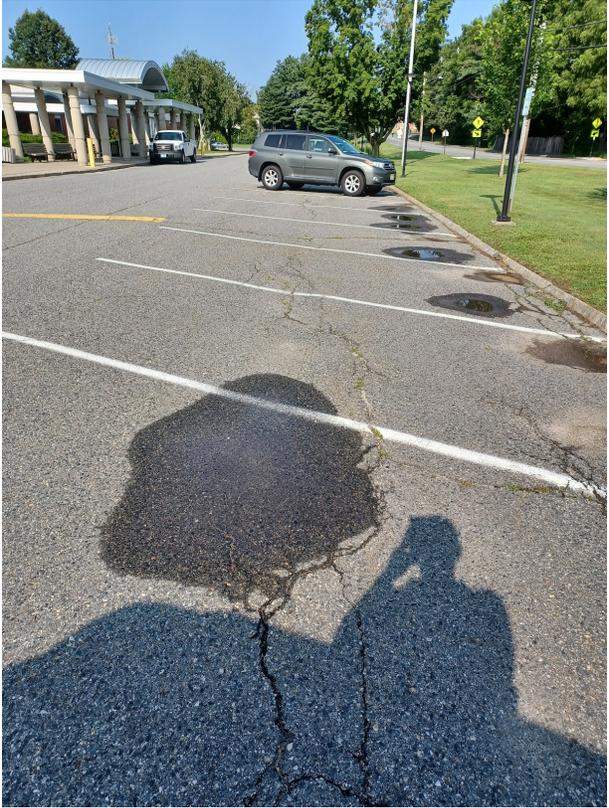
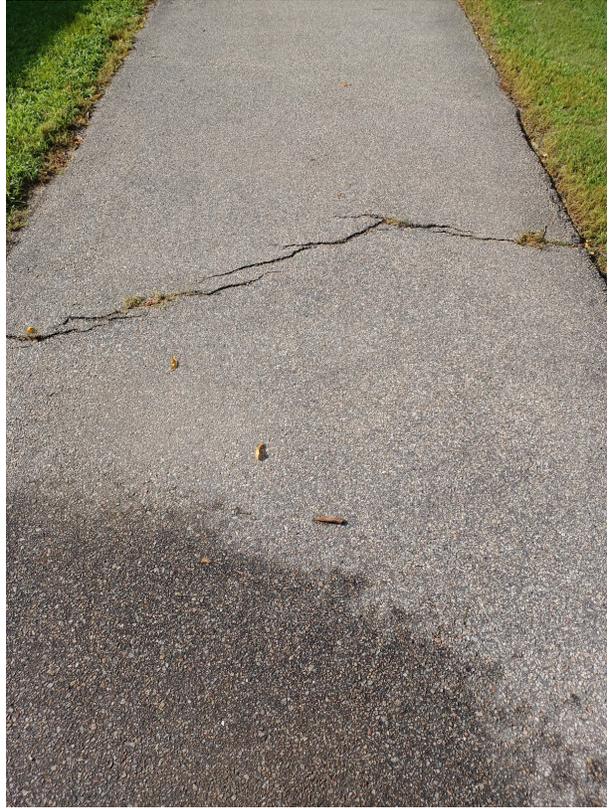
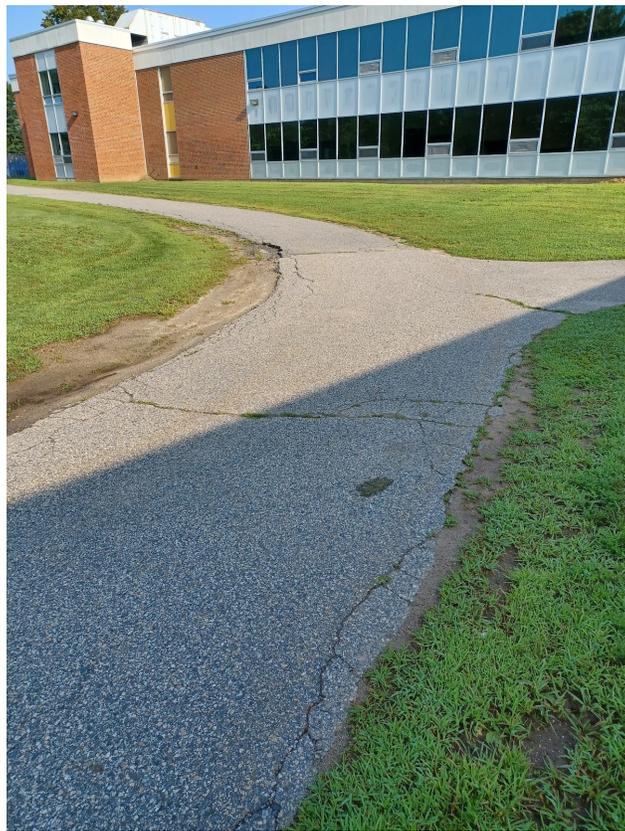
Poor Pavement Condition

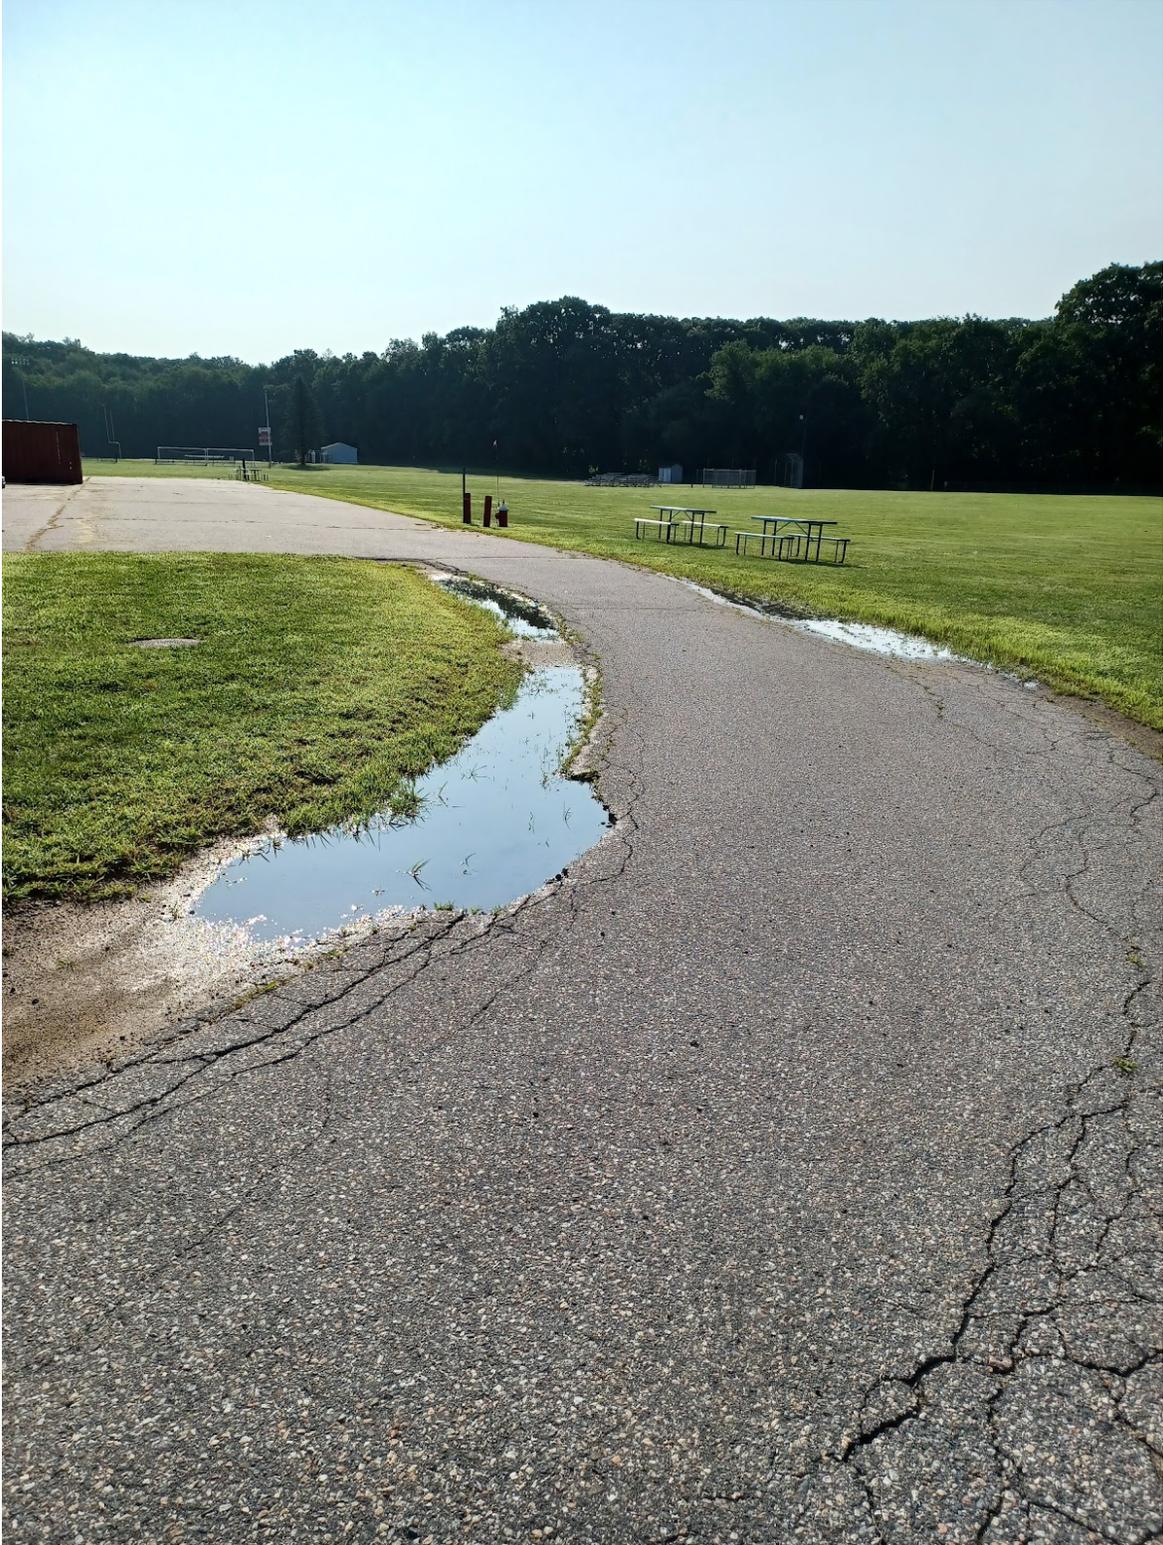
Poor Pavement Condition

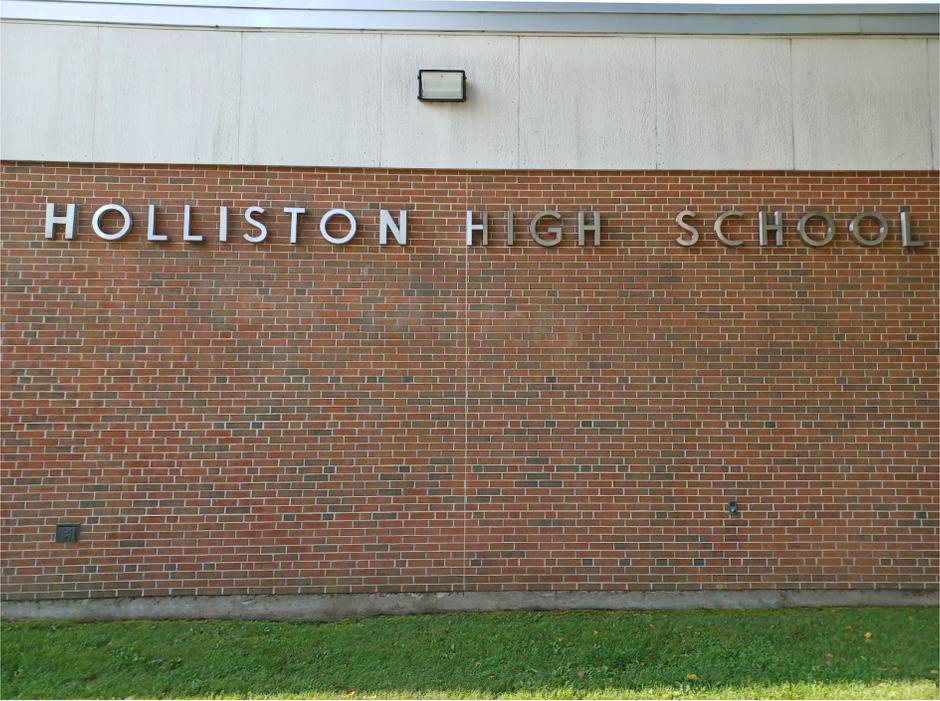
Walls, Foundation, Soffits- The exterior brick walls are in Fair condition with only a few areas in critical condition. Many areas require repointing of the mortar joints. Keeping the joints sealed will significantly improve the longevity of the brick material.

Fair Exterior Brick Condition

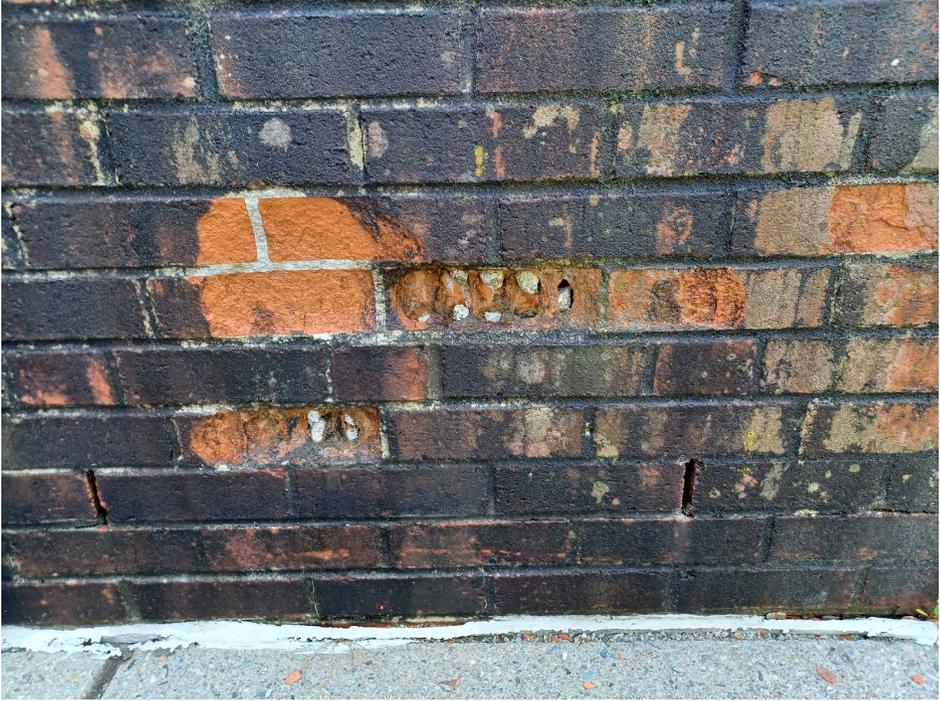
Critical Exterior Brick Condition

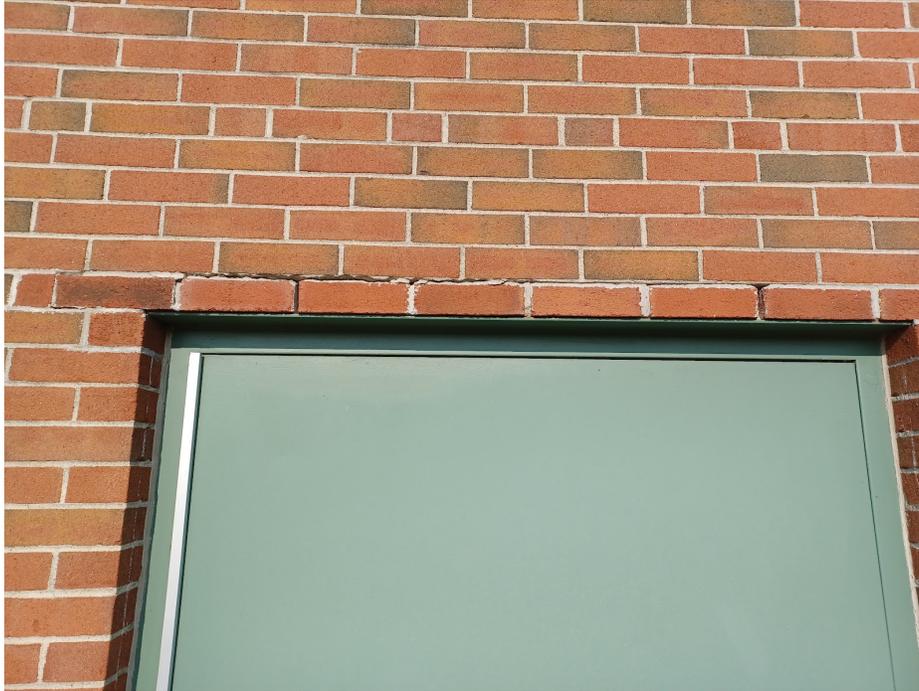
Poor Exterior Brick Condition

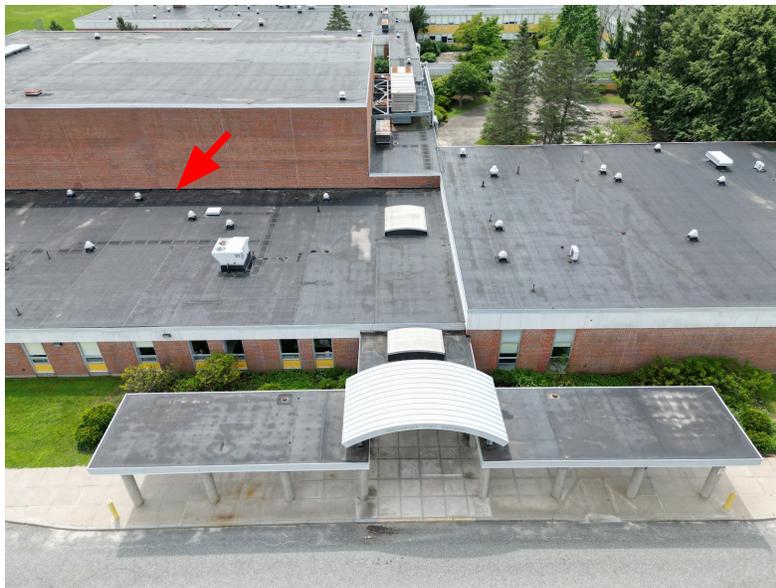
It should be noted that the brick wall area along the upper section of the auditorium had the brick drainage holes covered over with the EPDM roofing membrane during the 2001 renovation. This has resulted in an ongoing water leak issue. This area will be repaired soon. It was observed that the brick wall is bowing out in some areas. A section of this wall collapsed several years ago and was repaired by applying epoxy sealant between the brick wall and interior concrete block wall.

Area Where Brick Drainage Holes Are Covered

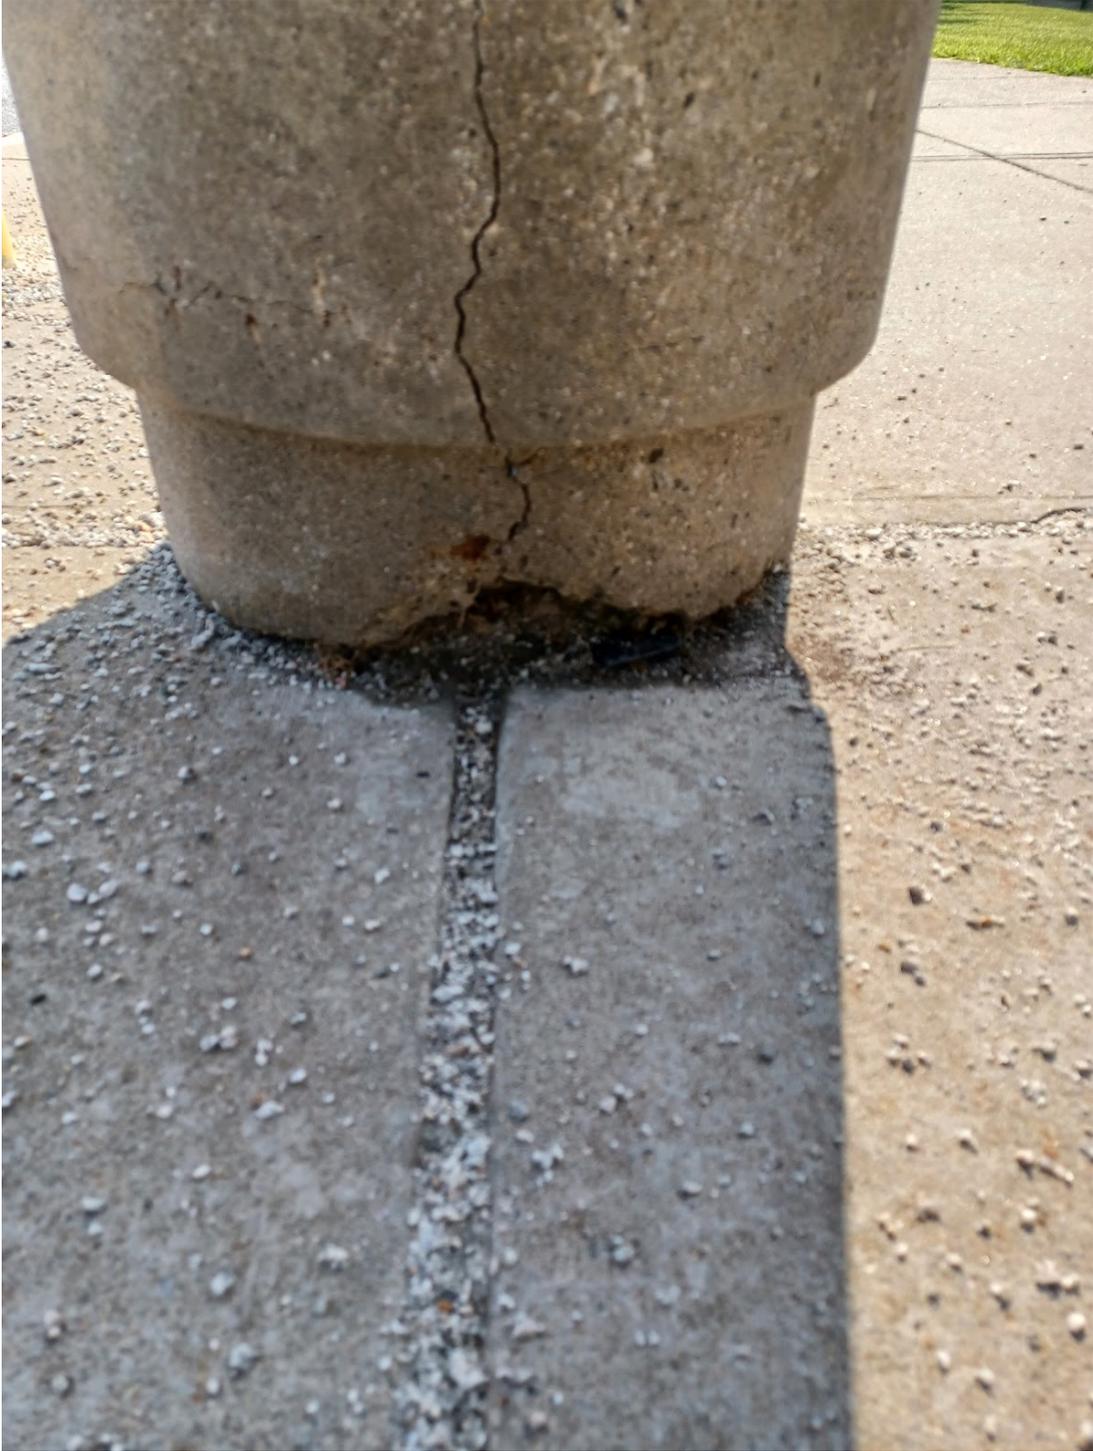
The foundation areas are generally in fair condition, however some poor to critical areas were observed and require immediate attention to prevent further deterioration. The structural columns at the main entrance have cracked and have exposed the metal reinforcement which is rusting. These columns should be reviewed by a structural engineer.

Cracked Column Main Entrance

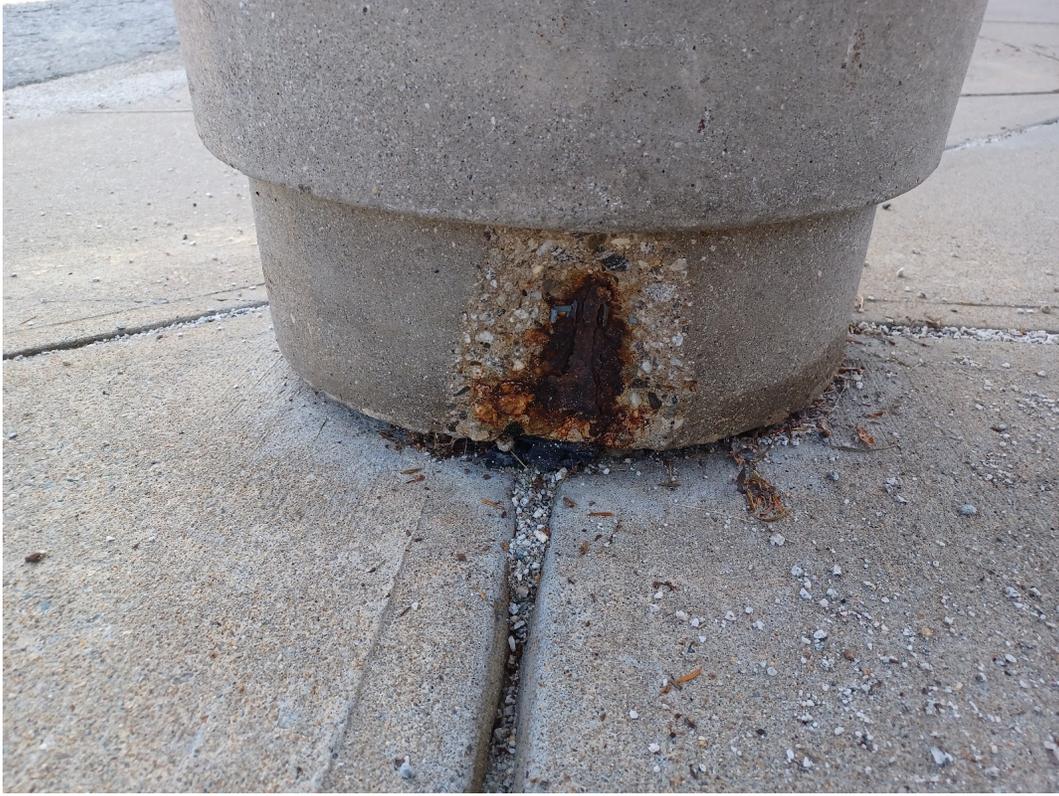
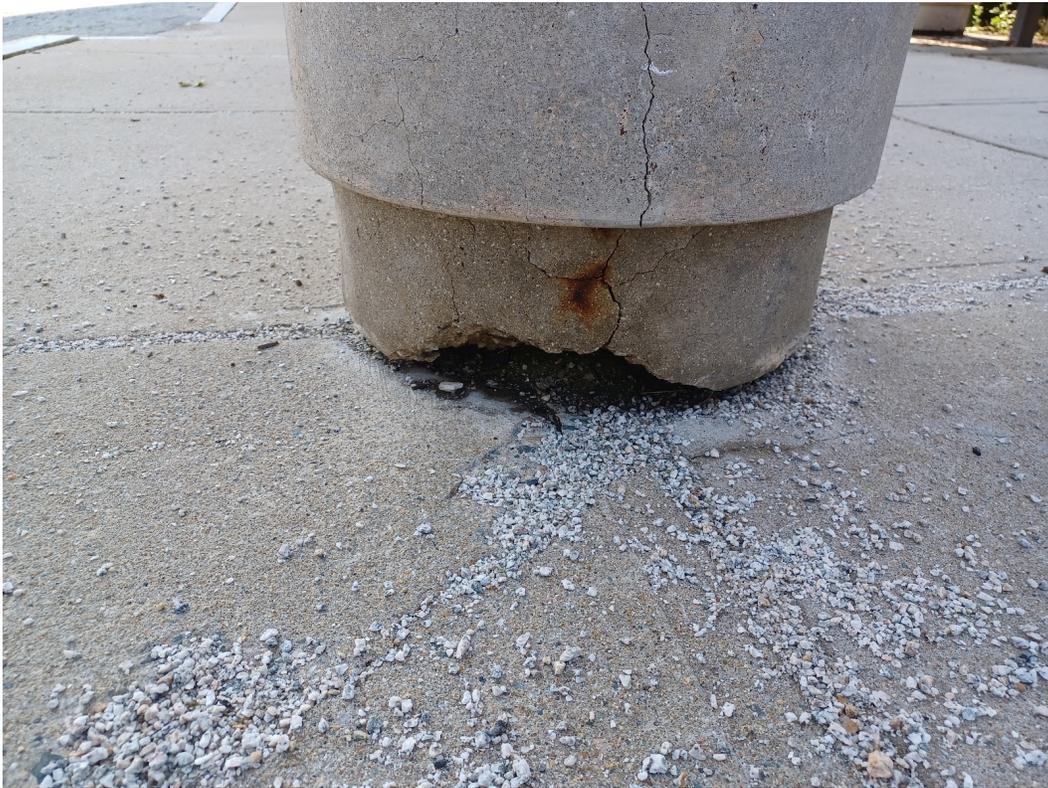
Cracked Columns Main Entrance

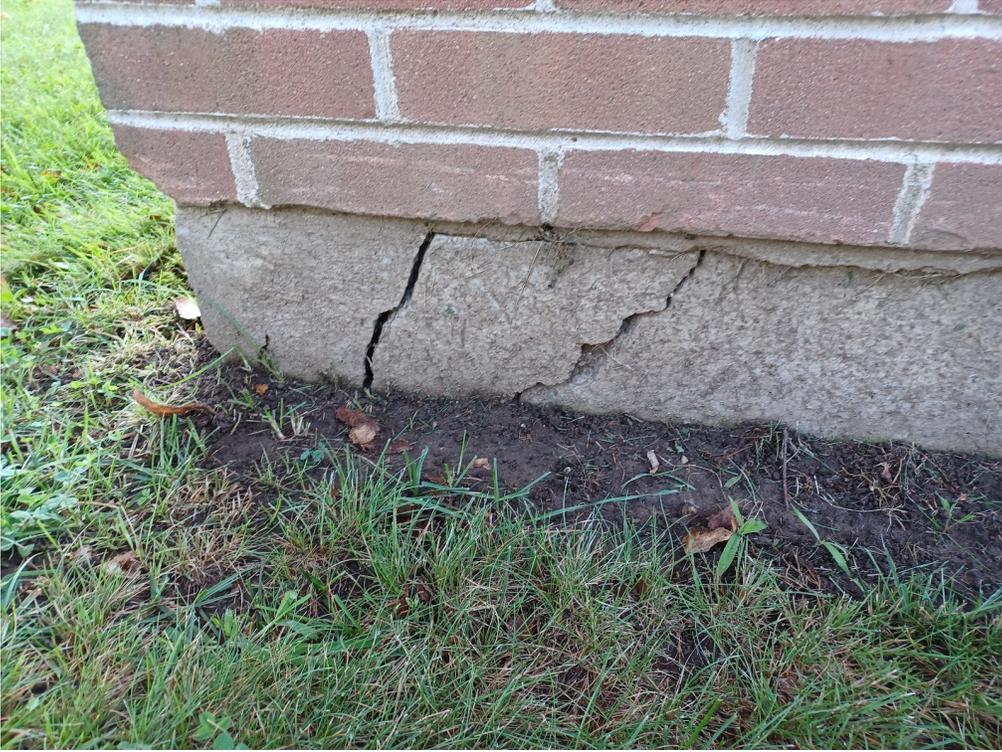
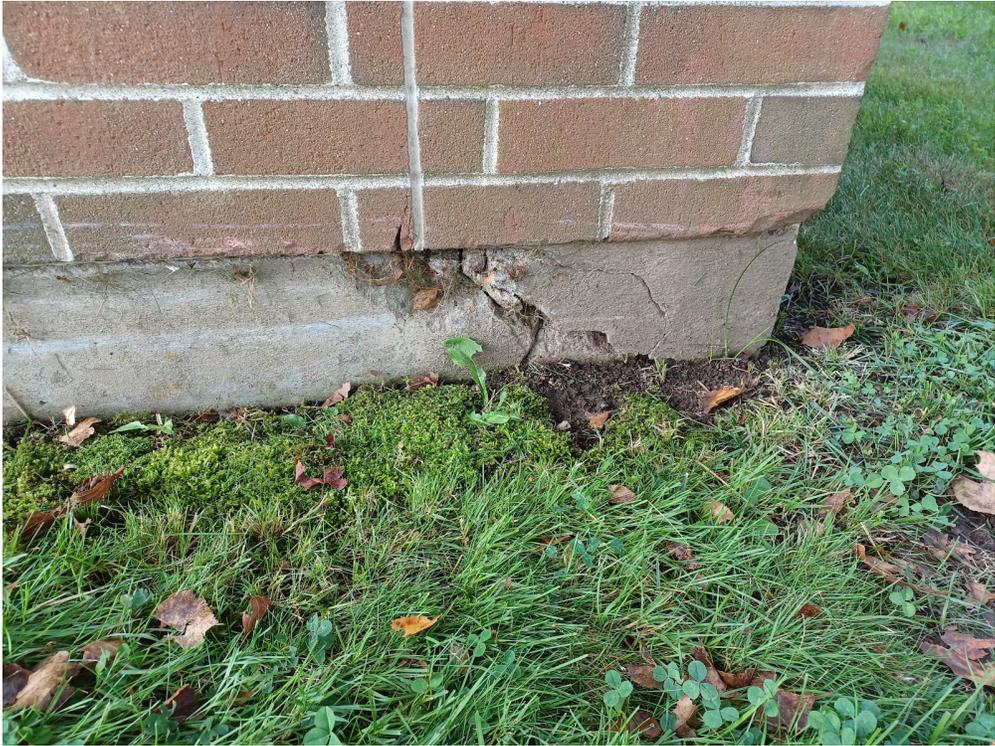
The concrete foundation on a few corners of the building have cracked. These areas should also be reviewed by a structural engineer.

Cracked Foundation Corner

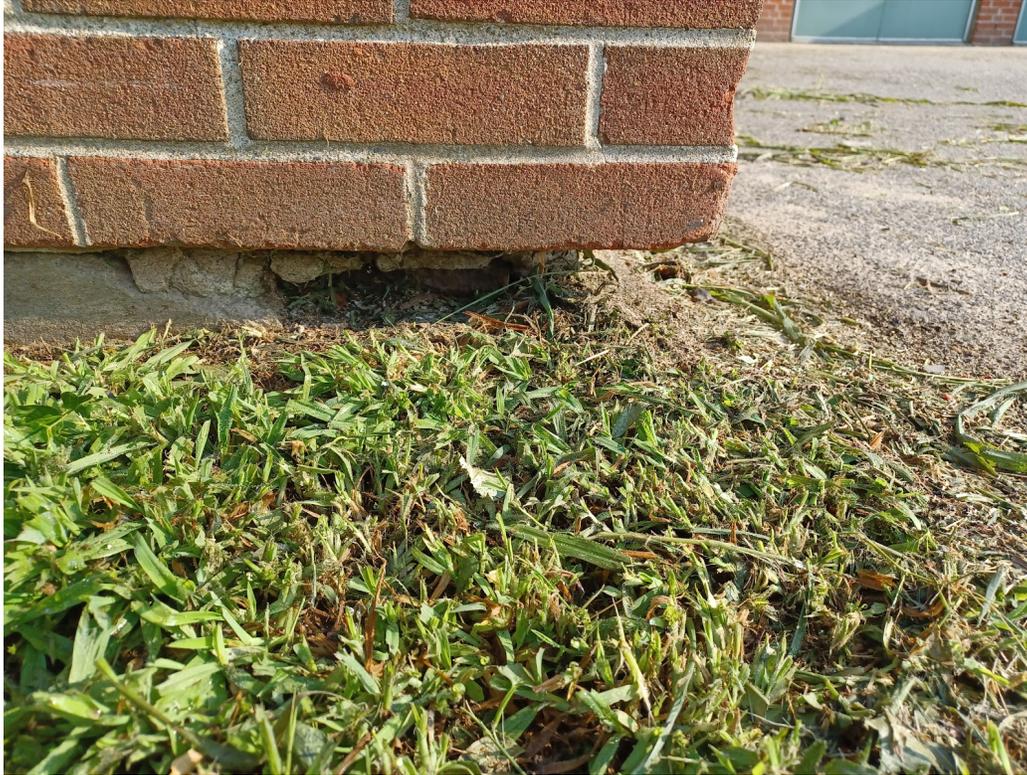
Cracked Foundation Corner

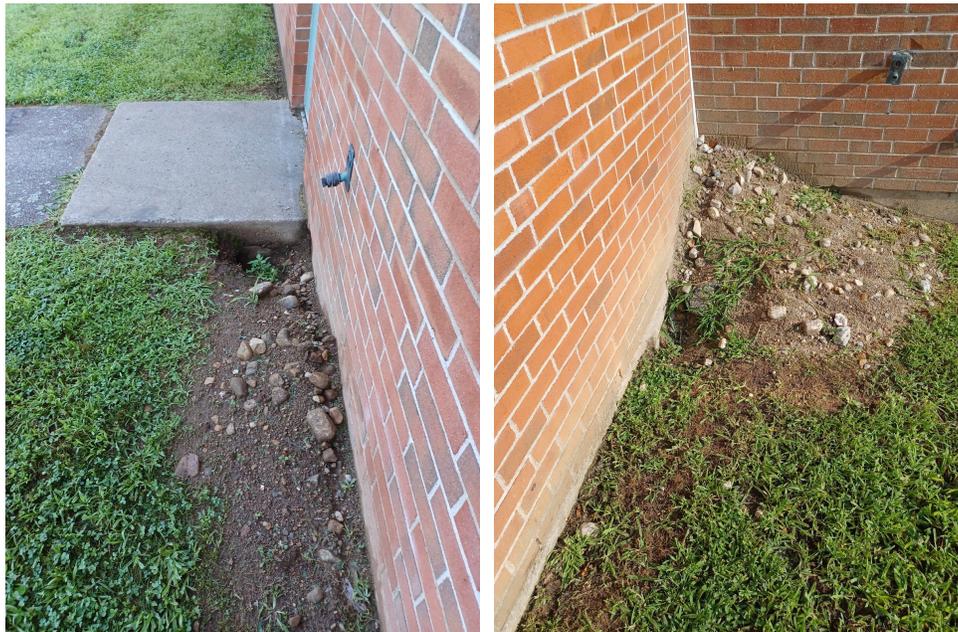
During the assessment it was noticed that several large rodent burrowing holes were around the foundation of the building.

Large Rodent Burrow Holes

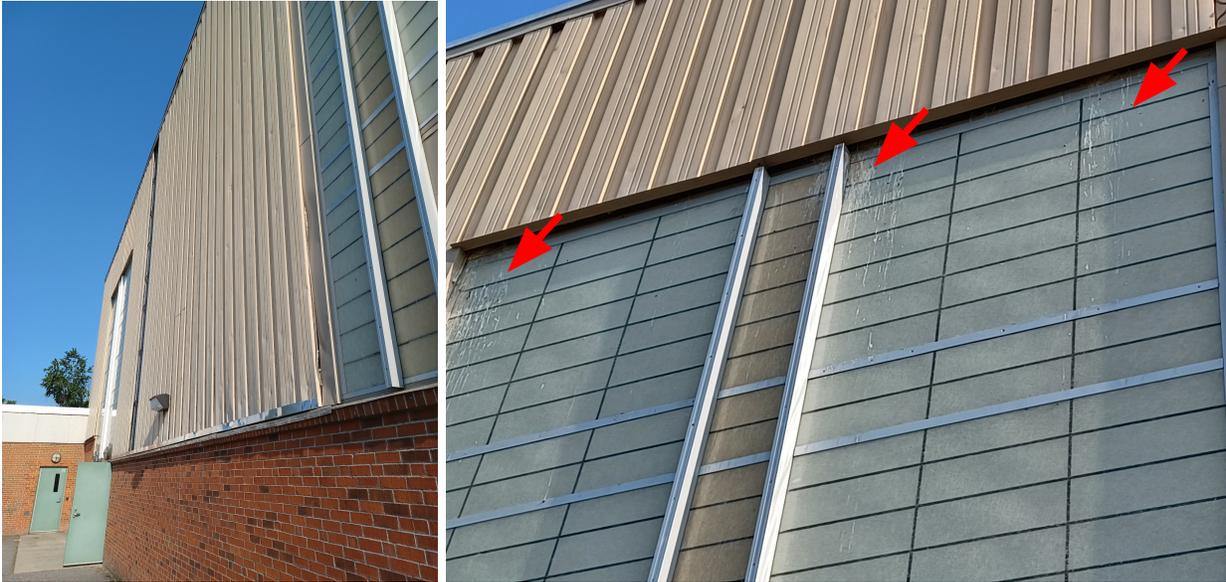
The exterior walls of the field house are galvanized metal interlocking panels with fiberglass Kalwall window inserts. It was noted that many of the panels have separated at the end joints and are flashed poorly. The areas above the window inserts are wide open allowing birds to nest above.

Field House Wall and Bird Nesting Areas

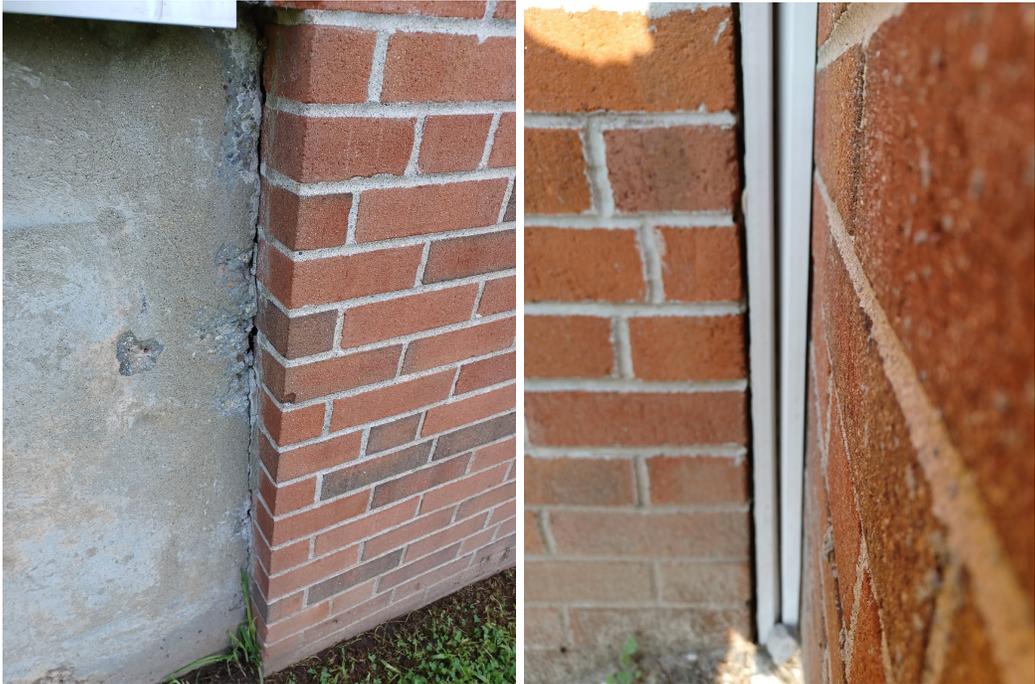
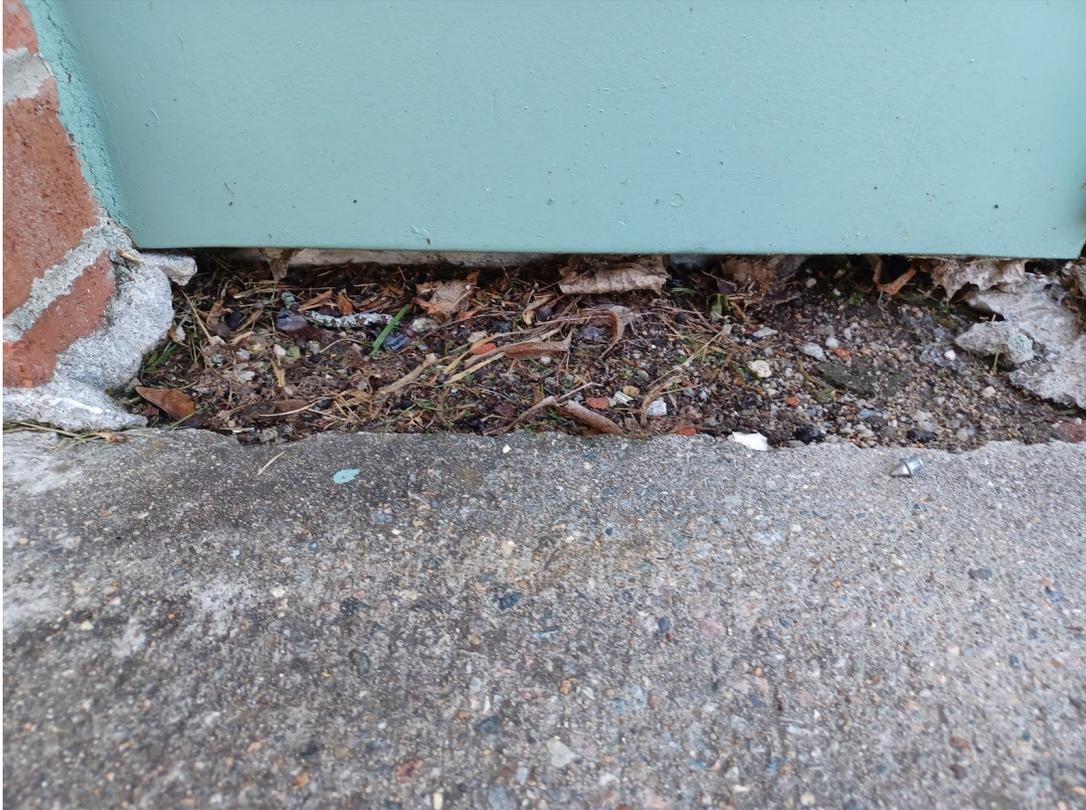
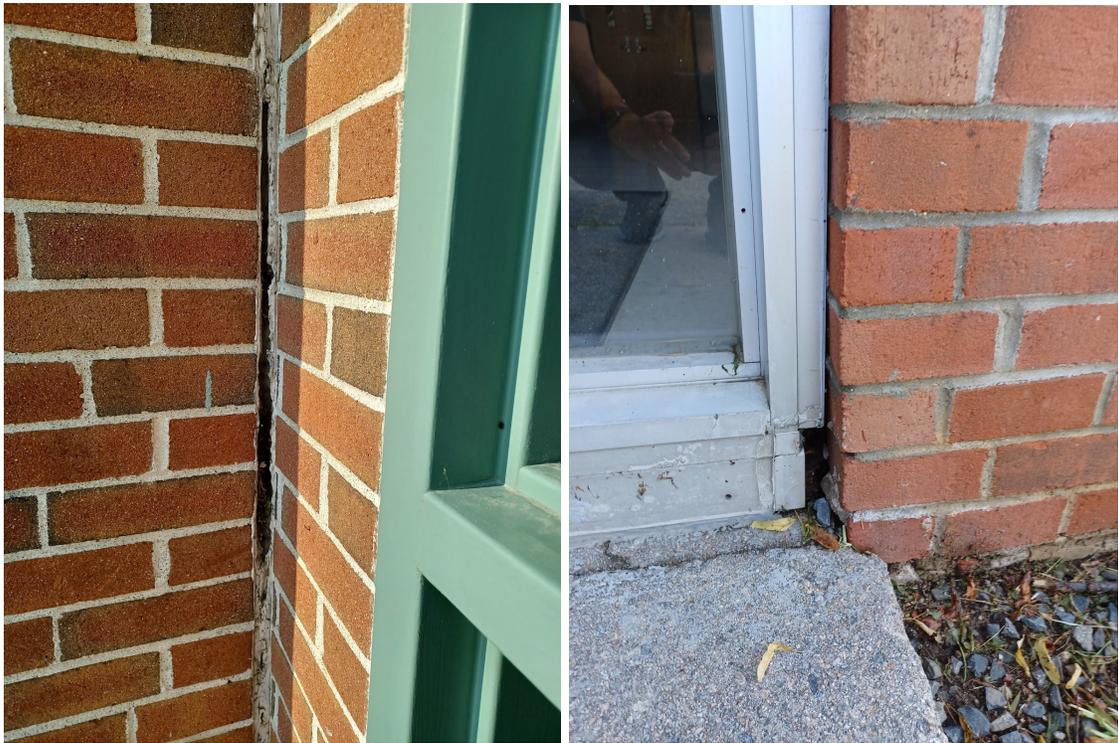
Several open conditions/gaps were noted in the exterior walls. These gaps allow pest, water and air infiltration into the building.

Open Wall Gap Areas

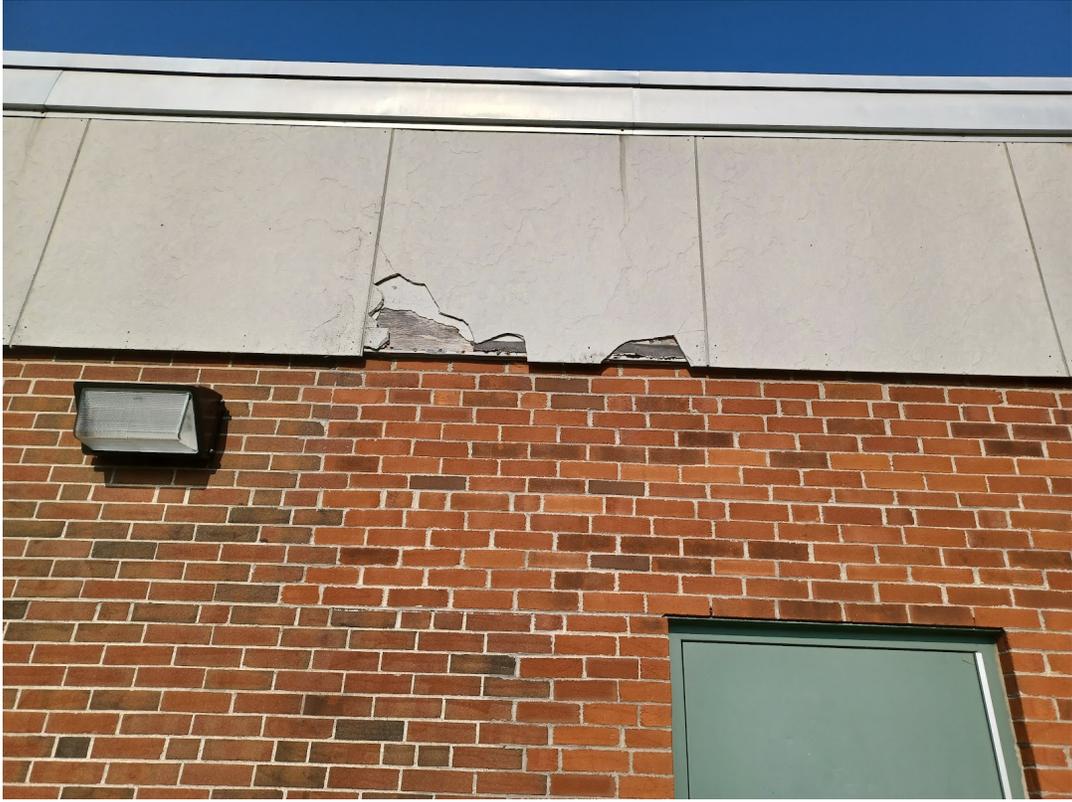
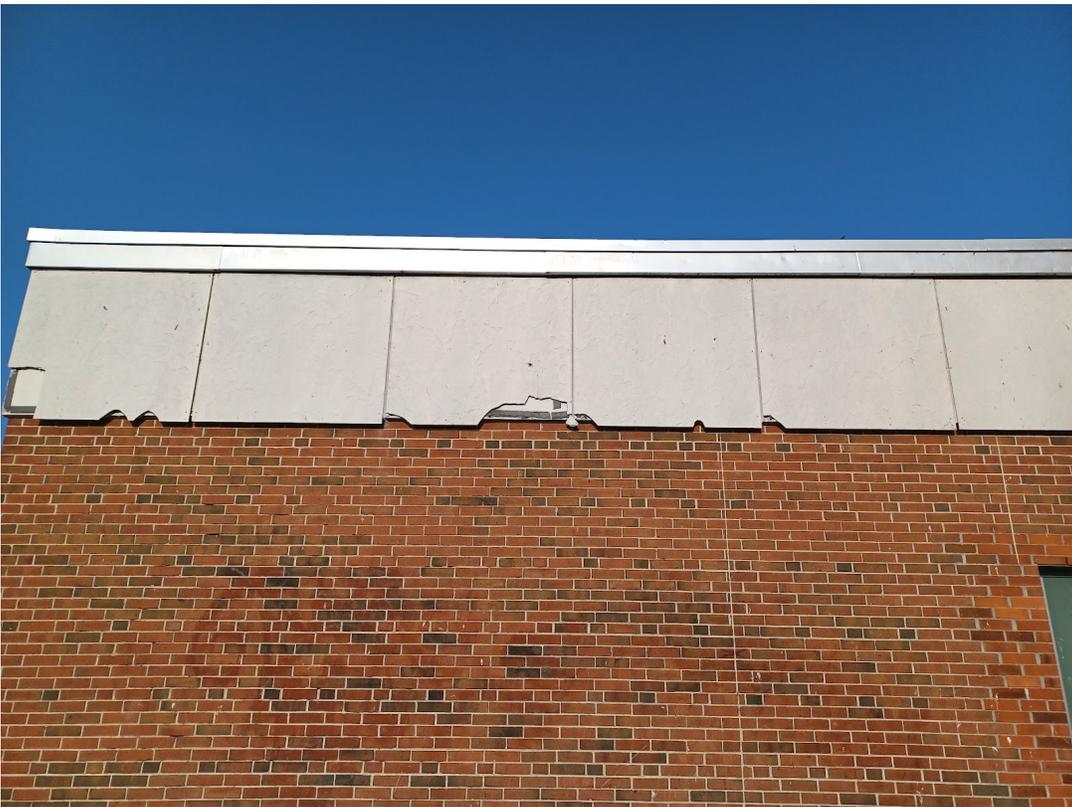
The facias are masonite panels approximately two feet tall and wrap around the perimeter of the building. These panels are generally in Fair to Good condition. It was noted that several panels were cracked. The panels in the shaded areas were also covered with organic materials like mold and algae.

Cracked Masonite Panels

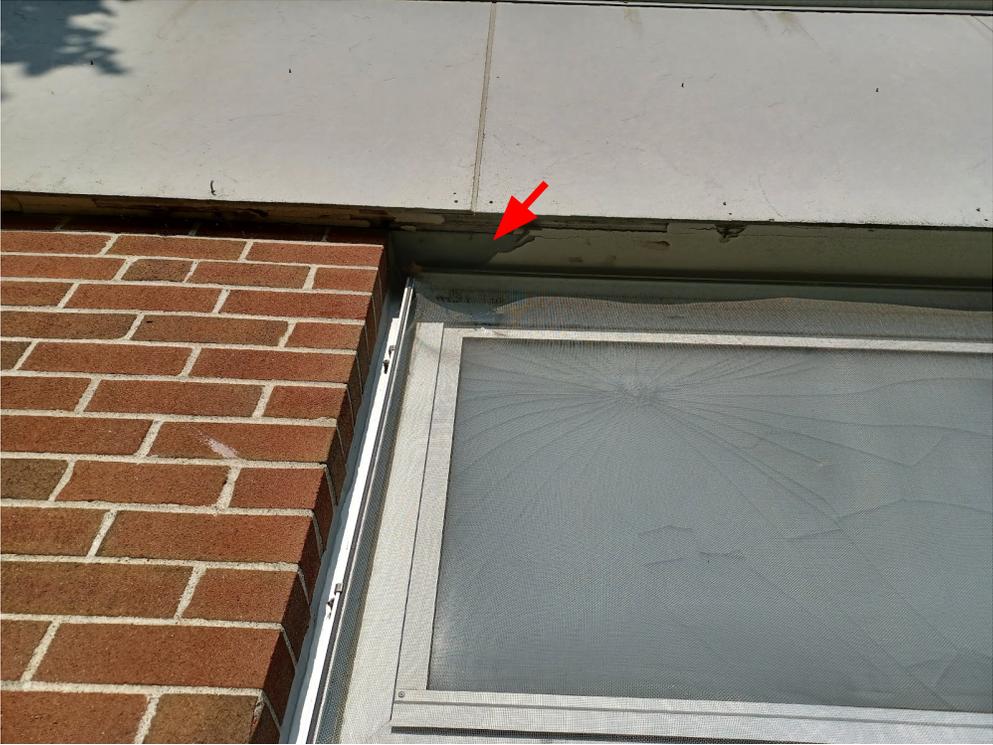
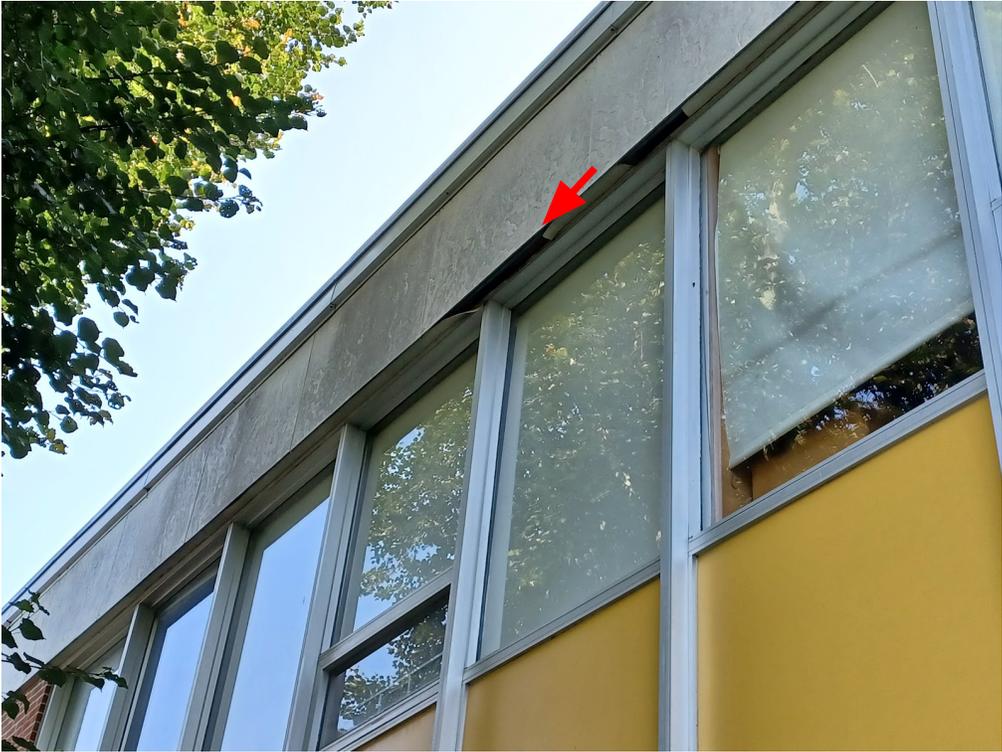
Some of the wall areas have a soffit. All of the soffit areas are in Critical condition and are in need of repair.

Damaged Soffits
