From: James Keast - Facilities Manager

Date: Aug 18, 2023

Re: **Facility Condition Assessment - Holliston High School 370 Hollis Street**

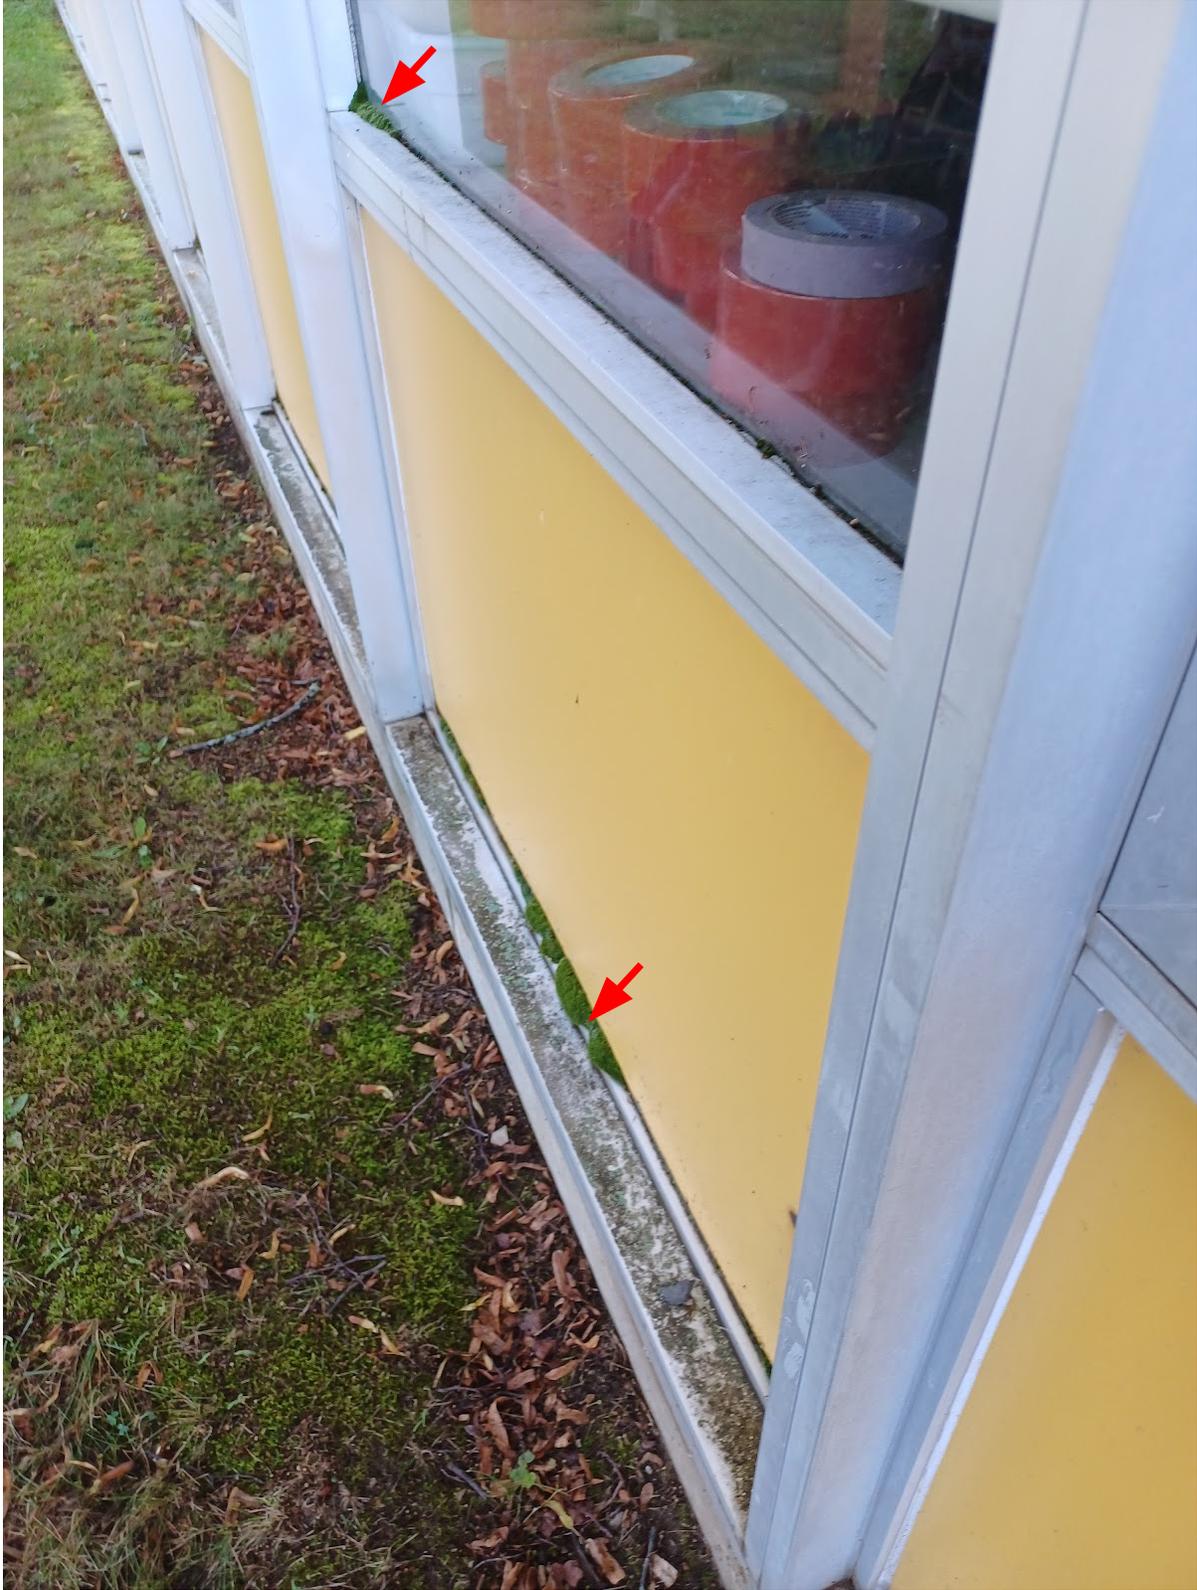
In general the panel wall system is in Fair condition with some repairs that have taken place over the years. Glass that required replacement was done with more energy efficient double pane units. However, the window glazing used to hold the window into the frames has failed and in critical condition. The glazing has deteriorated to the point where moss and other organic growth has filled the gaps allowing for water and air infiltration.

Critical - Failed Window Glazing

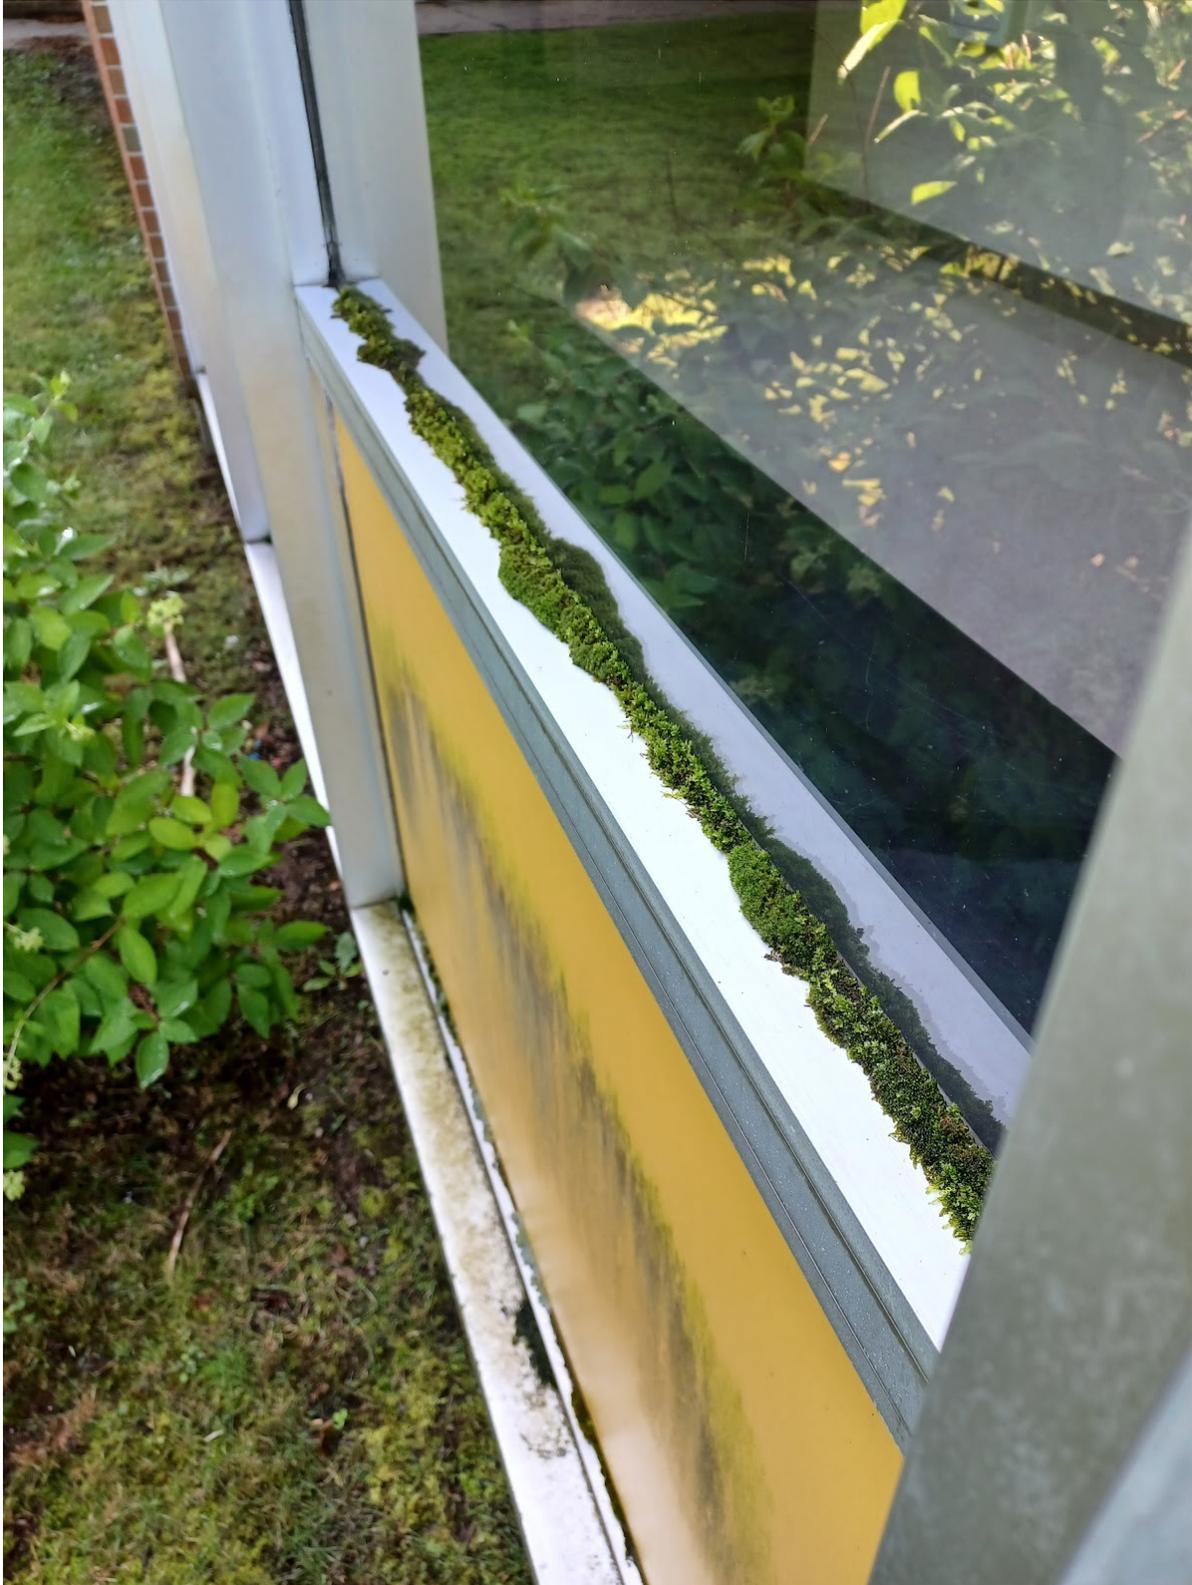
Critical - Failed Window Glazing

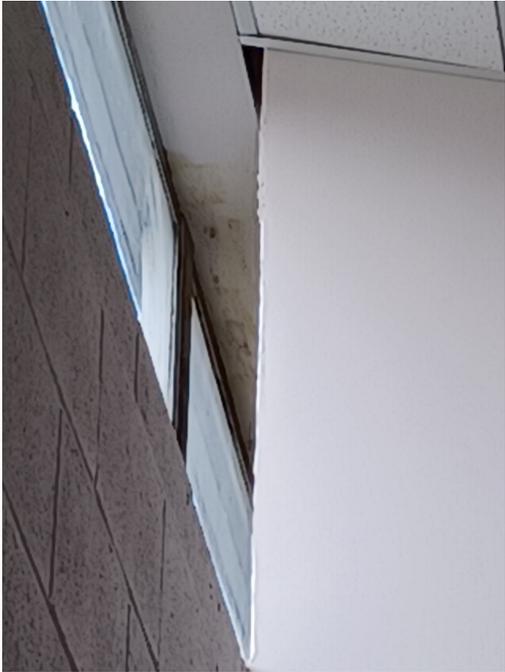
Interior Roof Leak

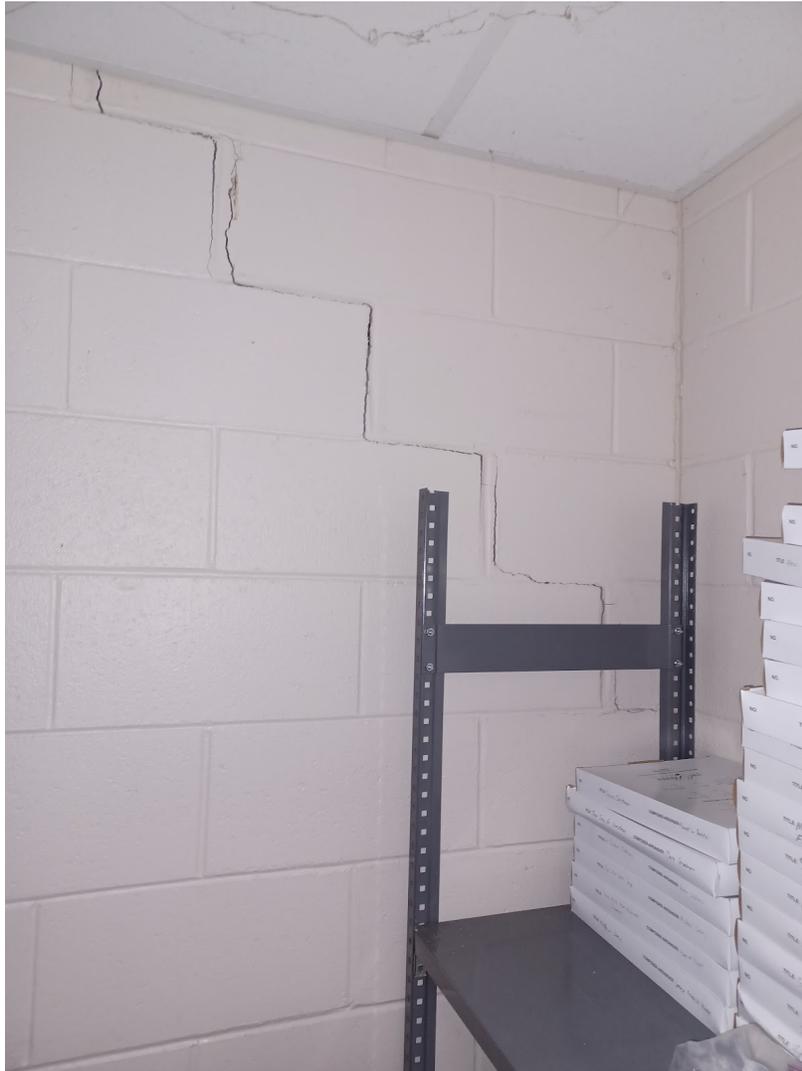
Walls- The interior walls are in Fair condition and primarily constructed out of concrete block. Most walls are freshly painted. However some cracks were observed. Although the cracks are present there does not appear to be any serious structural concerns.

Crack Observed in Concrete Block Wall

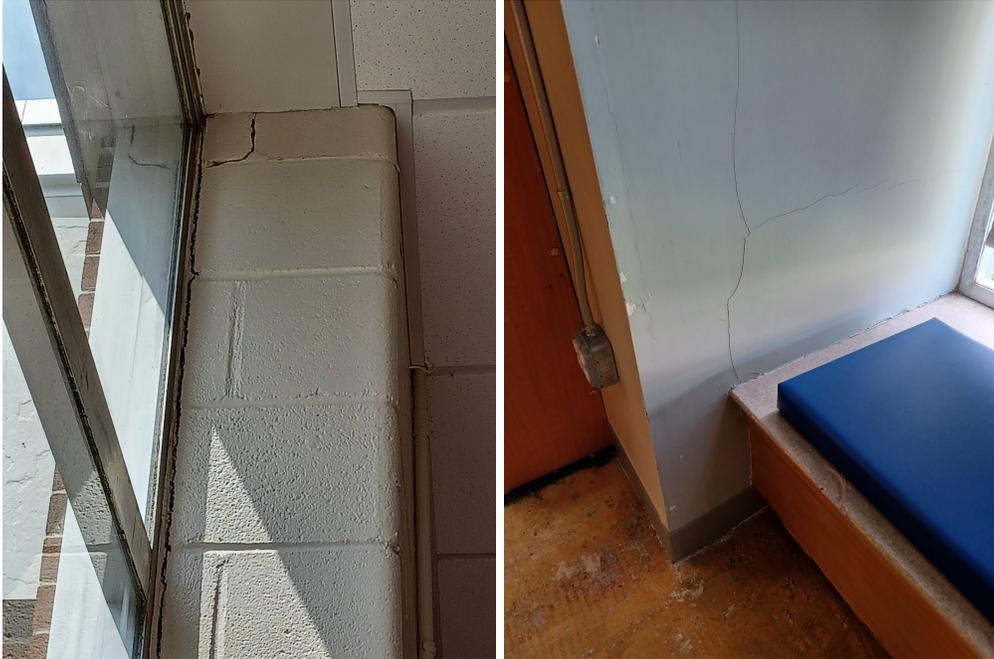
Additional Wall Cracks

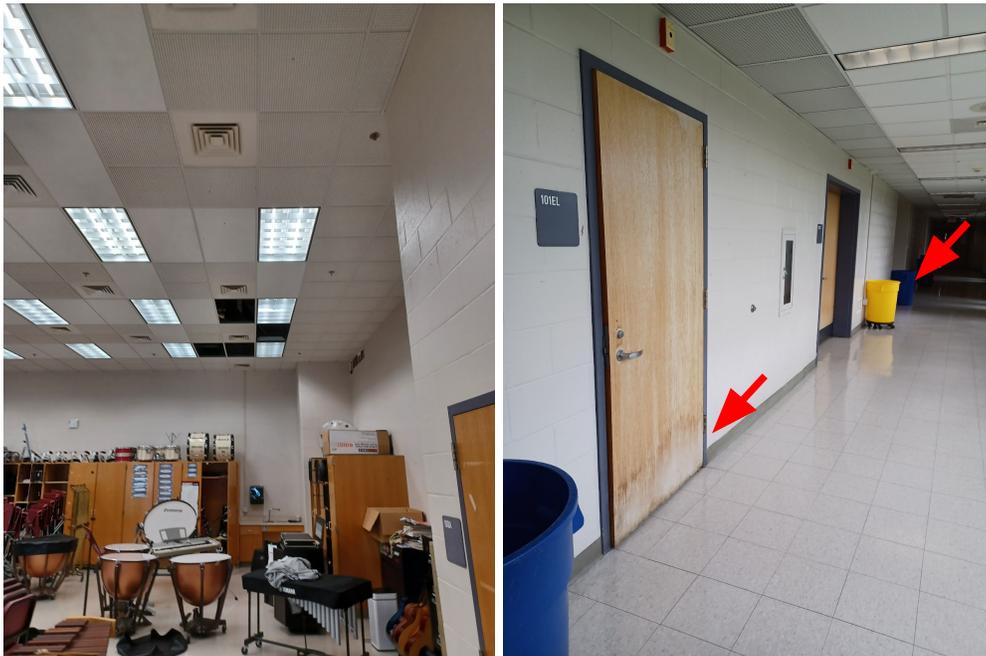
Ceilings- The ceilings are primarily a suspended grid tile system. Most of the ceilings are in Fair condition with few tiles damaged, stained, cracked or missing. The ceiling tiles around the perimeter of the auditorium where the persistent roof leaks are present have been replaced with plastic egg-crate panels to allow the water to flow through and be captured in barrels during heavy rain storms.

Ceiling Tiles Missing; Egg Crate Panels with Barrels Catching Rainwater. (Note Water Damaged Door)

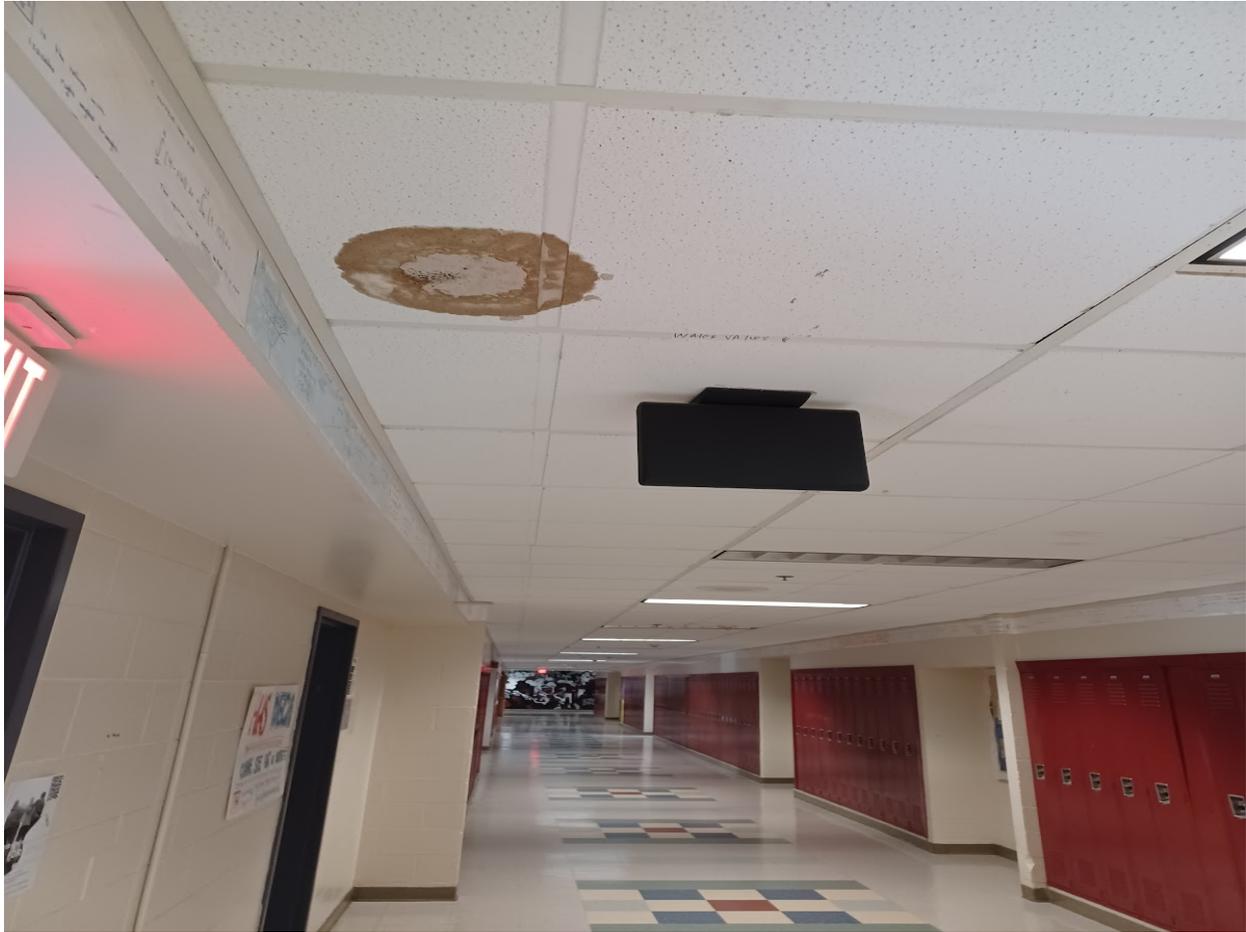
Water Damaged Ceiling Tiles

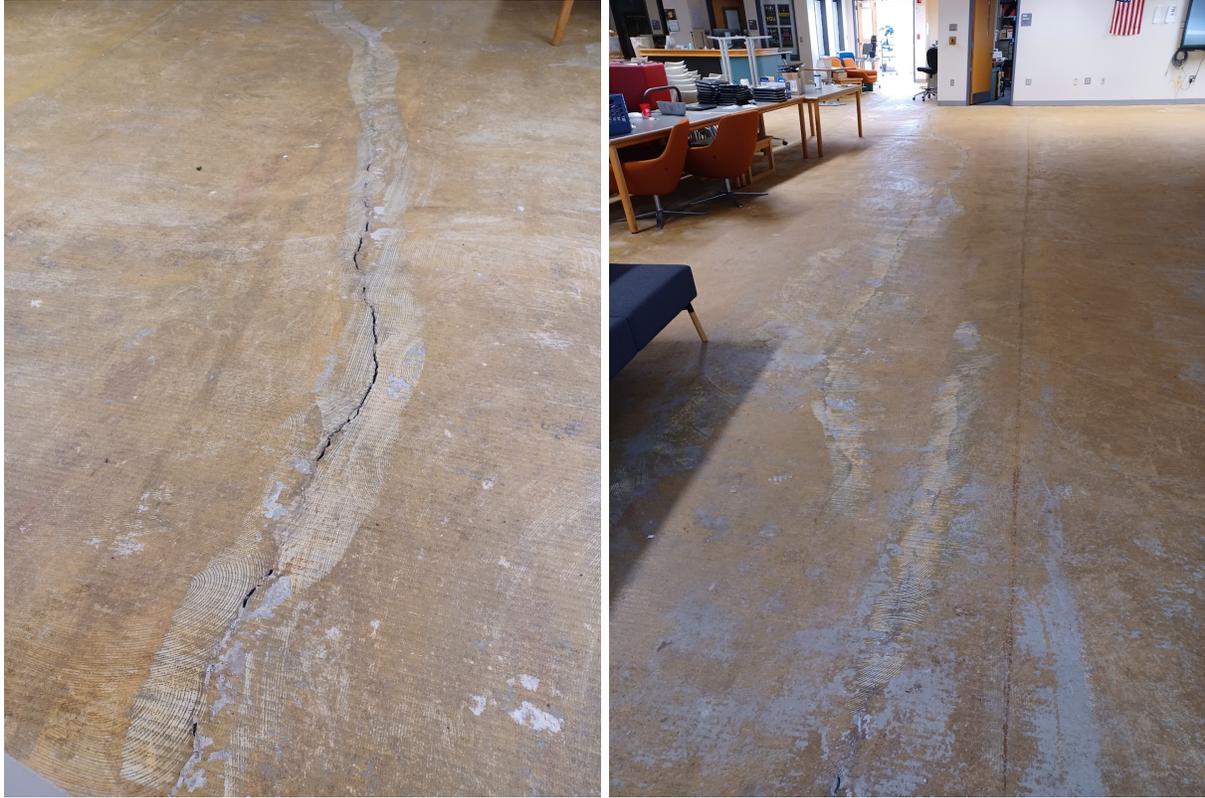
At the time of this review the carpet in the library was removed exposing the concrete slab. It was noted that a large (greater than ¼") crack was running through the center of the library. This is a large breakage of the slab indicating some significant settling of the base material has occurred.

Large Crack in The Library Concrete Floor Slab

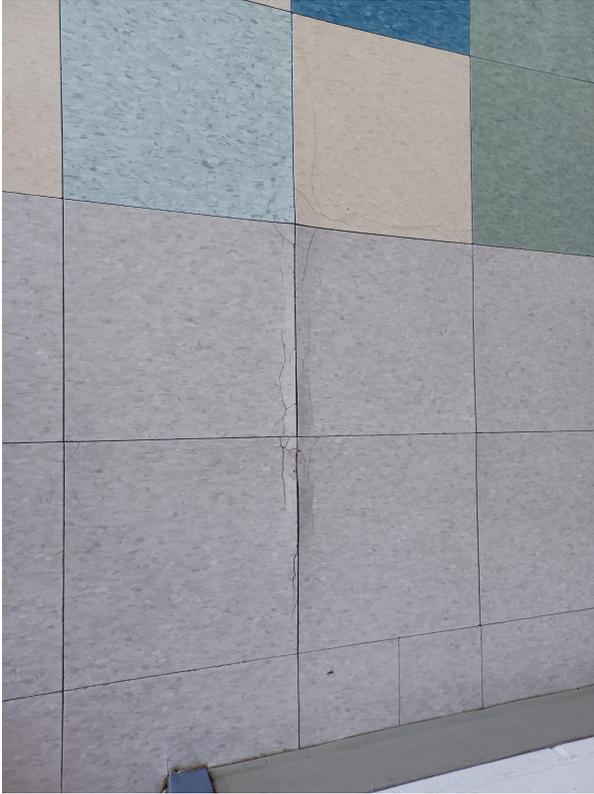
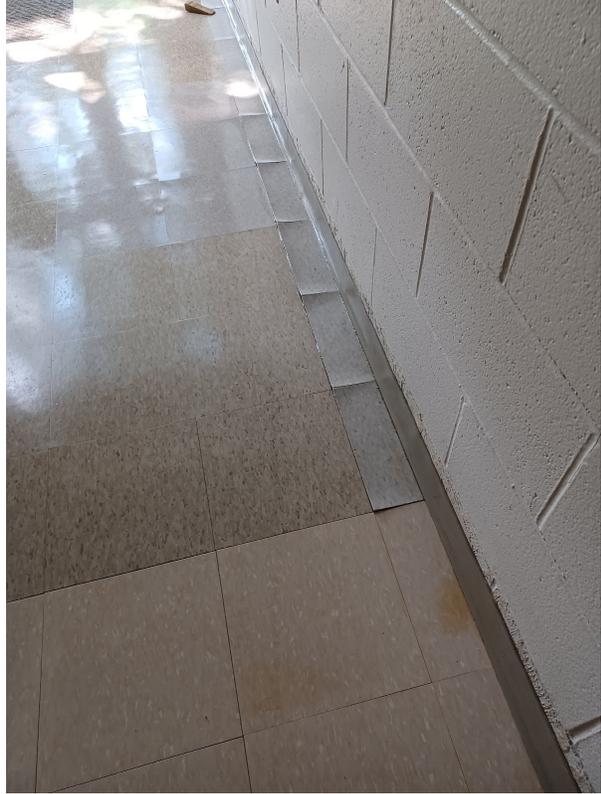
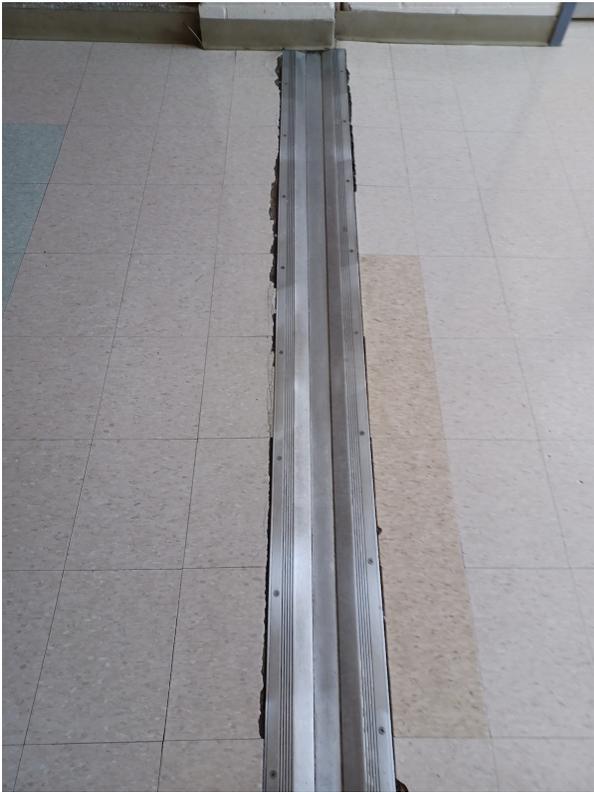
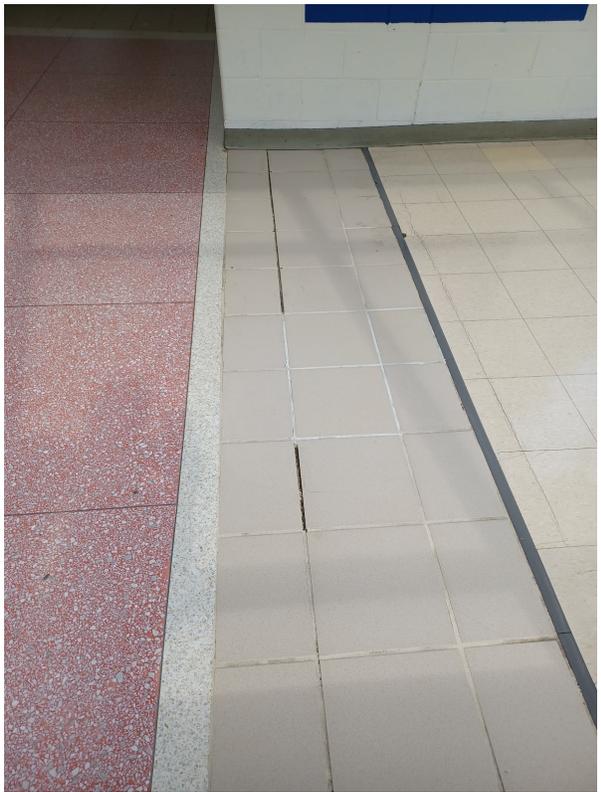
The VCT Floor is in Fair to Poor condition with some cracking and buckling observed. All of the tile surfaces have been recently waxed in preparation for the beginning of the school year.

Worn, Cracked, Buckled VCT and Ceramic Floor

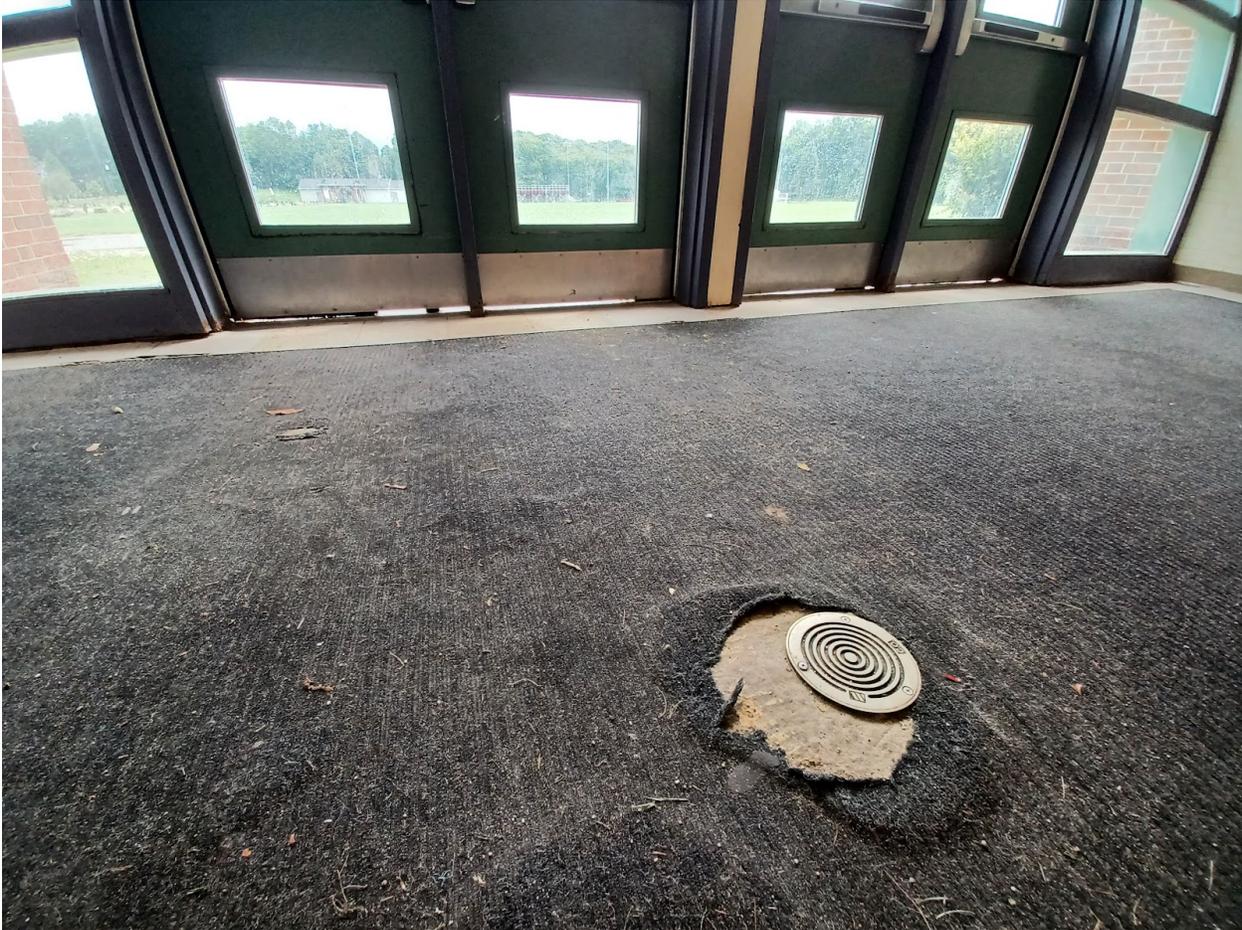
The carpeting is in Fair condition with remaining useful life. The library floor will be new. The entryway carpeting is in a failed condition and poses a trip hazard.

Failed Entryway Carpeting

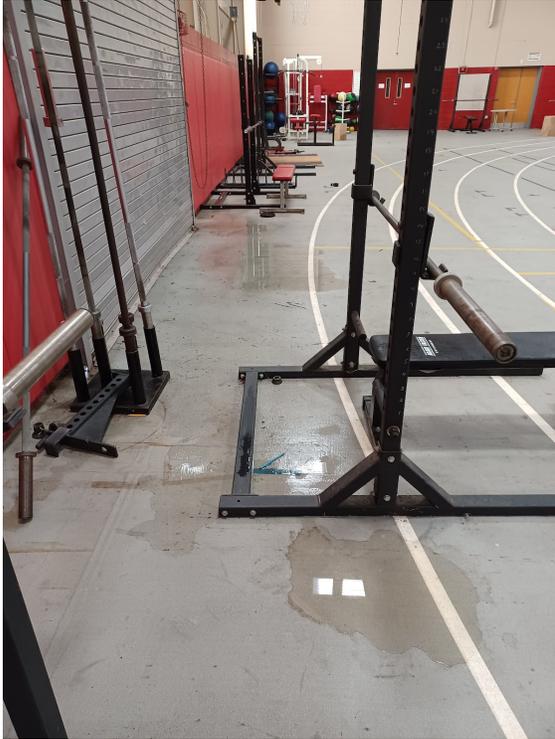
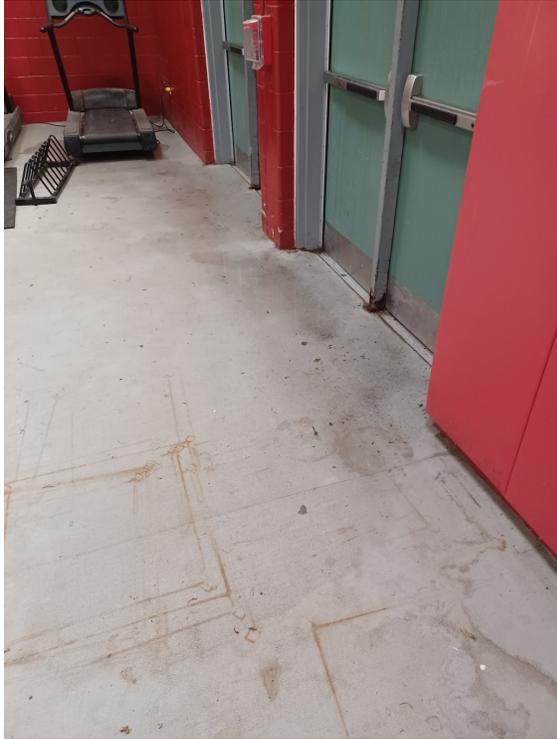
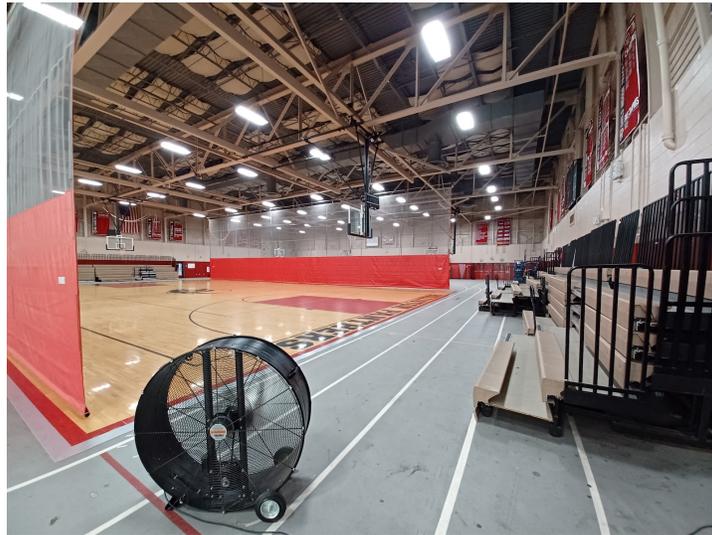
The fieldhouse floor is in Fair condition with the Maple Hardwood floor being in Good condition. It was observed however that rainwater has entered through the doorways in the fieldhouse and collected on the rubberized flooring surface.

Fieldhouse Floor (Note Water by Doors)

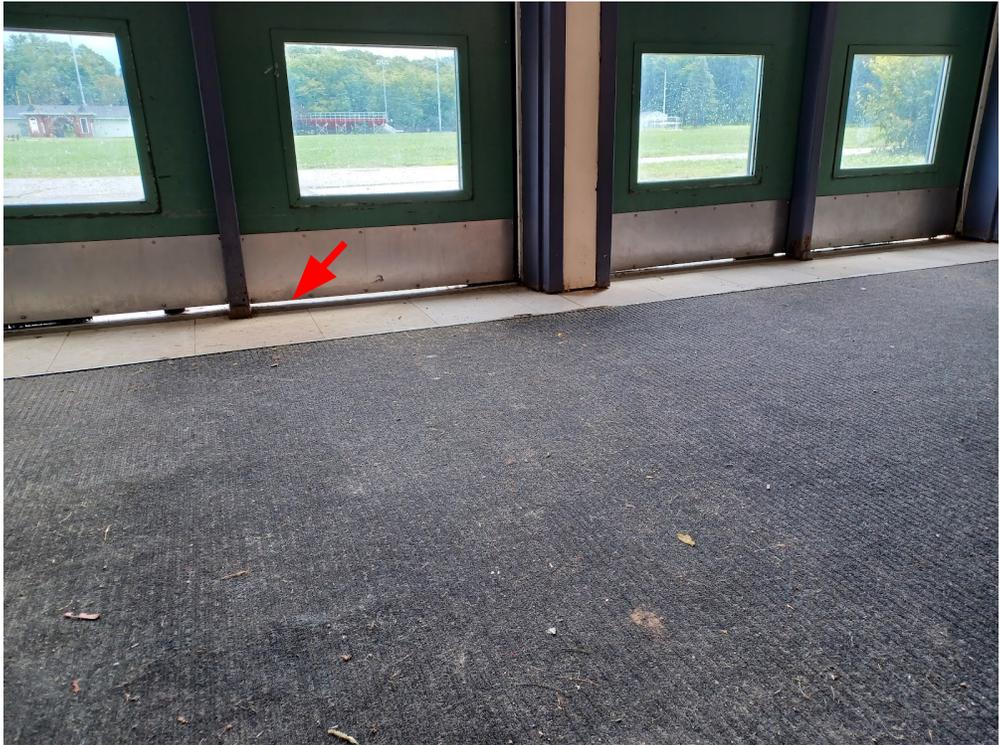
Most of the doors and windows are past their useful life. All of the exterior metal doors have various levels of rust, with some completely rusted through. The weather stripping around all of the exterior doors has failed significantly, impacting energy efficiency. The weather stripping around the windows has also failed allowing for air leaks and vegetation to enter the building.

Air Gaps Around Exterior Doors

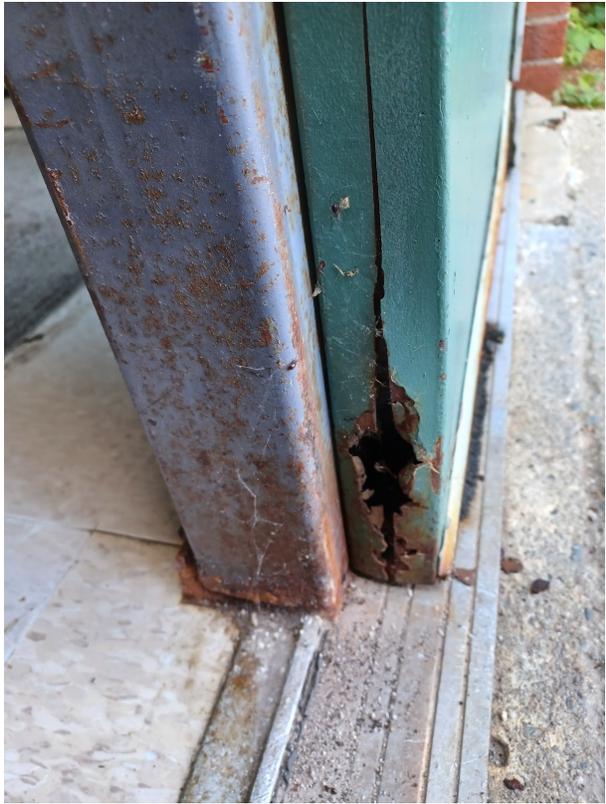
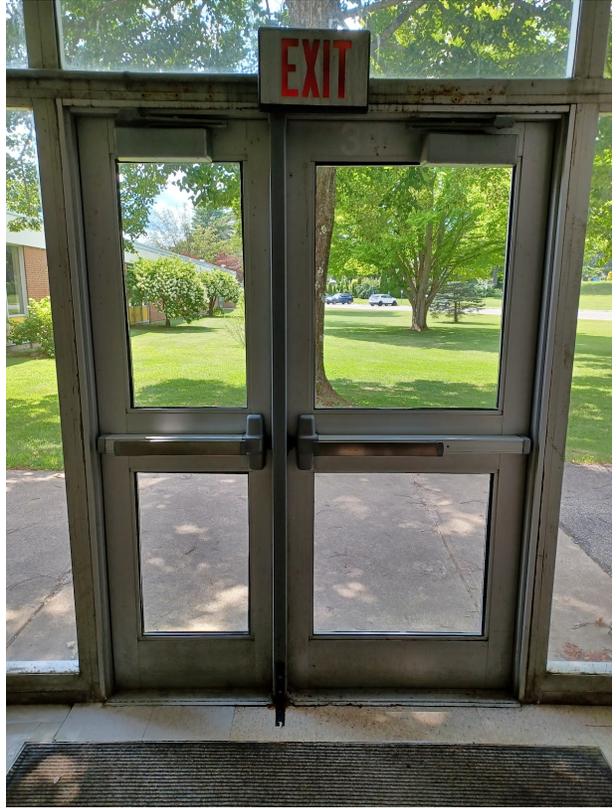
Rusted Steel Door and Deteriorated Aluminum Door

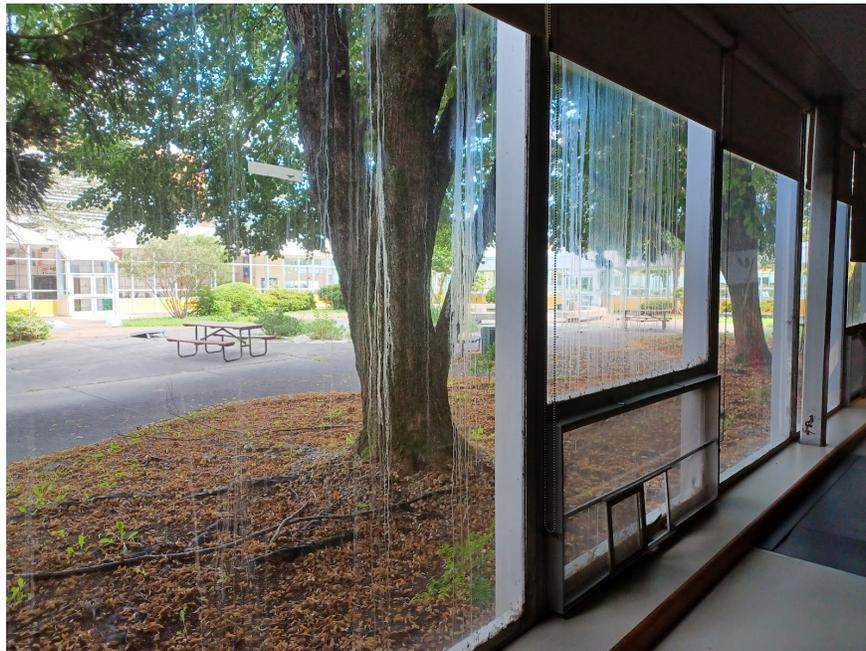
Leaking Windows

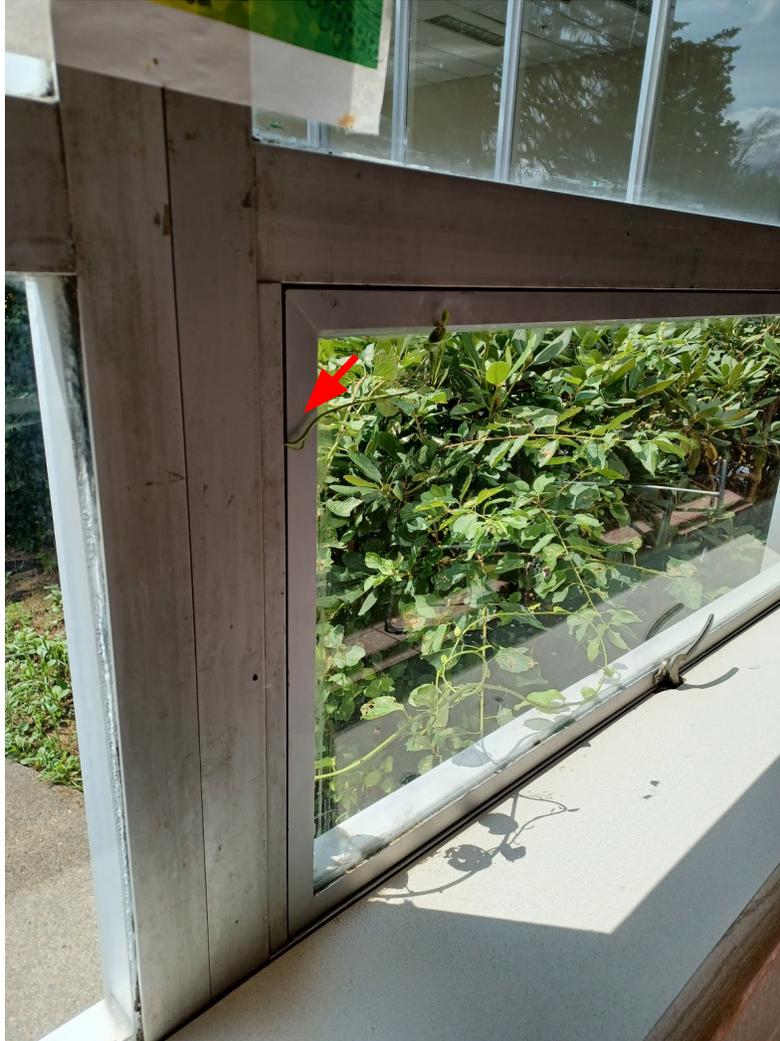
Vegetation Growing Through Gap In Window Frame

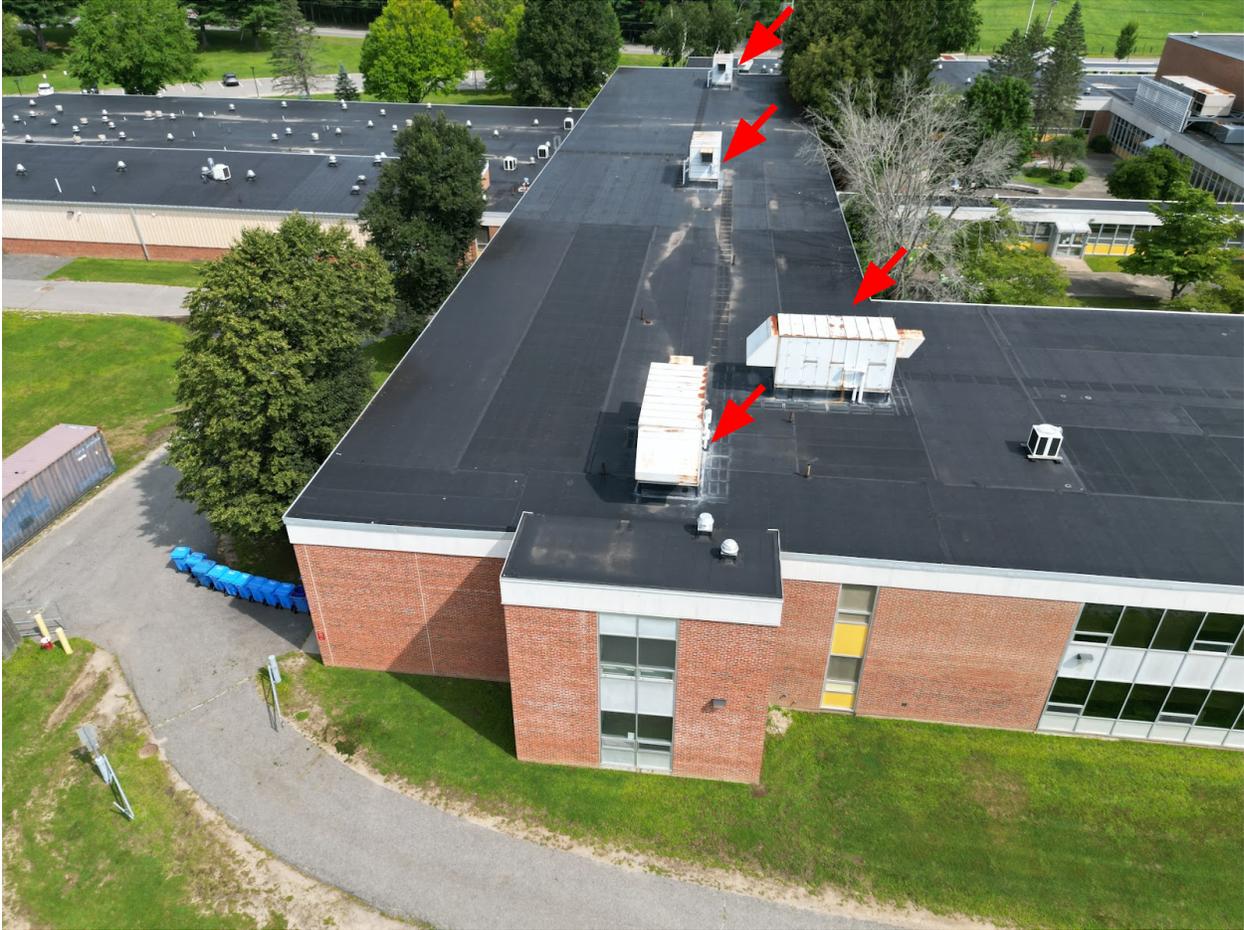
There are 11 roof-top make-up air units, 7 that use hot water from the boiler to heat the air in the winter and four that use natural gas. All of these units are original from the 2001 renovation and have reached the end of their useful life. Many components have been replaced, but due to the age many parts are getting difficult to obtain.

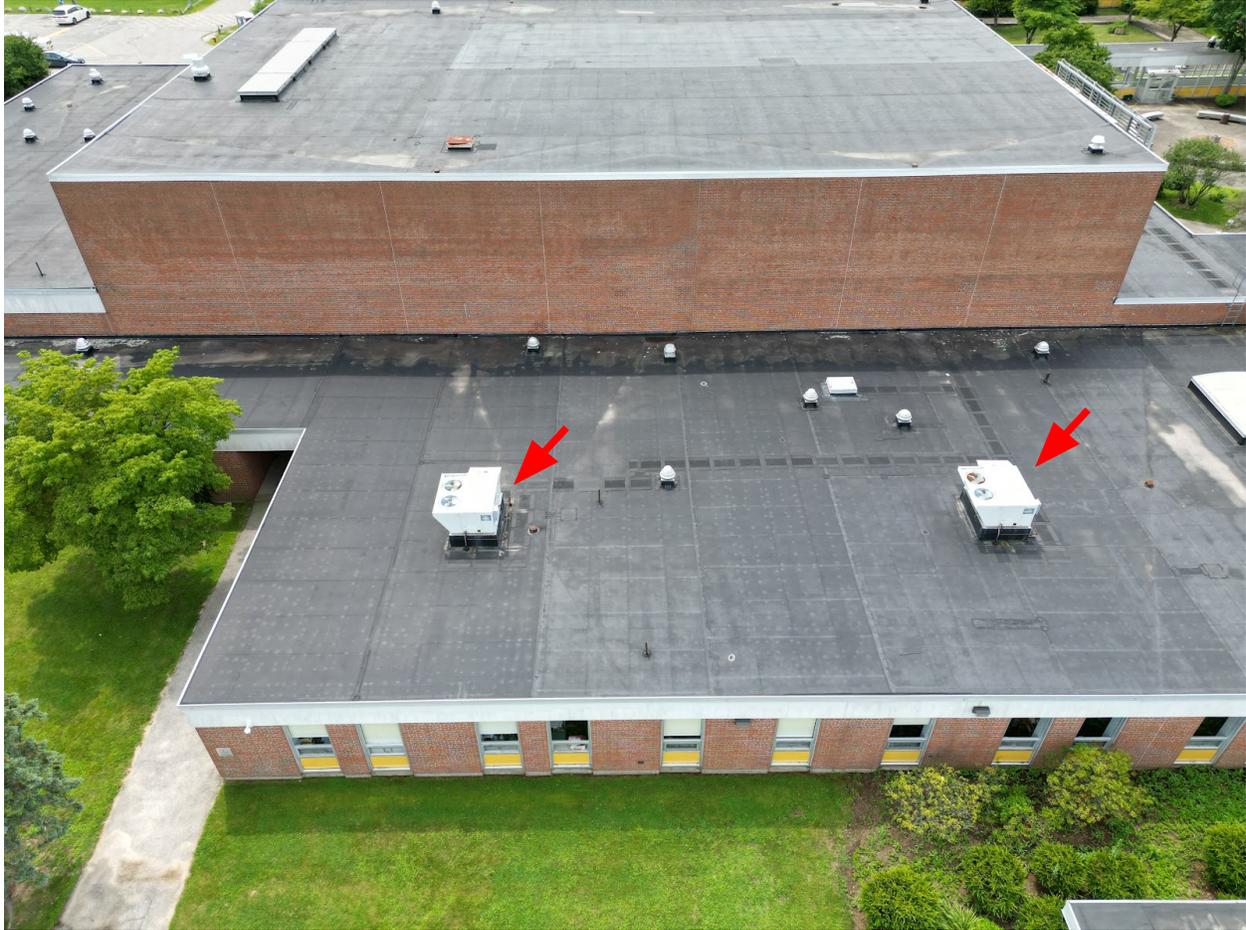
There are four roof-top package units with natural gas heat and air conditioning. Again, all of these units are original from the 2001 renovation and have reached the end of their useful life. Many components have been replaced, but due to the age many parts are getting difficult to obtain.

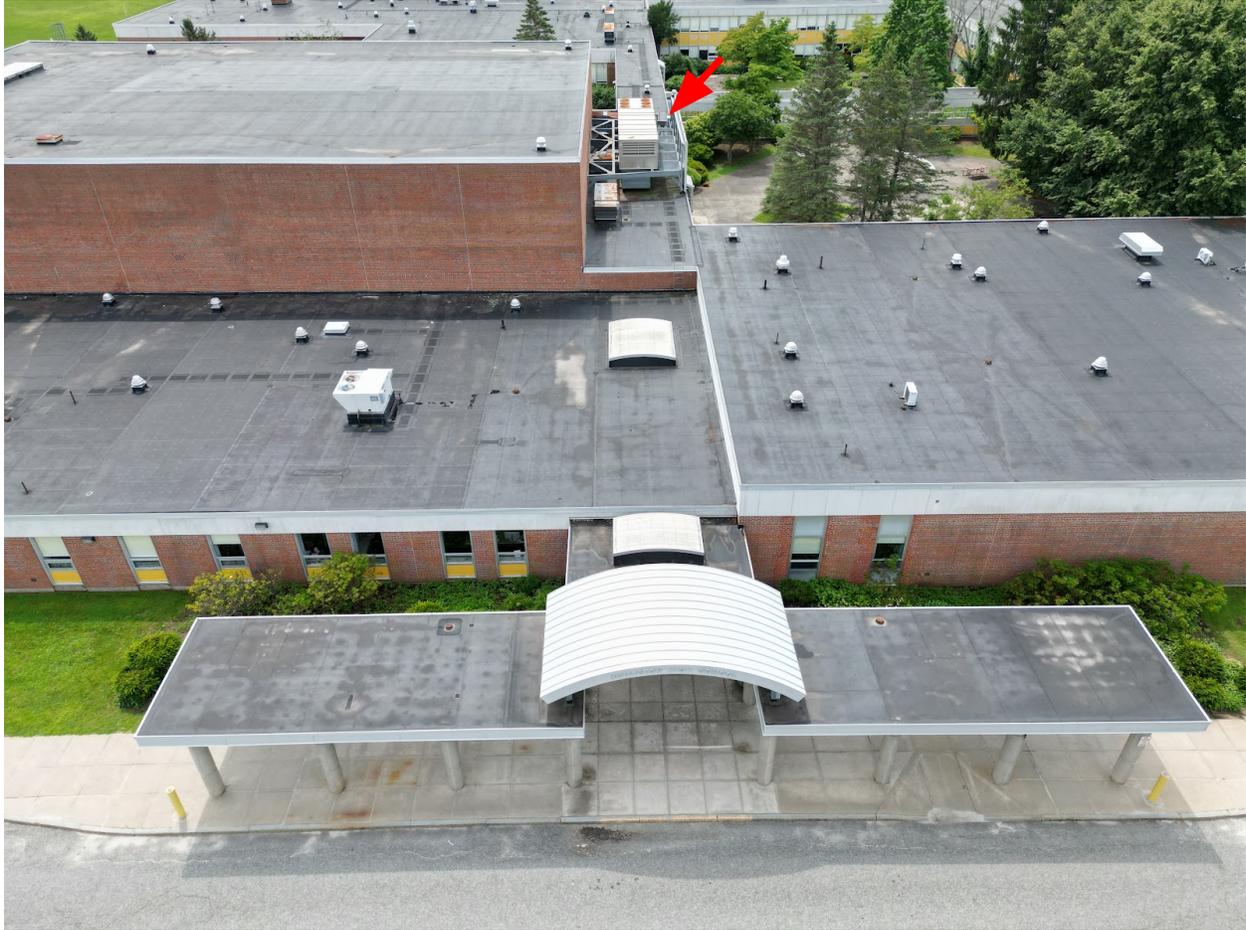
There is one large multi-stage heating and cooling unit for the auditorium that is also at the end of its useful life. This unit currently has funding for replacement.

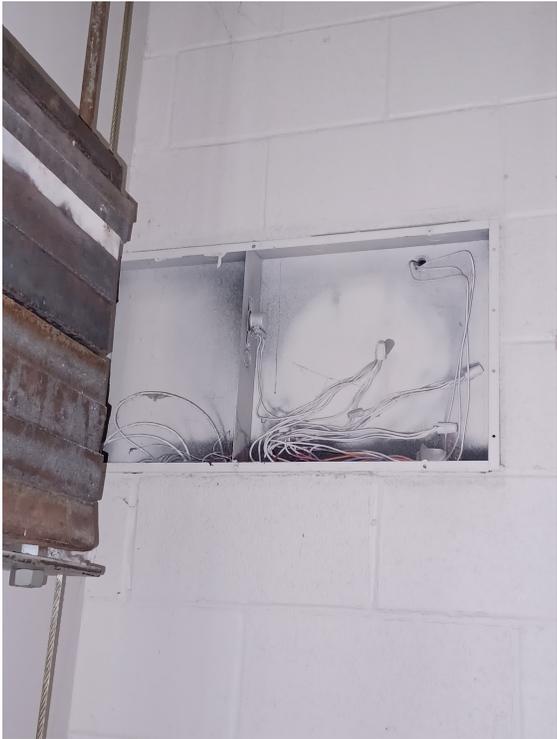
Overall the electrical systems throughout the building are in good to fair condition with no significant signs of degradation. There are some minor issues associated with exposed junction box wiring and broken outlets. Back power for critical building operations and safety is provided by an onsite diesel generator that is in fair condition with useful life remaining.

Exposed Wires

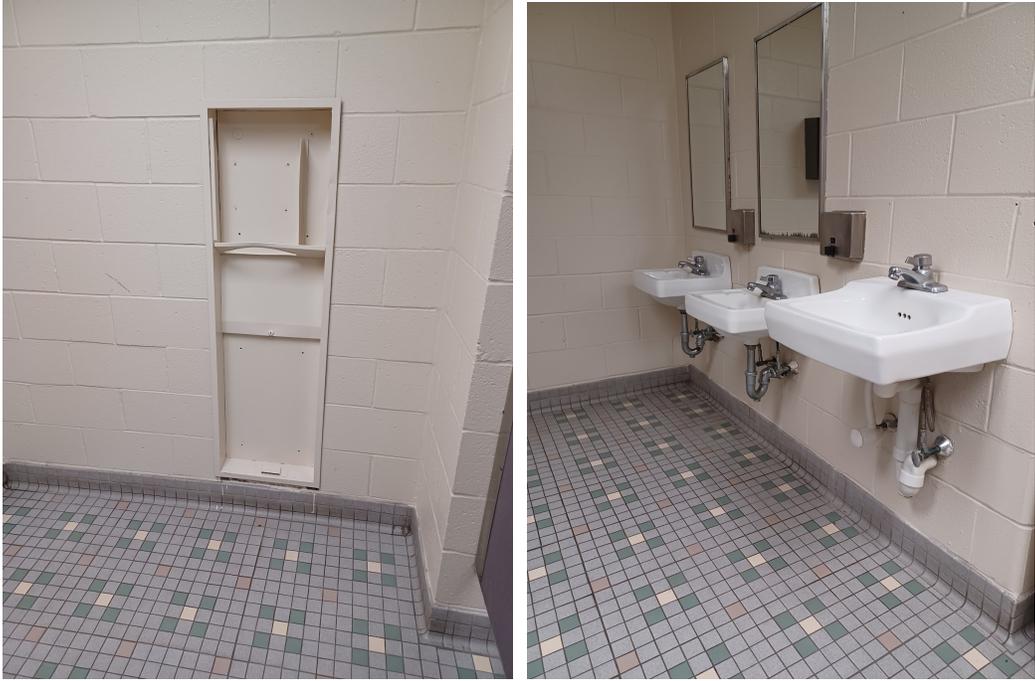
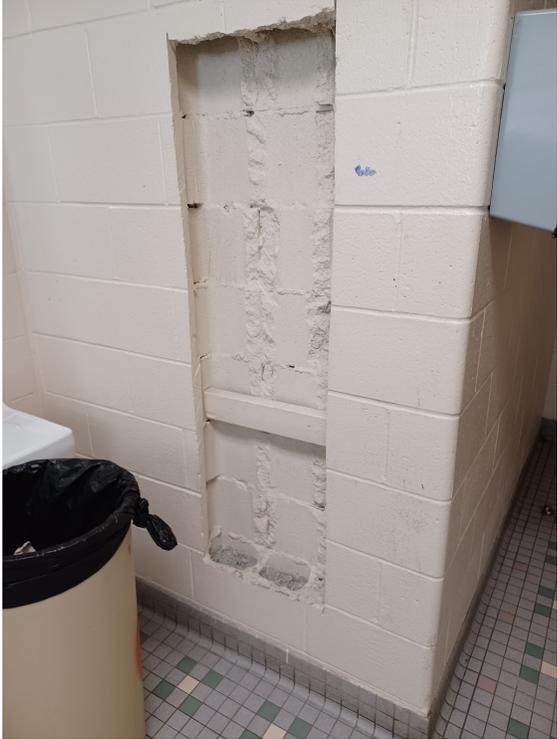
Restrooms - The student restrooms are dated with older fixtures and worn partitions all of which are in fair to poor condition. The lockers rooms for the field house are in poor condition with many damaged items.
