ASA Engineering

Re: 599 Concord Street
Holliston, Ma.

Per your request, I have performed a site visit, on 2/7/22, at the above referenced project location to evaluate the structural integrity of the existing concrete block foundation support wall and to provide an opinion on the structural adequacy of the wall for the proposed new structure.

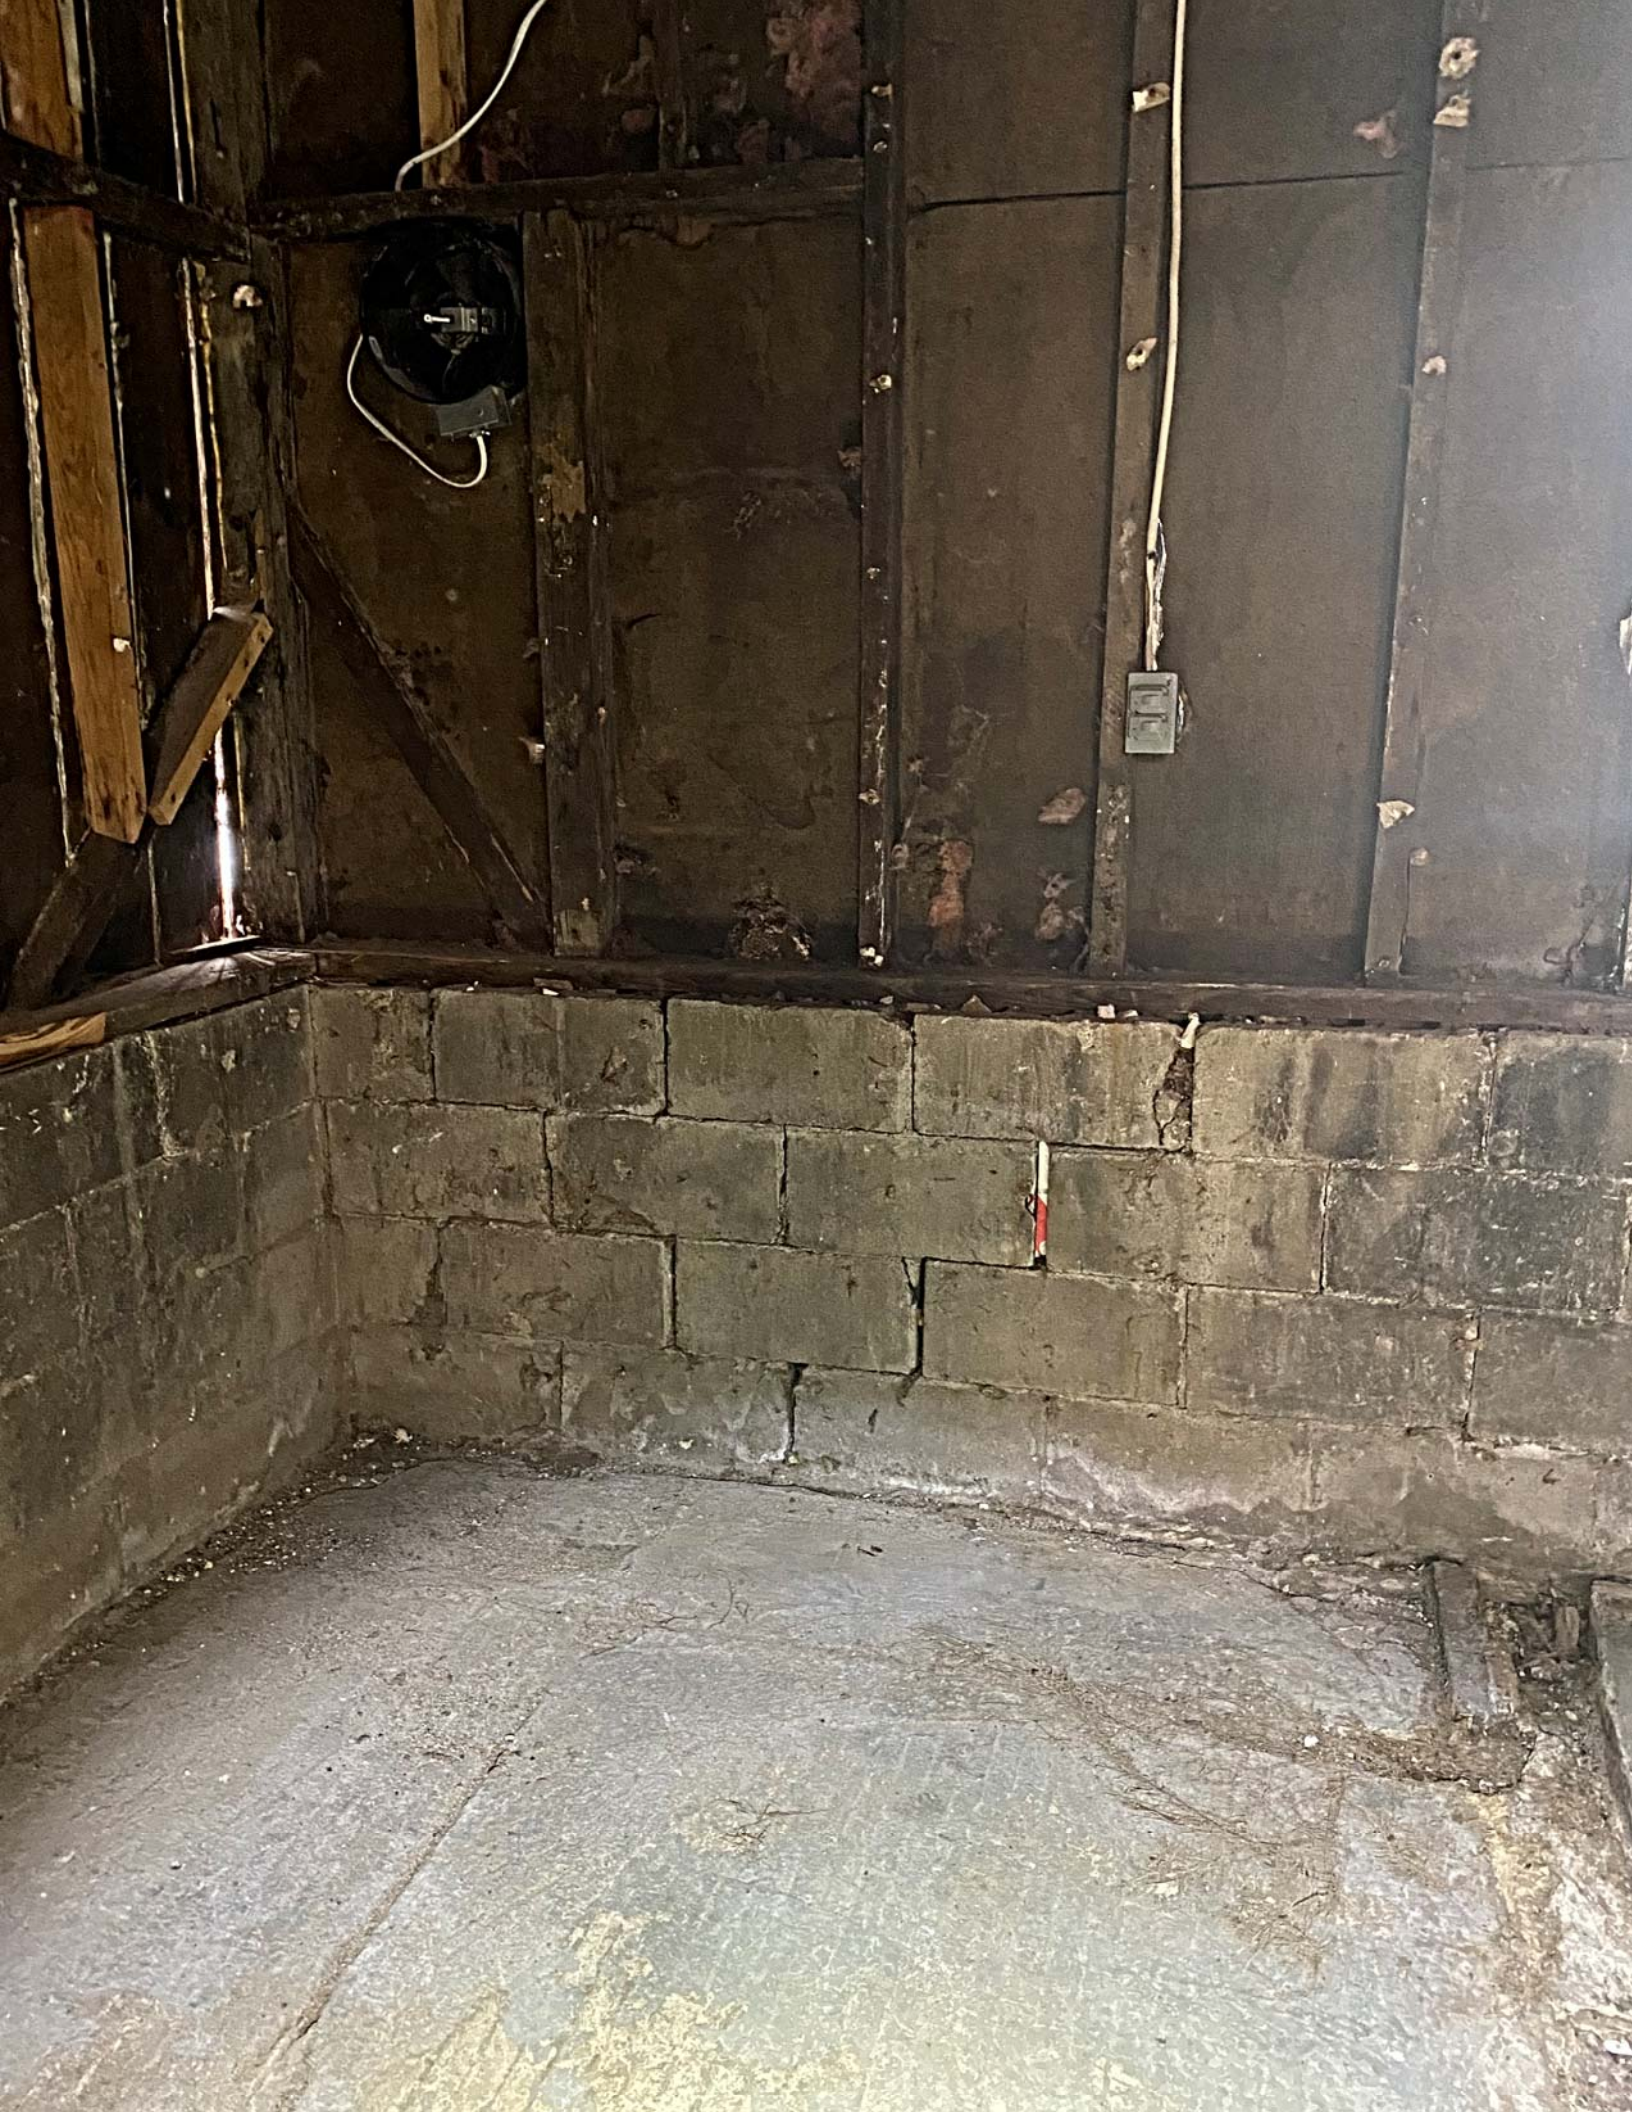
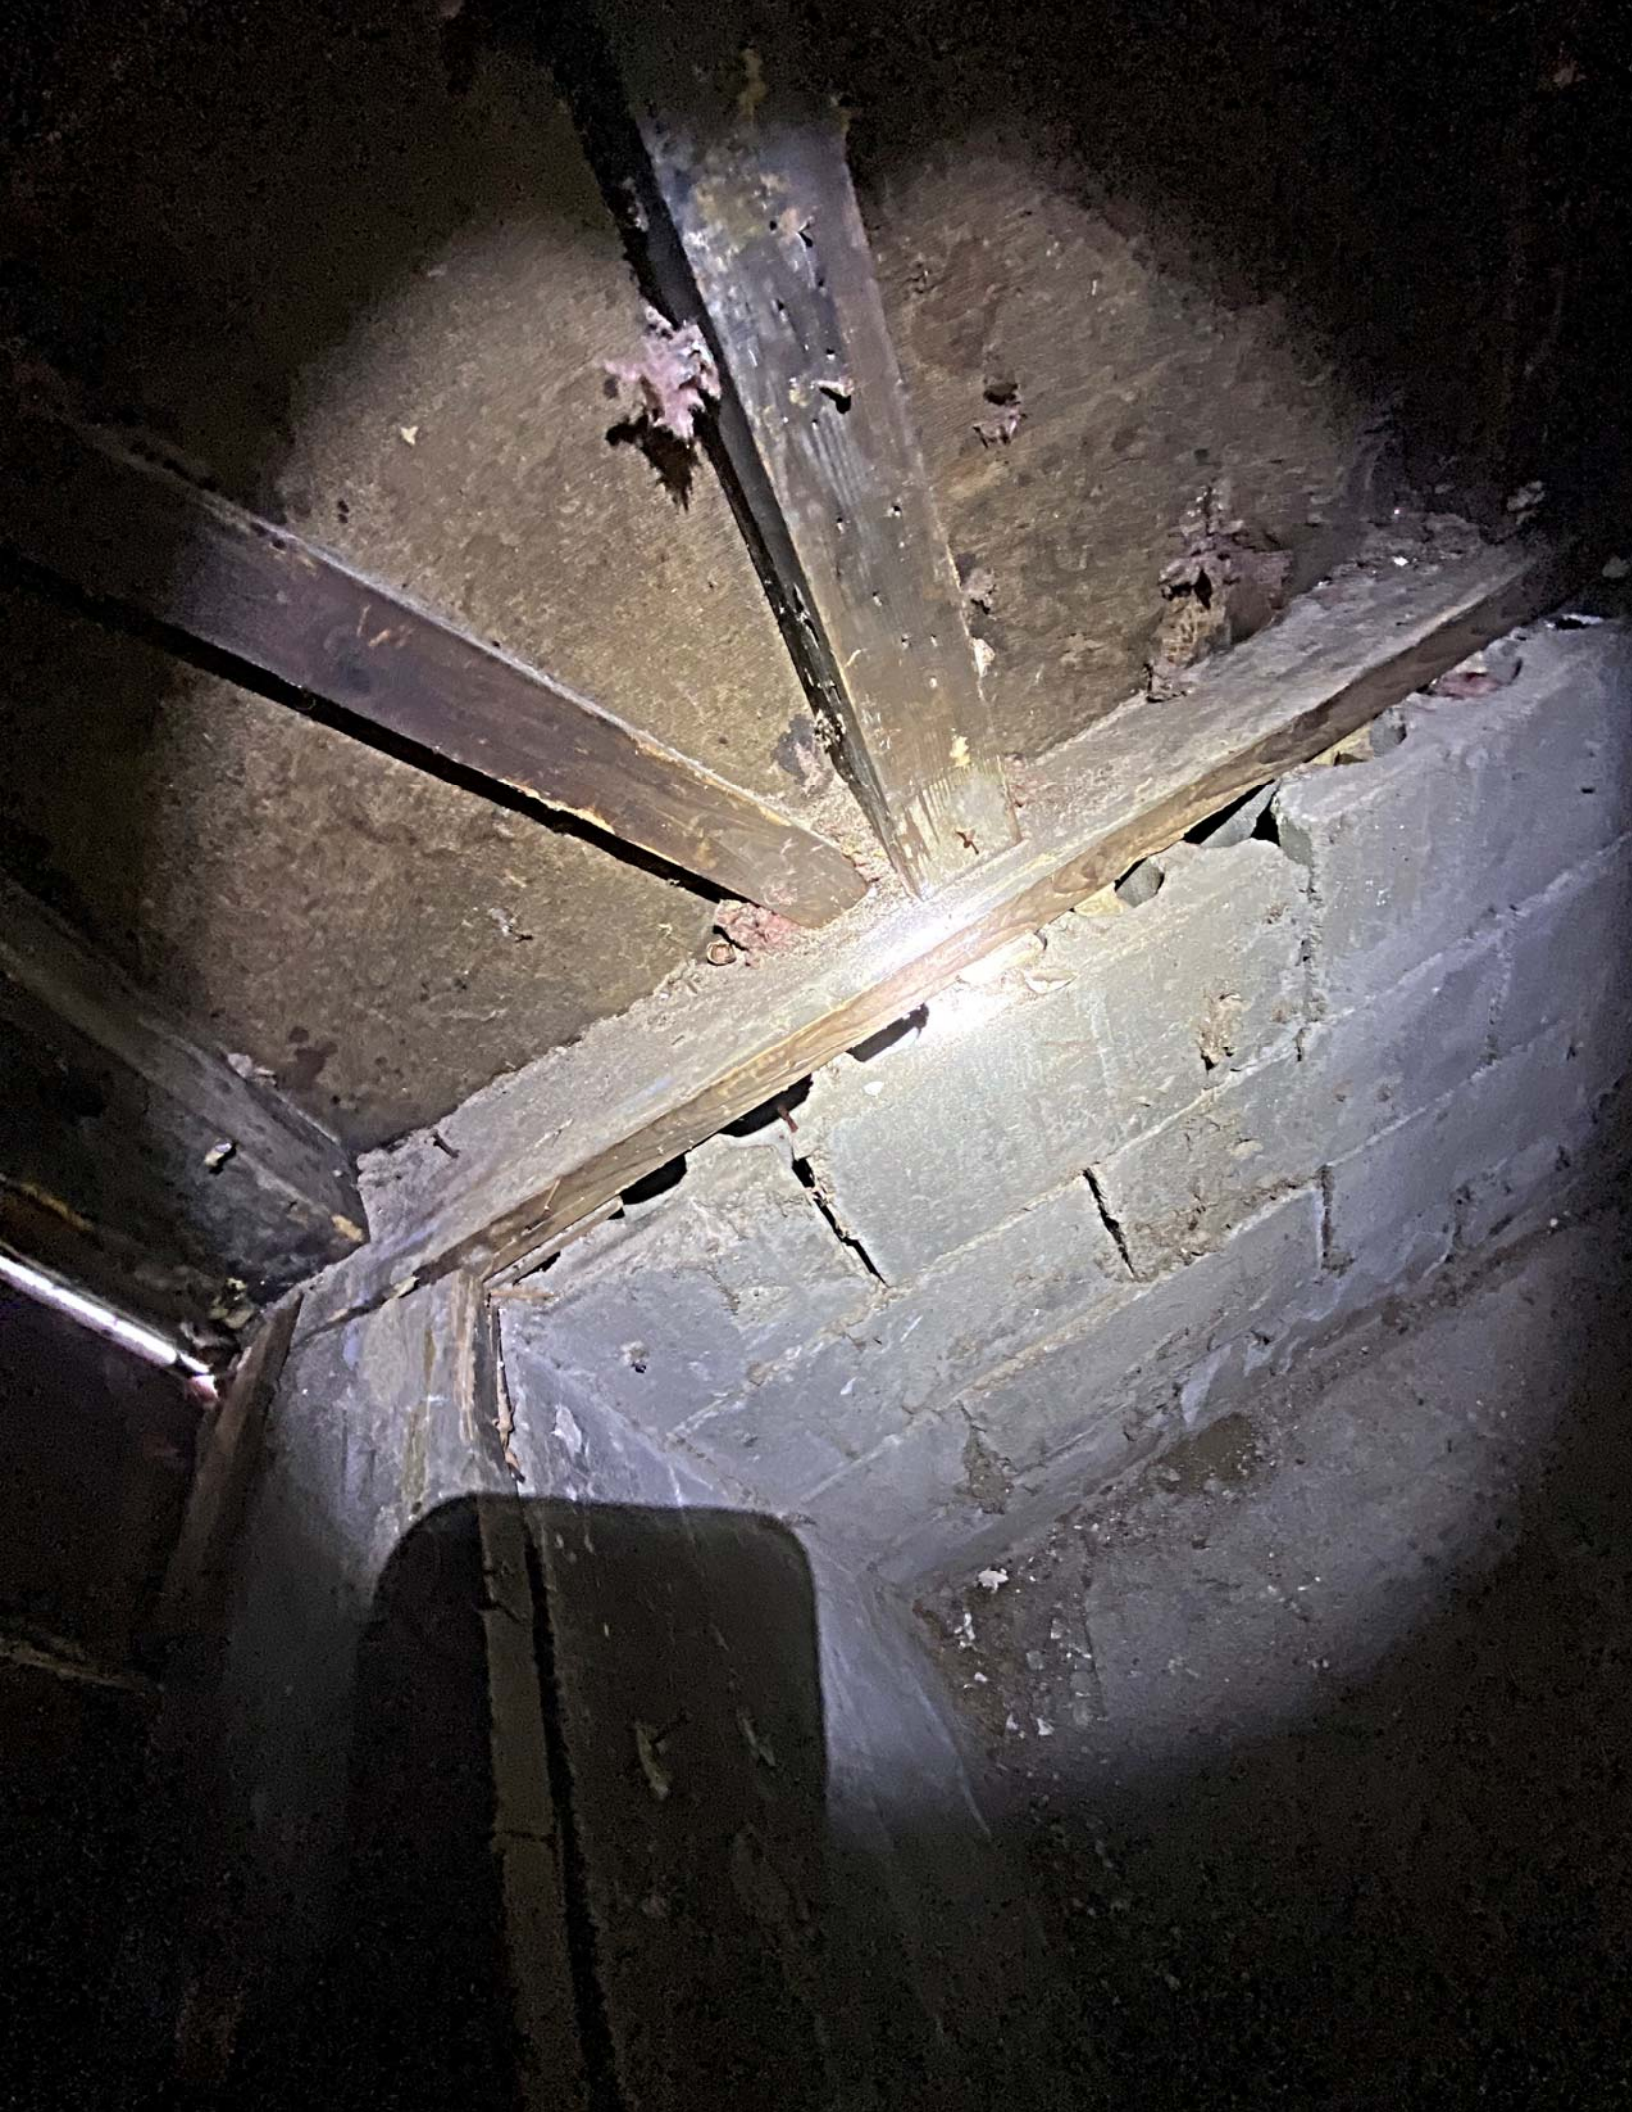
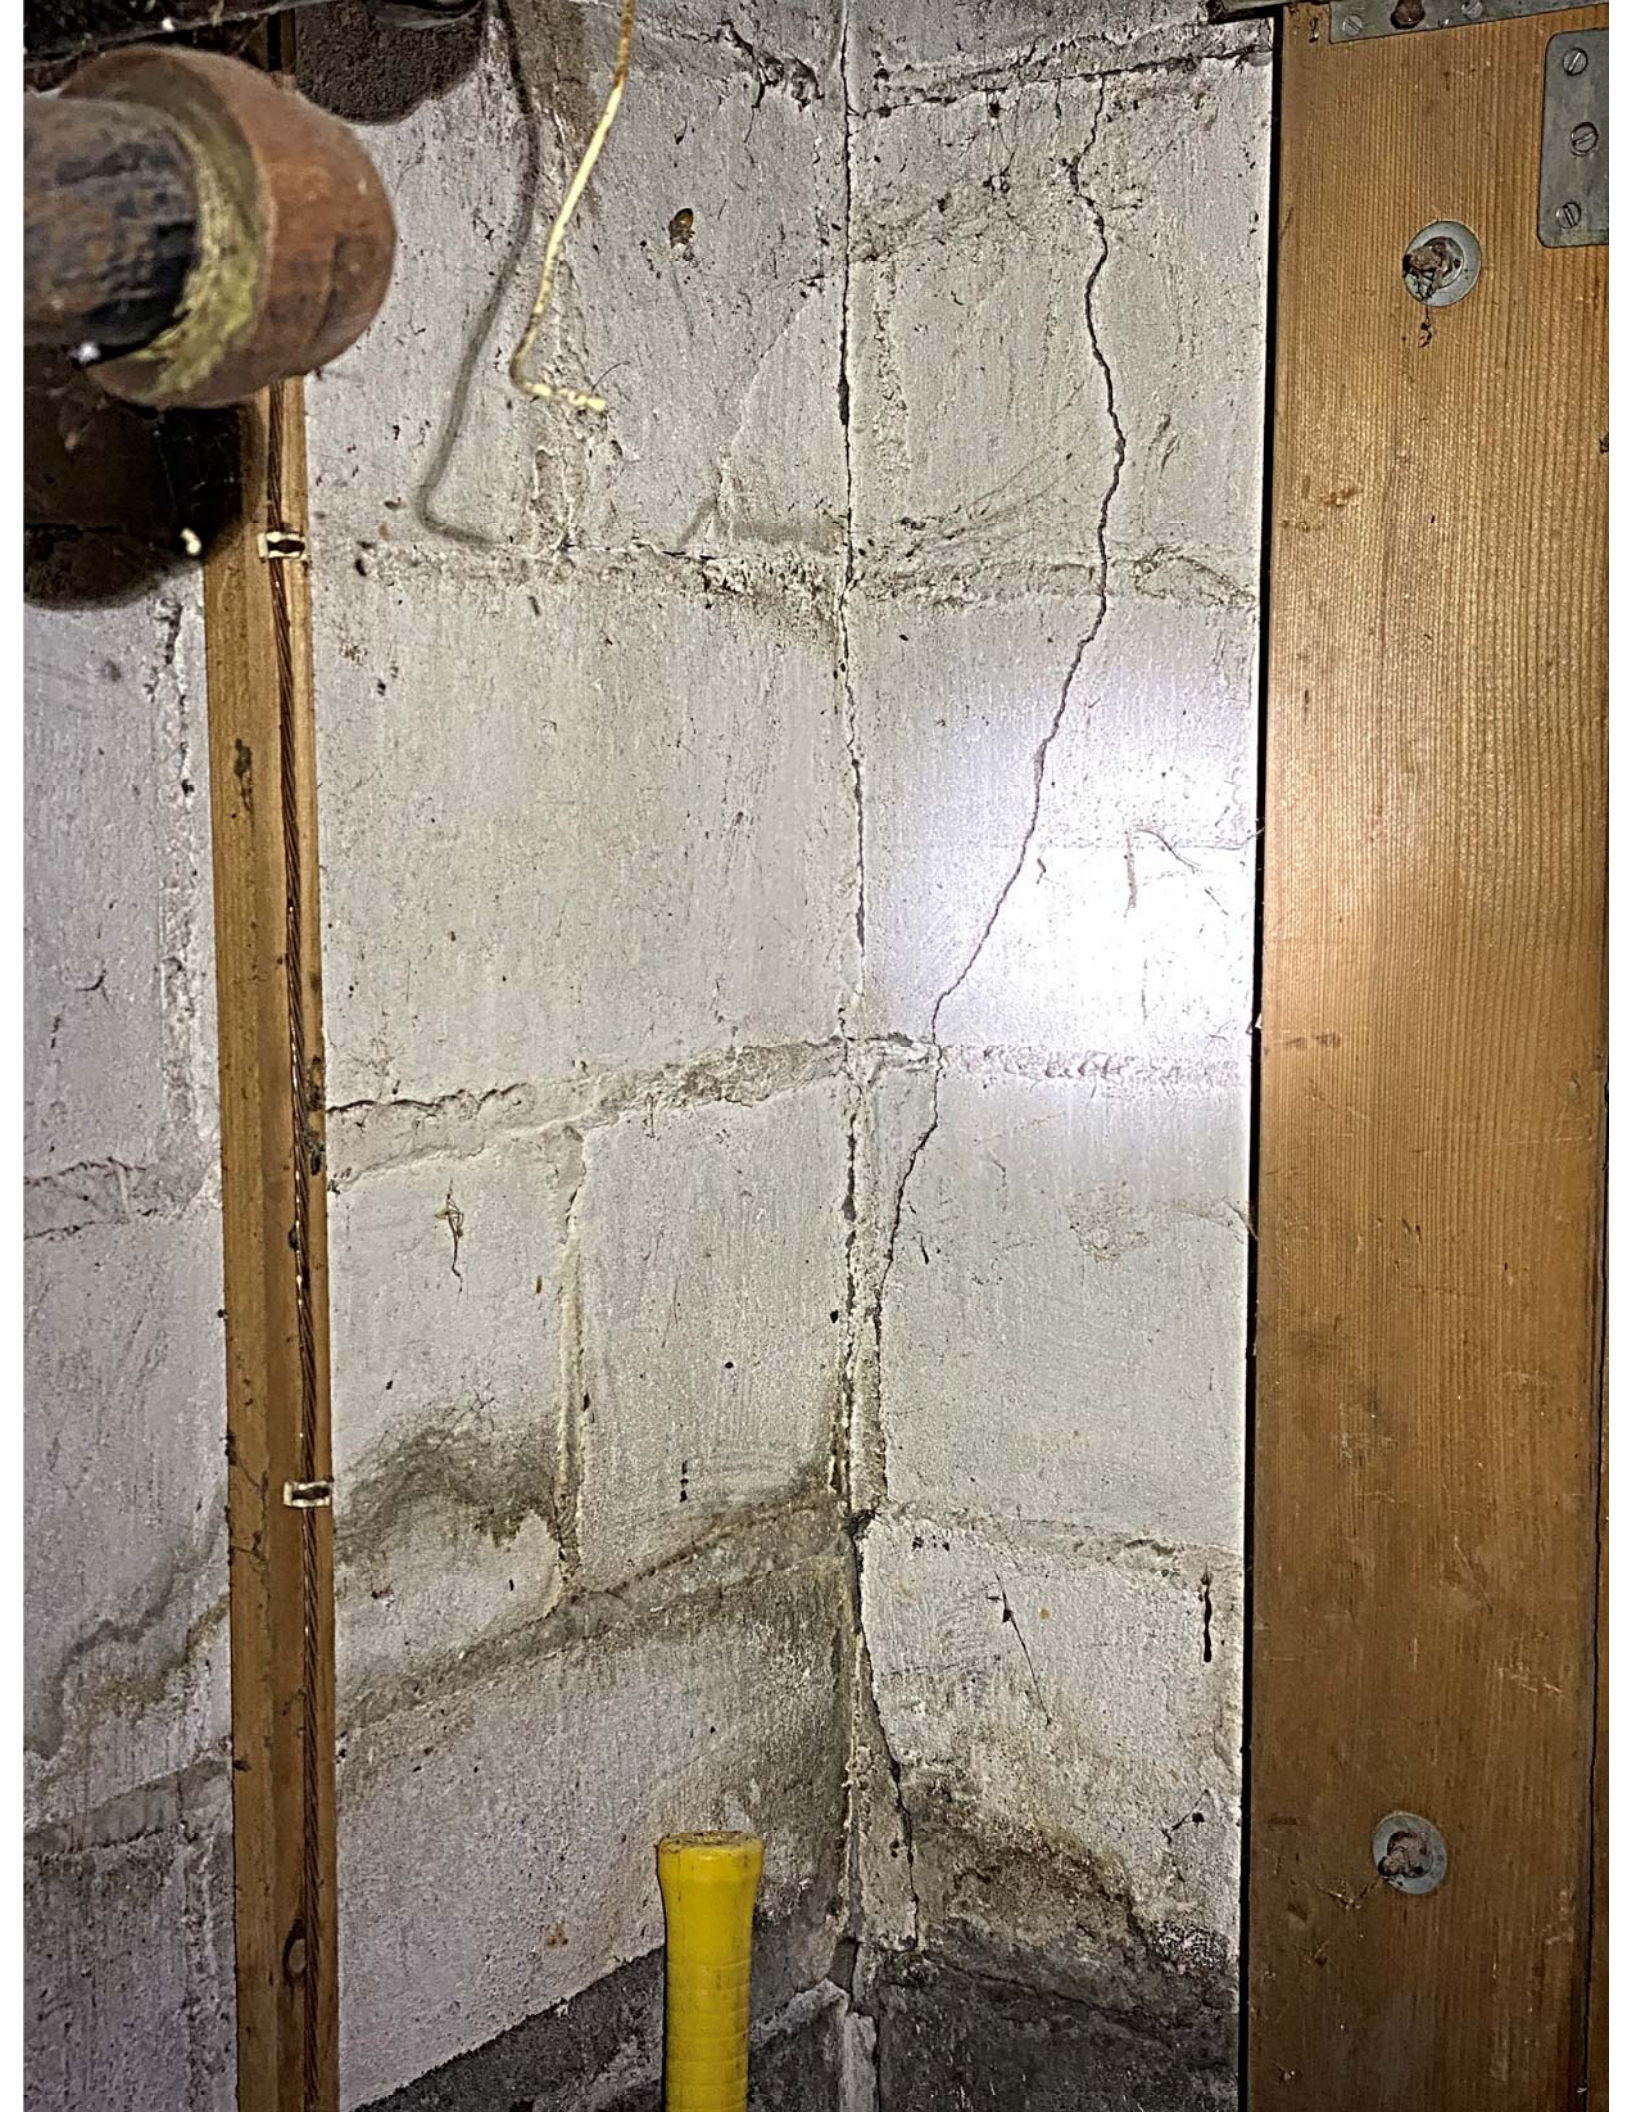
Based on the visual inspection of the foundation wall during the site visit (See Photos attached), it is my professional opinion that existing foundation is structurally deficient and cannot provide adequate structural support for the existing and proposed new structure. Furthermore, based on the following deficiencies listed, it is my recommendation that the existing foundation wall to be demolished in its entirety and be replaced with a new cast in place concrete foundation wall in compliance with current building code specifications.

- Dry laid blocks with no filler grout or reinforcing
- Dislodged block units
- Full height cracks
- Lack of full bearing at the bottom
