ALTERNATIVES REPORT
LAKE WINTHROP DAM
MA02949 / 4-9-136-3
HOLLISTON, MASSACHUSETTS

PARE PROJECT NO. 21214.00/203

November 2022

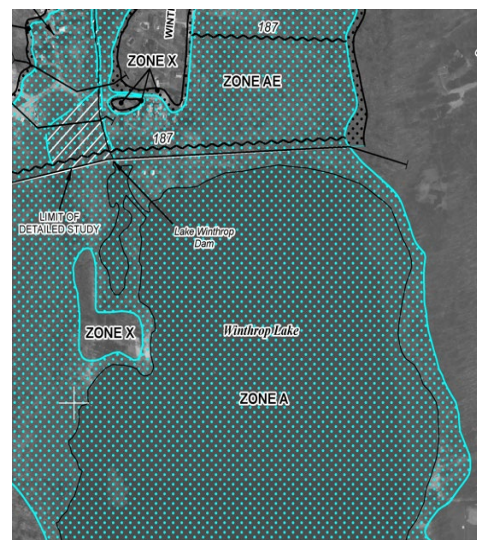
Image 3-1: FIS Panel in Area of
Lake Winthrop Dam

The effective Flood Insurance Study (FIS) for the dam (FIS Number 25017CV008C, issued July 6, 2016) suggests that the 50-year water surface elevation will rise to near El. 186.1, overtopping the dam by 3.9 feet; however, this flood depth appears to be the result of backwater from downstream crossings as opposed to capacity restrictions at the dam.

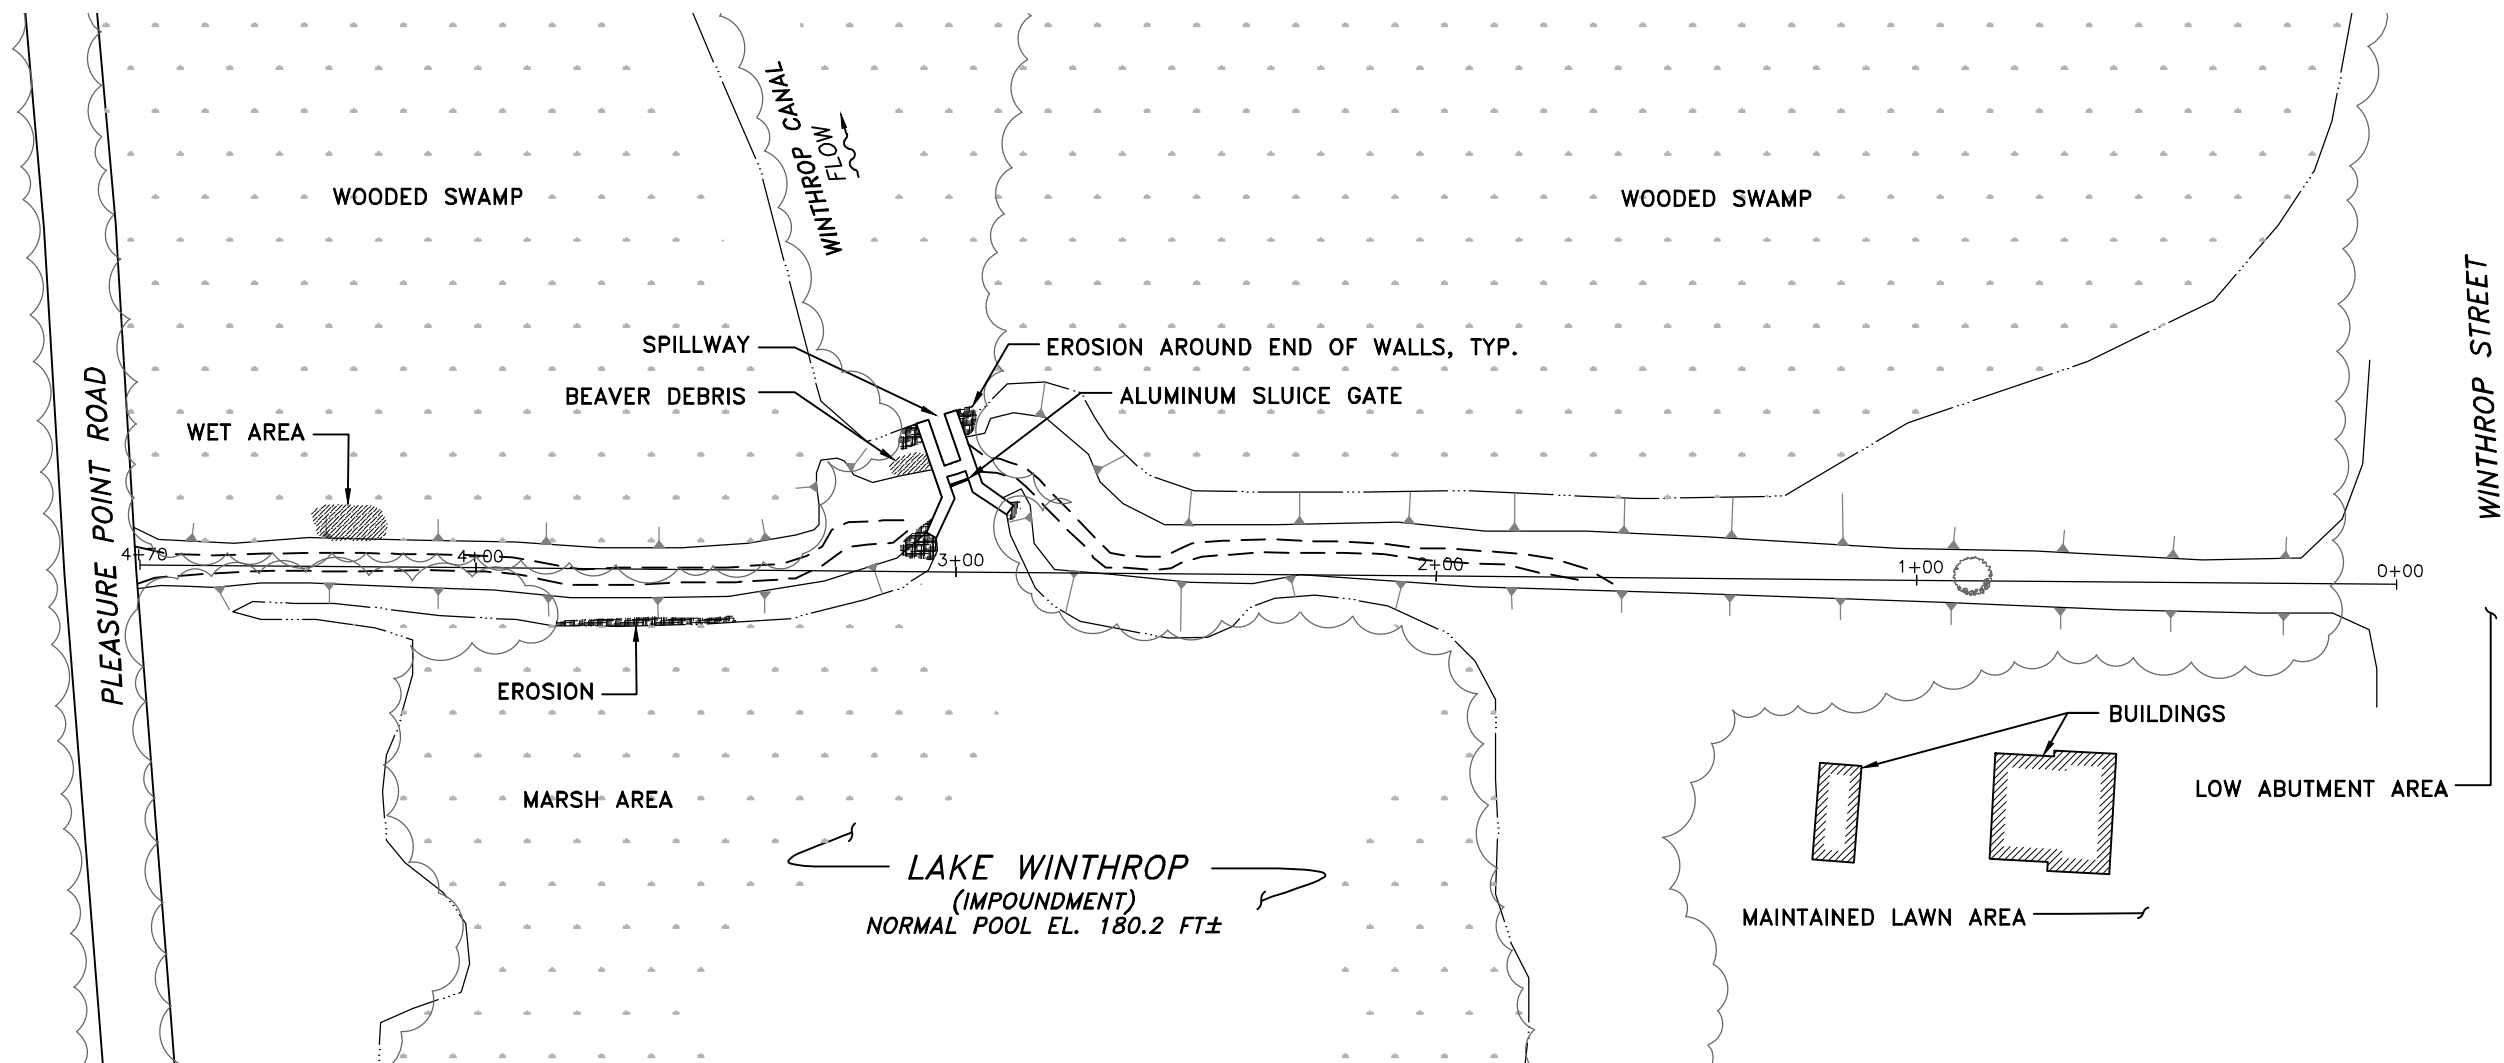
SITE SKETCH

As shown on Figure 3: Site Sketch, Lake Winthrop Dam is an earthen dam about 475 feet long oriented primarily east/west. The reported date of construction of the dam is 1966¹, though the lake existed as a natural body before this time.

The embankment consists of an approximately 5- to 10-foot-wide berm that widens to about 25 feet at the spillway. The upstream and downstream slopes are 2H:1V. The left portion of the crest carries a grass and dirt path with limited vehicle access from Pleasure Point Road to the spillway. The slopes are unprotected. The left abutment carries Pleasure Point Road, a 20-foot-wide paved roadway, to a recreation area upstream. The right abutment is a gravel driveway at the southern end of Winthrop Street.

- A. Erosion behind the spillway training walls.
- B. Debris was piled up on the left side of the spillway and at the spillway approach.
- C. Minor concrete deterioration including cracking and spalling.
