ALTERNATIVES REPORT  
**FACTORY POND DAM**  
MA02952 / 4-9-136-7  
HOLLISTON, MASSACHUSETTS

PARE PROJECT NO. 21214.00/202

**ALTERNATIVES REPORT**  
**HOLLISTON, MASSACHUSETTS**

May 2022

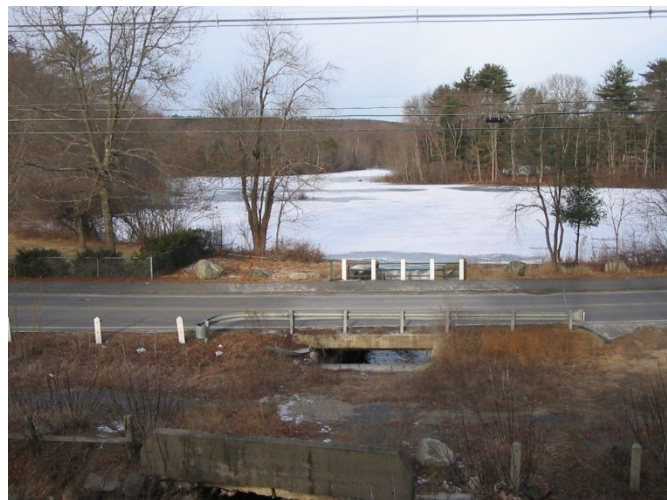
*Image 1: Factory Pond Dam impoundment and primary spillway looking northwest from the Upper Charles Rail Trail Bridge*

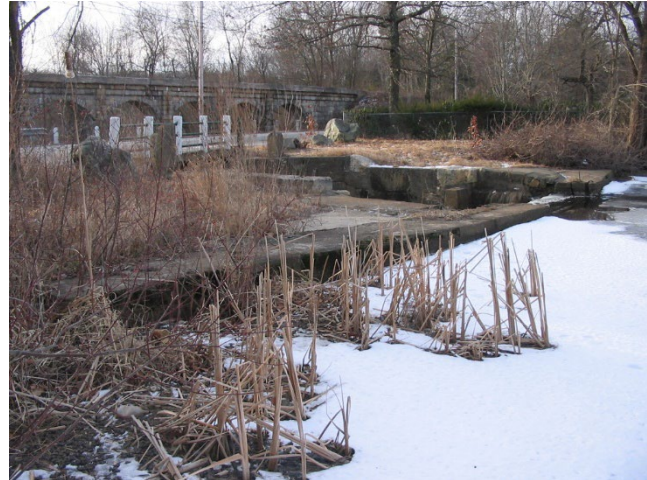
Image 2: Concrete walls at primary spillway approach

- A. Erosion between cap and spillway crest at the joints;
- B. Erosion of top of weir at the center of the spillway;
- C. Poor condition of the concrete overlay;
- D. Missing and cracked portions of the forebay weir walls;
- E. Poor condition of the scour apron.

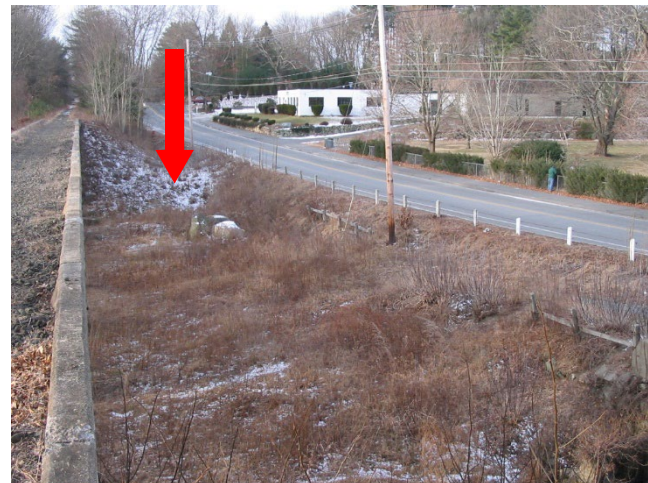
Image 3: Downstream slope right of primary spillway. Arrow indicates approximate location of stone masonry wall and outlet.

- A. Mature trees and brush within 20 feet of the dam area;
- B. Inappropriate or missing grass cover on slopes;
- C. Failing downstream stone masonry wall which supports both the downstream dam embankment and the abandoned roadway embankment at the right of the spillway.

Areas of seepage have been reported at the downstream toe near the right end of the dam. However, this seepage has been noted to be related to a potential former outlet structure. Flow rates have generally been low with no indication of sediment transport. No other areas of seepage have been reported.

3. **Evaluate for the presence of and formerly abandon the reported potential outlet through the right end of the dam;** this may include an open cut and replacement, a grouting program, or driven sheet pile cutoff.

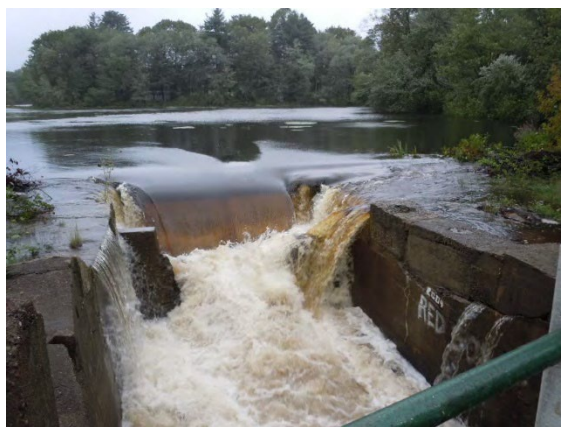
Several occurrences of overtopping of the upstream walls and training walls at the spillway have been reported, including August 2011 (Tropical Storm Irene) and most recently after heavy rainfall around September 2, 2021. While the upstream walls and spillway training walls overtopped, no overtopping of the roadway has been reported.

*Figure 3-3 High water levels post Tropical Storm Irene (August 28, 2011)*
