ALTERNATIVES REPORT
HOUGHTON POND DAM
MA00444 / 4-9-136-6
HOLLISTON, MASSACHUSETTS

ALTERNATIVES REPORT

HOLLISTON, MASSACHUSETTS

May 2022

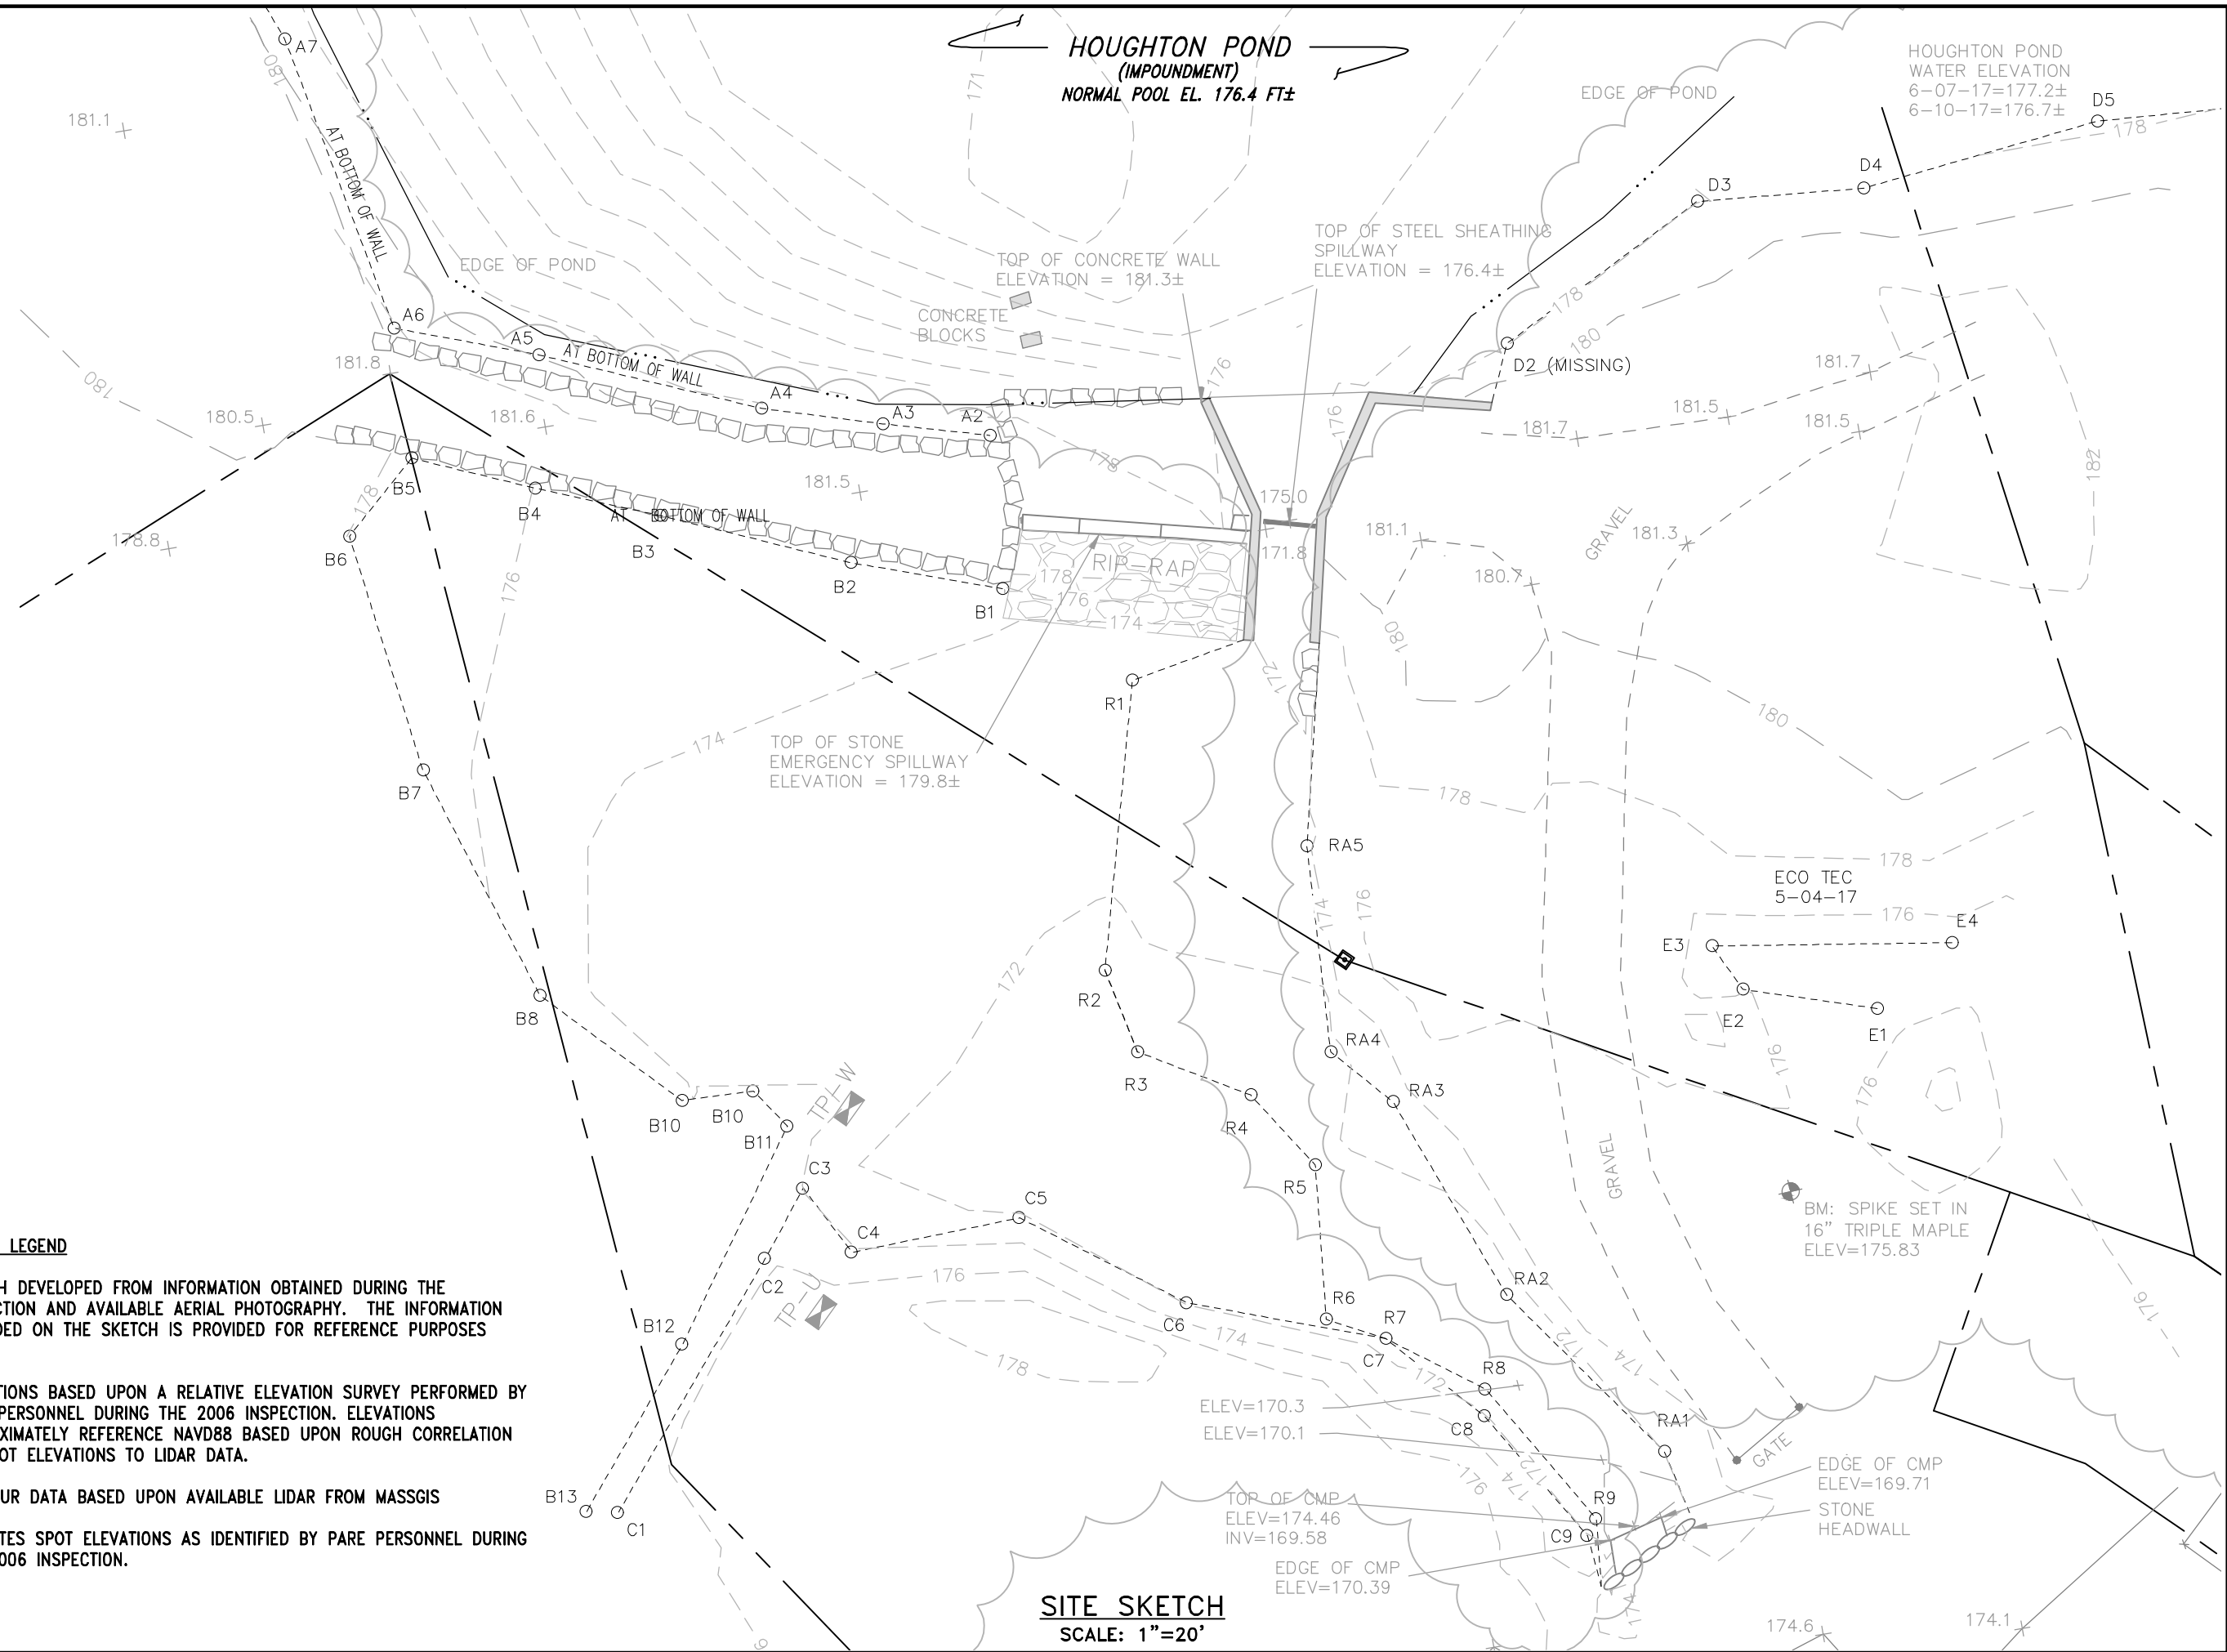
SITE SKETCH

In addition to previously reported observations, significant displacement of both the upstream and downstream walls was observed during site visit completed as part of this study. This apparent displacement suggests that the actual geometry of the stone masonry retaining walls along the upstream and downstream sides of the dam is less than assumed during previous analysis and that the walls are inherently unstable.

No previous evaluations of the stability of the spillway and appurtenant training walls at the dam has been completed. The right upstream wall is currently misaligned and generally appears unstable. No apparent displacement of the spillway section has been previously noted.
