MAKRIS FIELD REPORT**Date of Field Visit/Observations: 1 March 2019****Project: Holliston Library****Date of This Report: 3 March 2019**

1 March 2019, Chris Bromley of RebuildEx and I checked in with Leslie McDonnell and conducted hands-on inspection and layout measurements of the roof trusses. We also reviewed the basic steps necessary to jack the trusses into their original configuration; this requires more specific planning.

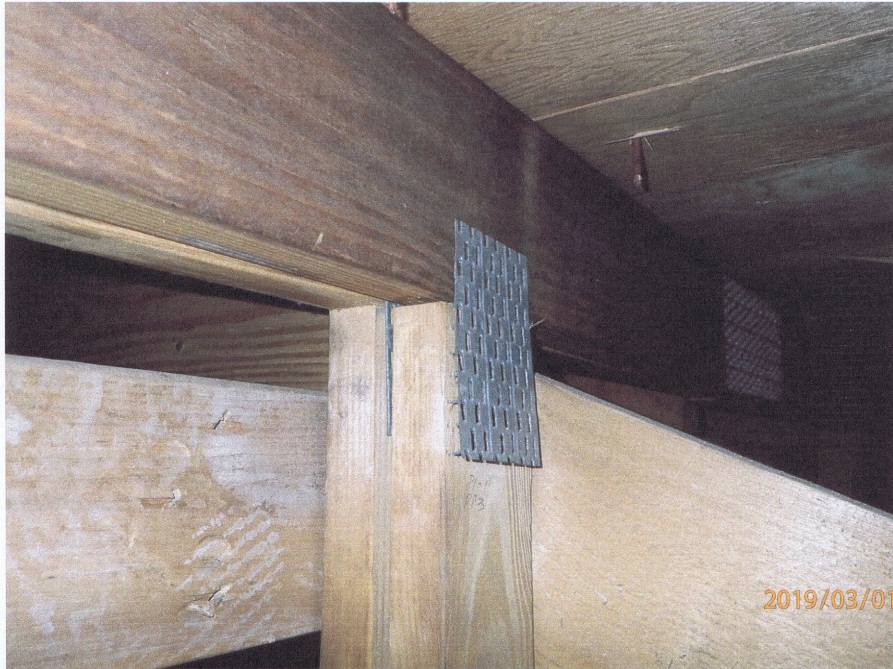
- b. Three of these additional damage panel points were found on the westerly D1 truss; one of the additional damaged splice points was found on the easterly D1 truss. See Photo 1.

PHOTO 1 - Example of previously unreported damage at truss D1-1. The metal connector plate at panel point #3 has nearly released from the web vertical which has slightly separated from the top chord. This likely resulted from the transverse bracing transferring loads from the adjacent trusses.

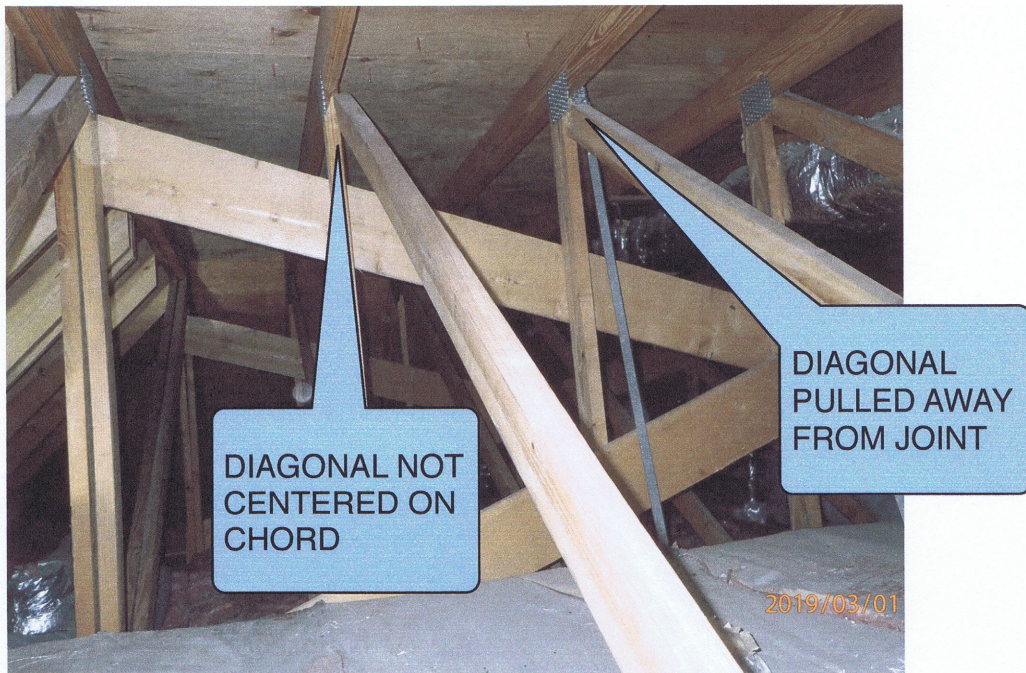
7. Separation of the diagonals from the panel points at numerous trusses is excessive, up to 3 inches in some cases. See Photo 2. This indicates dramatic redistribution of forces to unintended load paths. The distribution of forces in the trusses should be rebalanced as close as possible to a nominal condition prior to applying joint restraints with plywood gussets.

PHOTO 2 - Examples of web members' misalignment.

- a. Rebalancing the forces will require careful jacking of the trusses to restore the geometry of the members meeting at each panel point.
8. A few of the web vertical members are out-of-plumb by as much as an inch due to the loose diagonals being jacked into the side of the vertical during the shoring installation and stabilization of the roof.

4. Prior to installing panel point gusset repairs, the trusses need to be jacked up as near as possible to their "original unloaded" configuration with all diagonals tight to the panel point and web verticals as close to plumb as possible. Jacking of the trusses will require careful planning and execution.
