**RE: Response to BWC Bogastow Brook, LLC BESS Project Stormwater Design Peer Review #1
Proposed Battery Energy Storage System – 600 Central Street, Holliston, MA**

Inspection: *Documentation of Site and Drainage Pre-Development Conditions*

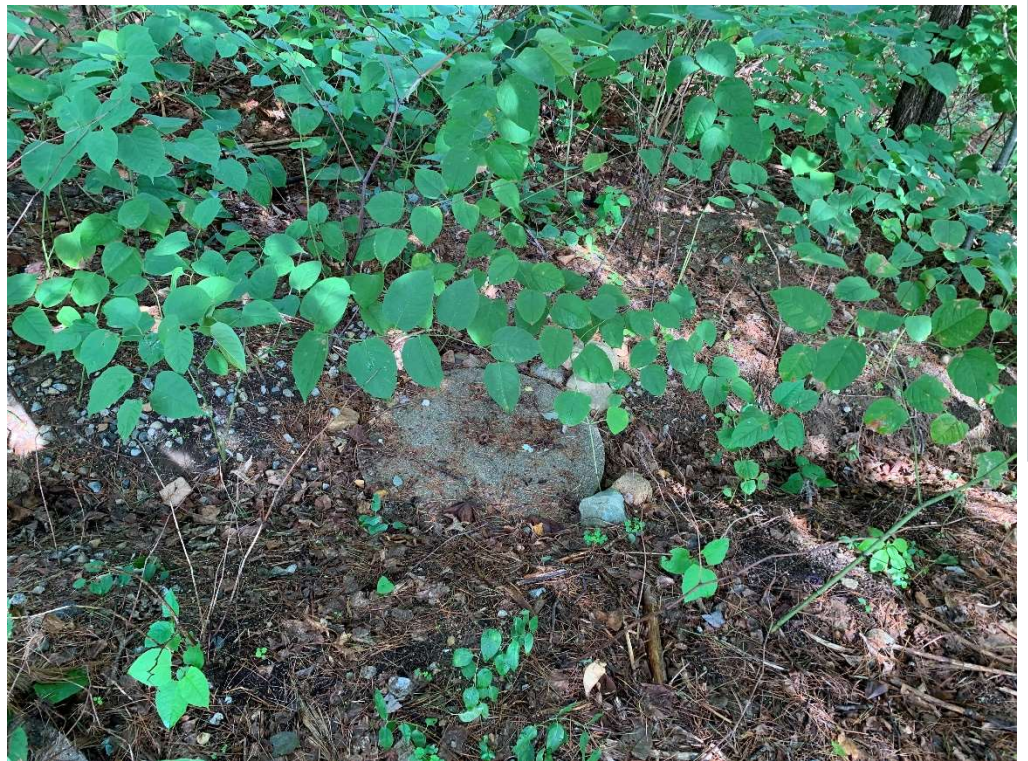
Photo No. 8

View from inside stormwater basin, view towards drainage outfall.

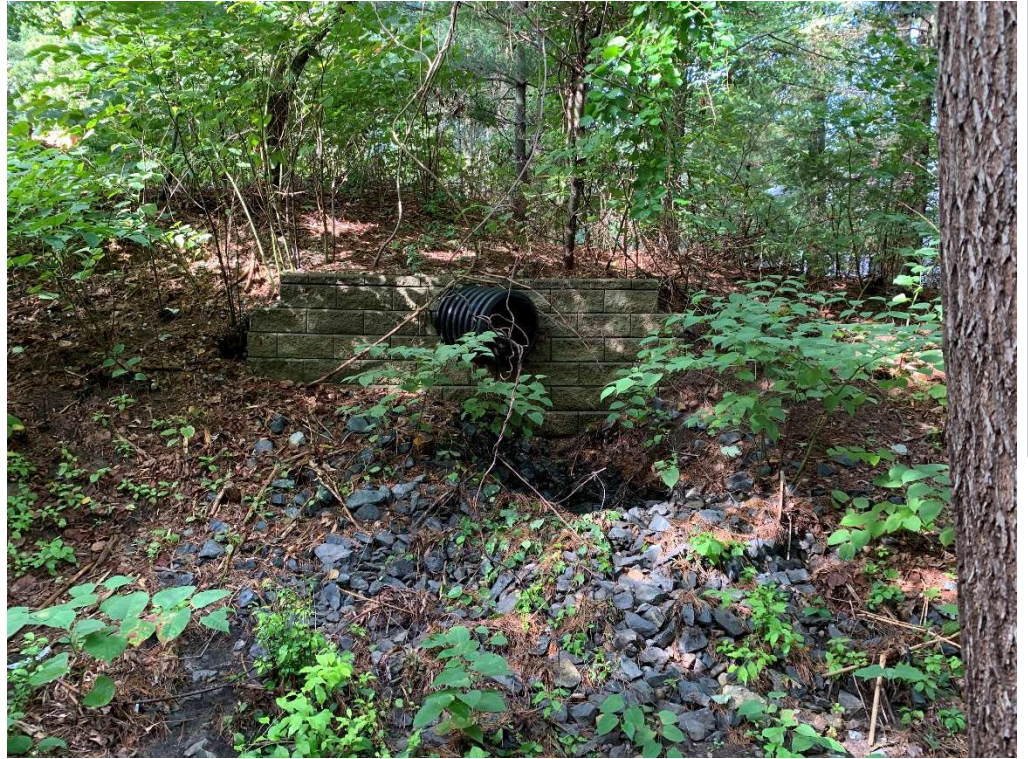
Photo No. 9

The sediment forebay for the drainage outfall observed in good condition.

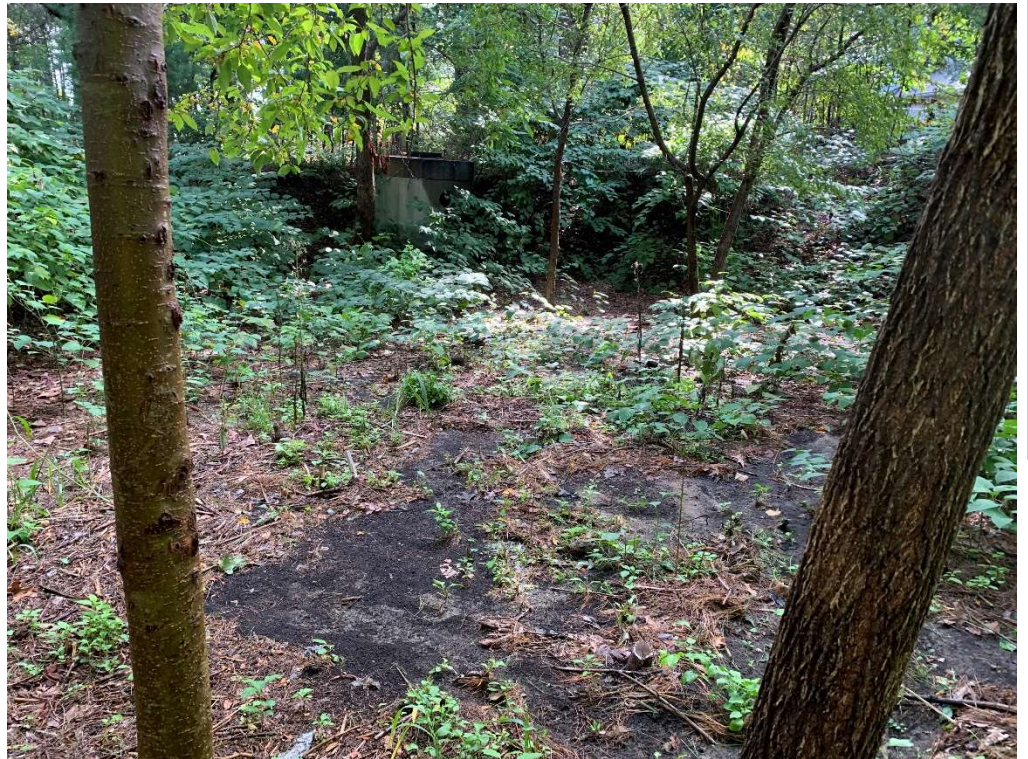
Photo No. 12

View of stormwater basin outlet control structure.

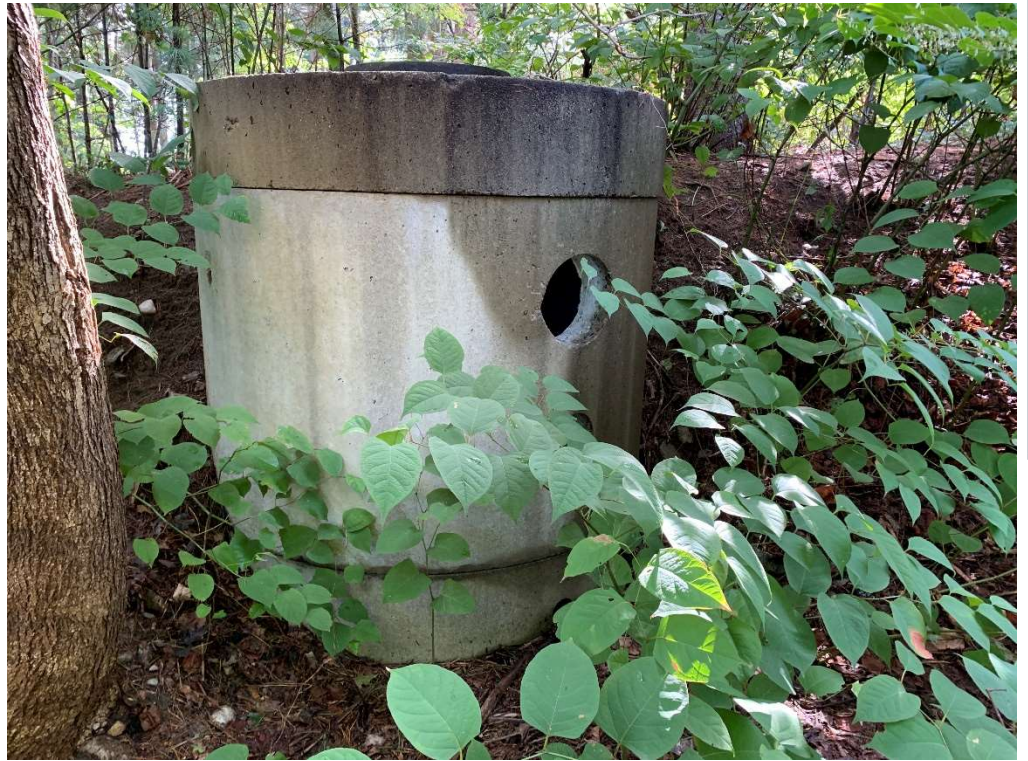
**Photo No. 13**

View inside outlet control structure. The structure is observed in good condition. No excess standing water or apparent clogging observed.

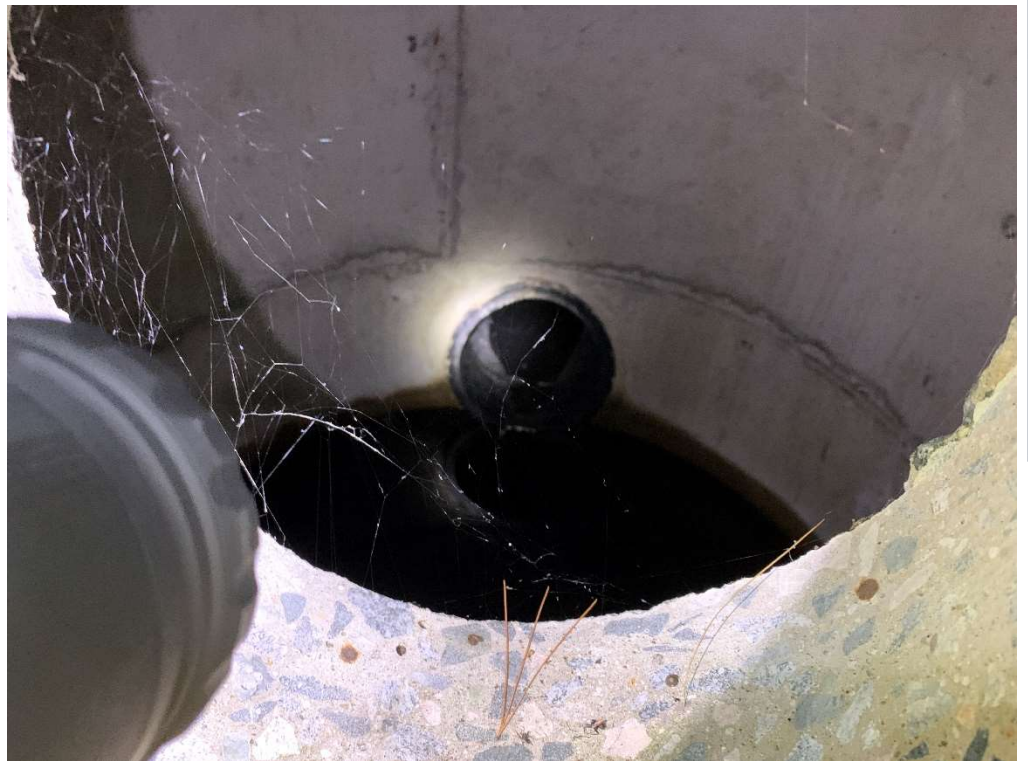
Photo No. 14

View of outlet pipe from outlet control structure. No erosion observed around the area.

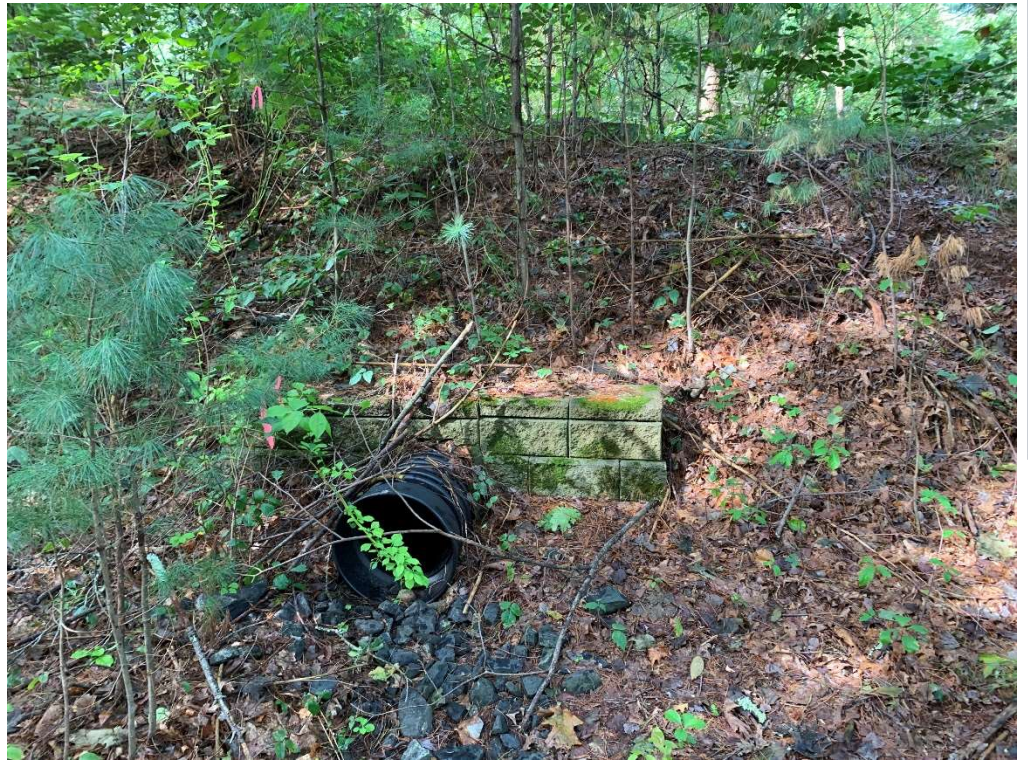
Photo No. 15

View of drainage channel downstream from the outlet control structure discharge pipe. The channel is observed not eroded and is in good condition.

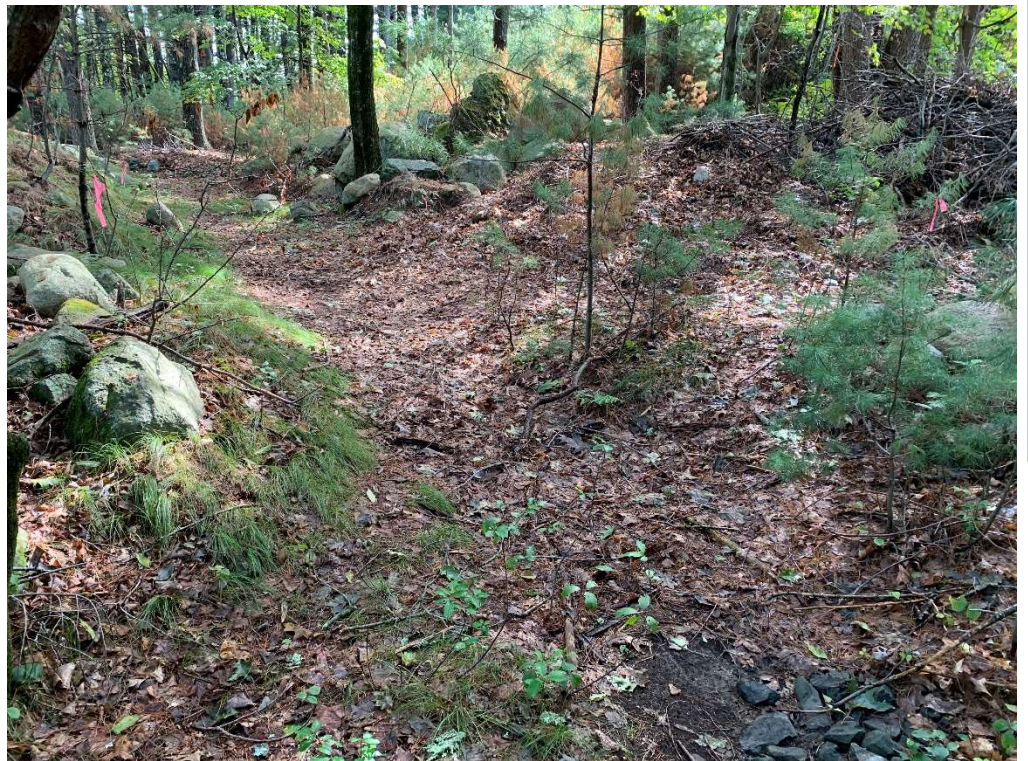
Photo No. 16

View of pond embankment observed in good condition. There is no evidence that water overtops the embankment of the basin during storm events.

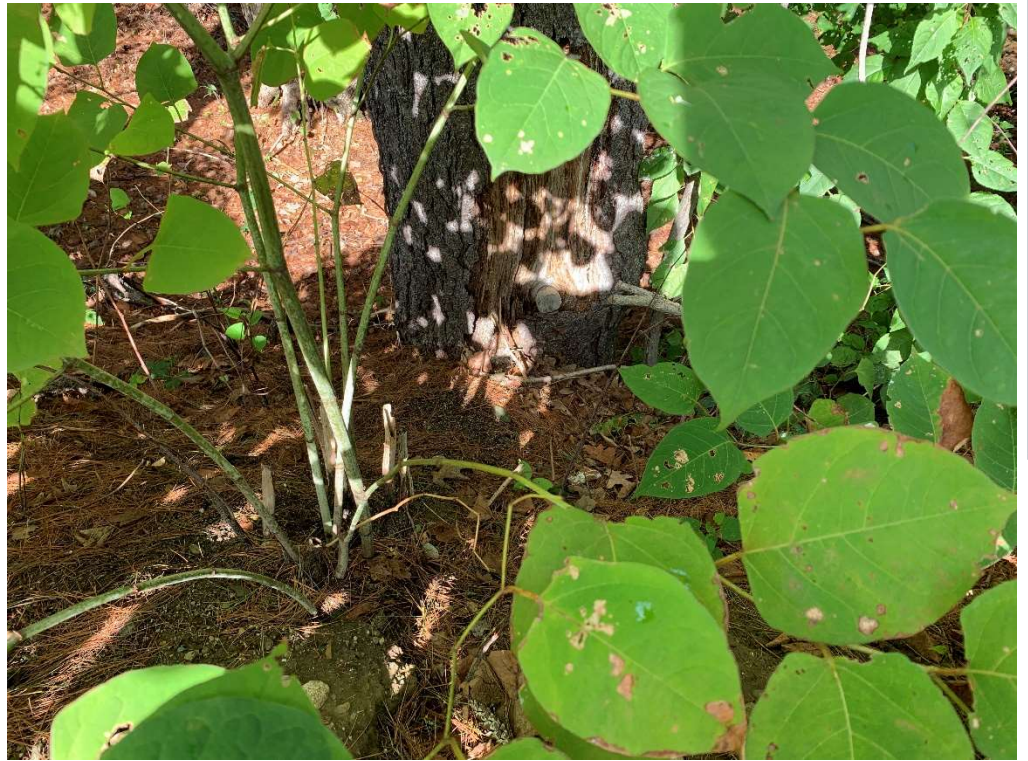
Photo No. 19

View looking down an embankment from the subject parking spot. An abutter shed is located adjacent to an area where stormwater may flow.
