# MASTER PLAN

## HOLLISTON PARKS

### Holliston, Massachusetts

**July 2019**

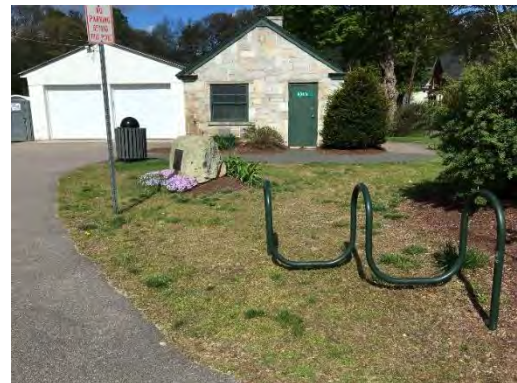
- The existing walkway to the restroom building is laid out poorly. It goes from the side of the tennis courts towards the front of the restroom, however most people are coming from the playground side to use the restroom facilities. Because of this, they cut across the grass and planter bed. As such, the grass in this area is compacted and sparse.

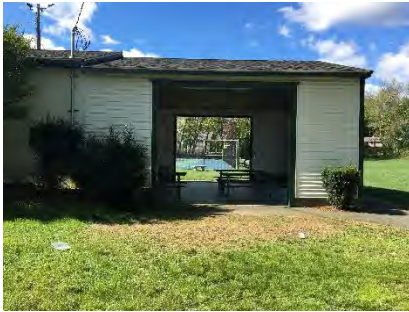
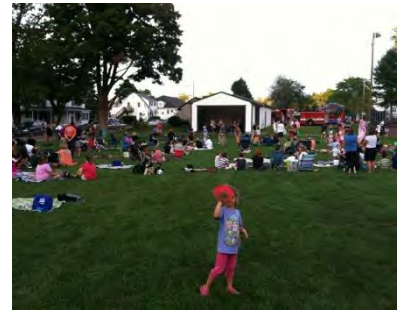
#### Four (4) Standard Tennis Courts

- Courts are new and in very good condition.
- An ADA accessible route is provided to a spectator area; however, there is no ADA accessible route to the tennis courts. An accessible route/path should be provided to the courts.

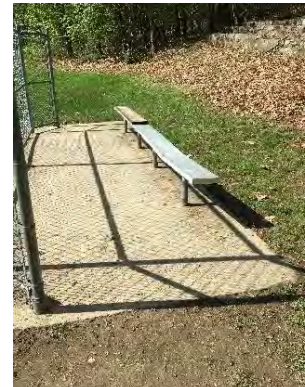
Information Kiosk

- One wood and Plexiglas bulletin board/kiosk is located just off the parking lot, between the playground and tennis courts. It is in good condition, and does seem to get some use. There are notices of local events and classes posted on the boards.

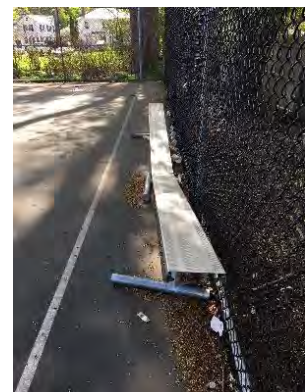
Picnic Tables and Benches

- There are a couple picnic tables and benches located as spectator seating for the tennis courts. The tables are wooden and mismatched. The benches are in good condition and do match one another. The tables should

be replaced and be surface mounted to prevent moving of them and other vandalism.

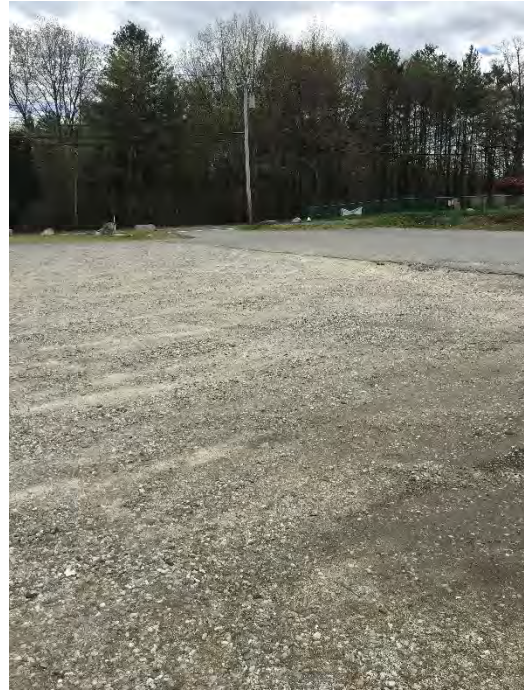
Weston Pond Recreation Area is accessed by a single driveway from Washington Street into the parking lot. Where the paved driveway abuts to Washington Street, there are large deep potholes, which makes entering and exiting the park dangerous. Cars slow down to almost a stop to avoid the potholes when entering and pull into traffic more slowly when exiting to accommodate driving through the potholes. The entrance and exit could be modified to create two different driveway openings to allow for improved circulation into the parking lot. A portion of the parking area is paved, where most of it is simply gravel. Individual parking spaces were not demarcated.

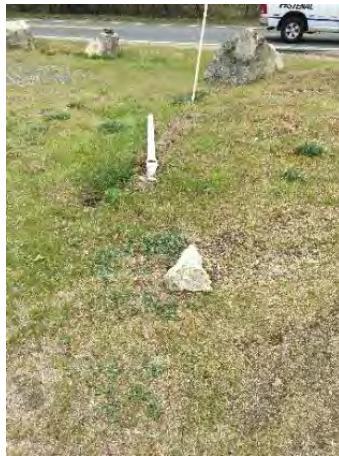
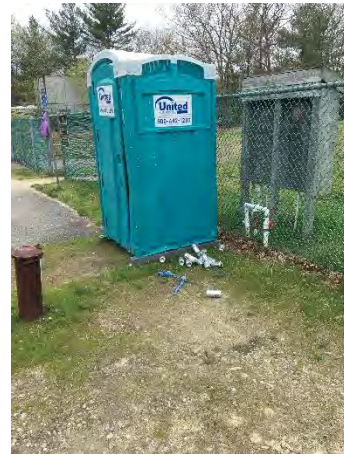
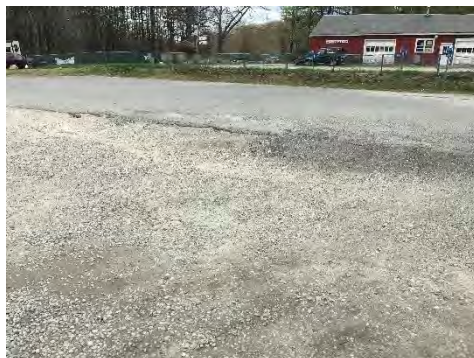
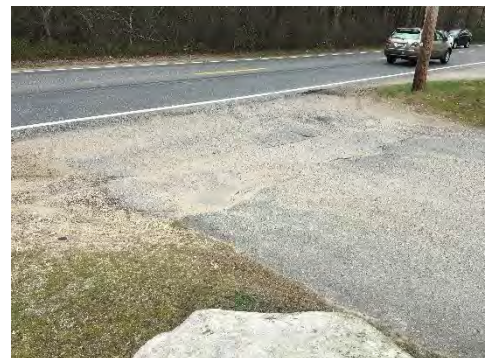
- One accessible parking space is provided.
- There are many exposed utility pipes located both within the parking lot (near the portable restroom) and between Washington Street and the parking lot. Protective bollards or fencing should be installed to help avoid damage to the utility pipes.

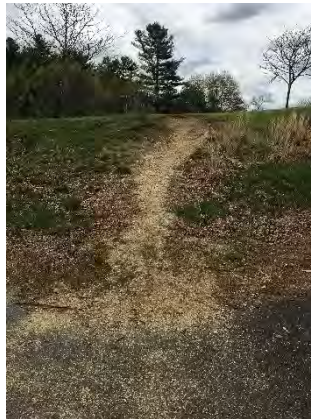
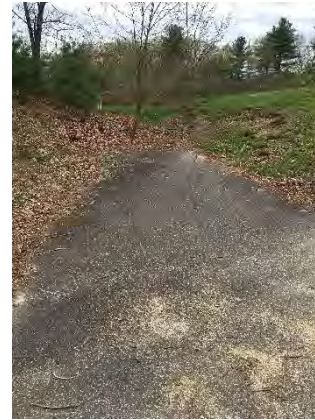
- There is a paved walkway that leads from the parking lot down to Weston Pond. The walkway cuts through two embankments on either side of the path. These embankments are eroding and there is soil/sand spilling onto the walkway, resulting in a narrowing of the path.
- There is an unofficial footpath down the side of the embankment near where the pathway meets the pond area. It is eroding and spilling down onto the paved pathway.
- The sides of both embankments should be planted with a groundcover to help alleviate erosion problems and prevent foot traffic from coming down the hillsides.
- The paved path dead-ends to the northeast side of the pond. It appears it was meant to connect into a future pathway, which has not been constructed. The path should be continued to connect with the soccer fields, which would help alleviate the footpaths down the embankment.

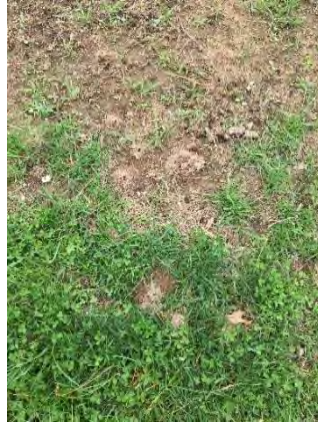
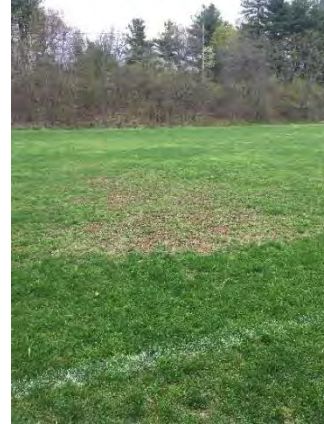
- The existing playing field area has many bare spots and is infested with ants, clover and dandelions. The field areas need to be regraded, top-dressed, fertilized, treated for ants, re-seeded, and re-grown to address these problems.

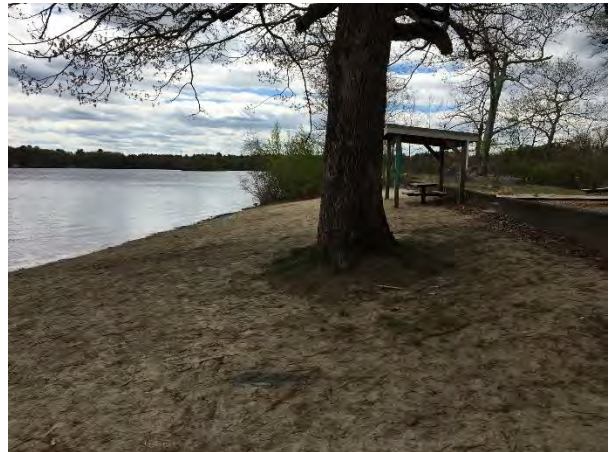
The site has some interesting characteristics. For instance, the playground, on the beach side, is divided from the beach by a concrete retaining wall with two (2) steps that lead down to the sand. This wall is about 24" higher than the sand and has a very narrow rounded top. The slope on the beach is not ADA accessible nor is there an accessible path from the parking area to the playground and beach areas.

- Along the beach side, the playground is divided from the beach by a concrete retaining wall. There are two sets of steps that lead down to the sand. The wall is approximately 24” higher than the sand, and very narrow with a rounded top. This may be a fall danger for children who climb on top of the wall. The Town might consider installing a different playground divider/retaining wall option.

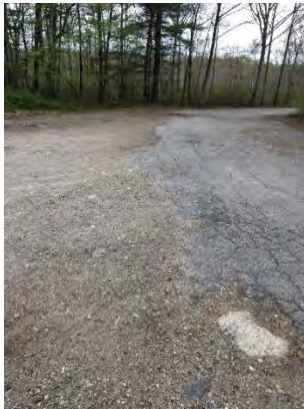
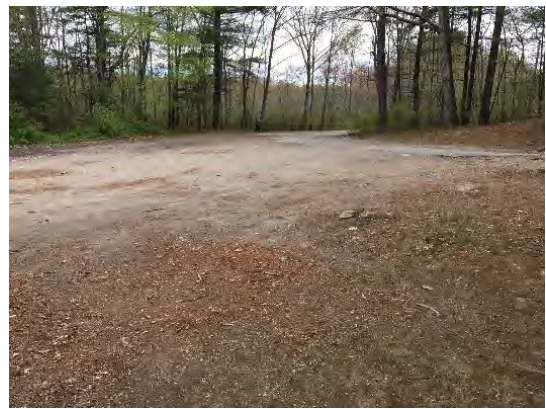
- The access road off Arch Street, called Pleasure Point Road, is paved. A gravel parking lot is located at the end of Pleasure Point Road.
- There is a noticeable grade change between the paved driveway and where it meets the gravel parking lot. There is also a lot of erosion in this area. The edge of the pavement is crumbled and cracked. The pavement in this area should be repaired, and the juncture between the gravel and the asphalt should be brought to the same grade. Drainage should be redirected to avoid eroding the gravel where it meets the asphalt.
- No accessible parking is provided.

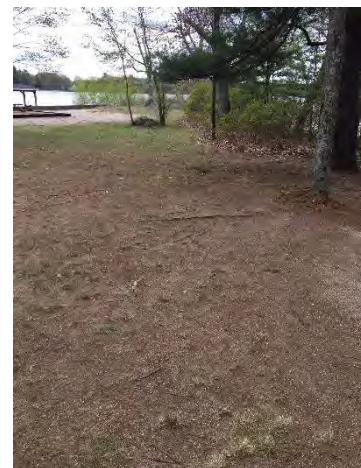
- The playground is in acceptable condition overall. However, it is showing signs of wear from use and weathering.

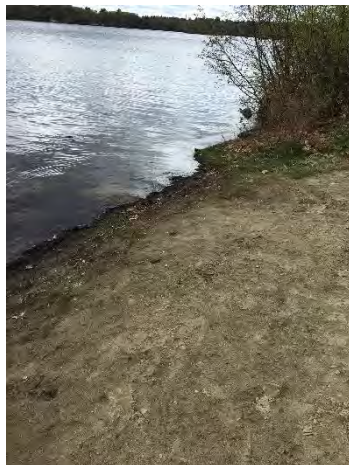
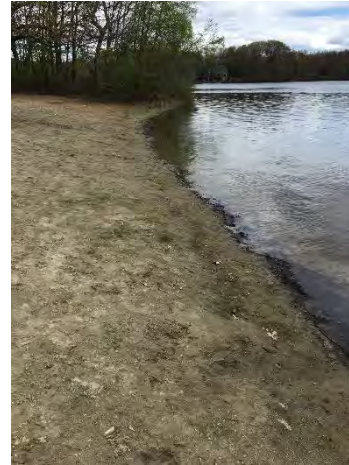
#### Beach Area

- The beach is only open to Holliston residents during the summer, and stickers are required to park at the site.
- The beach has some minor erosion and compaction at the water’s edge. Some erosion control measures should be installed to prevent further damage to the shoreline – such as closing of the beach area during the off-season for repairs and rest.

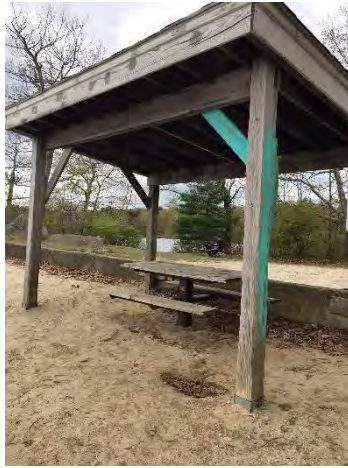
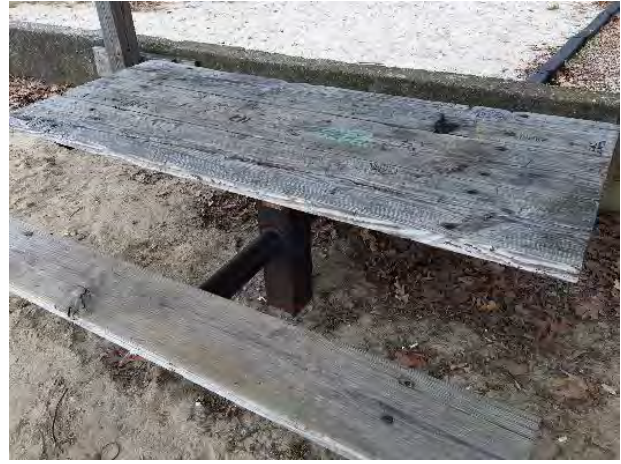
- There is one picnic shelter located at the top of the beach, near the playground. It accommodates one picnic table. The shelter is constructed out of wood and is in good condition overall.

- The table inside of the shelter is in disrepair. The wood is old and weathered, and the surfaces have been vandalized as well.
- One additional table, the same as the one mentioned above, is located next to the picnic shelter as well. It is also in the same state of disrepair. Metal or concrete tables may be a more suitable replacement – as they resist weathering and vandalism better.
- More shelters and/or tables should be considered to accommodate use during the peak season.

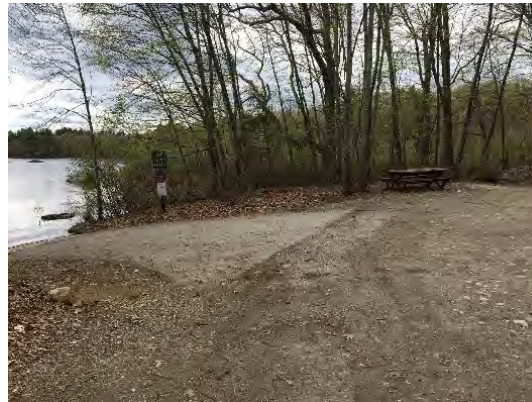
- There is a non-motorized boat launch at the end of the parking lot. It is in good condition but does not offer much in the way of trailer parking. The site, when full, would be difficult to park a vehicle attached with a trailer. Restricted trailer parking areas should be identified and notated with signs.

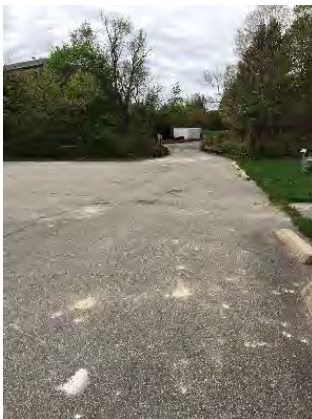
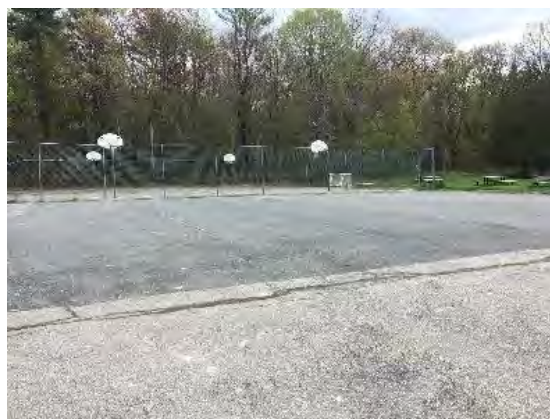
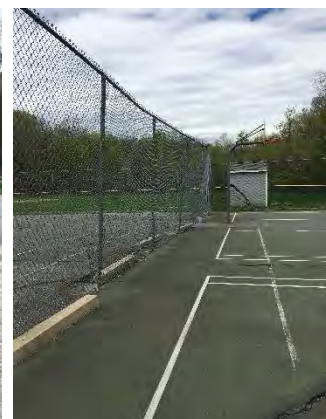
- What appears to be an old tennis court area abuts to the parking lot. It is also paved, but there is no barrier between the courts and the parking lot. Because of this reason, cars park on the tennis courts. If it is intended for this area to be used as tennis courts, a fence or other barrier should be installed between it and the parking lot. If the tennis court is not intended to be used for this purpose any more, the area should be striped with the rest of the parking lot. A sufficient barrier between the basketball fence and the parking area should be established to prevent cars from hitting the fence and pushing it over.

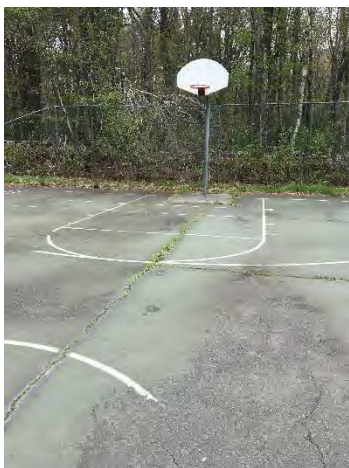
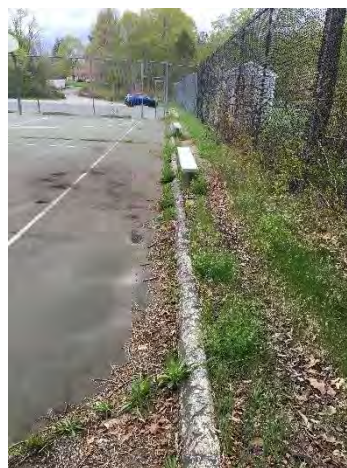
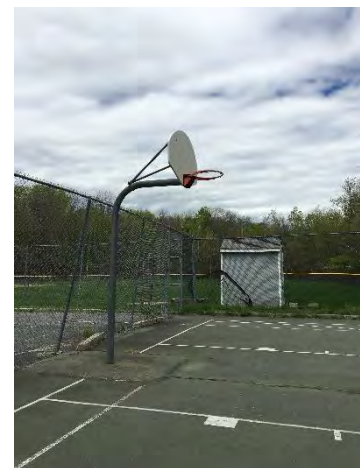
- The basketball courts are in poor condition. The asphalt mat surfacing is significantly cracked, heaved and unleveled. There are serious structural deficiencies in the asphalt mat. The court requires complete pulverization and reconstruction to become adequately serviceable and avoid potential safety hazards associated with the failing condition of the asphalt mat.
- The basketball hoops are missing nets.
- The fencing around the court is falling down in some parts. At the back of the courts, where the courts abut to the woods, a tree has fallen on the fence and pushed it in. At the front of the courts, it appears a car pushed and bent one of the posts, making the fence lean into the court.
- The player/spectator seating around the perimeter is in bad shape as well. Some of the benches are falling over, while tall weeds surround others.

Players benches at the baseball field and basketball court need to be replaced. They are currently bent or broken and unusable.

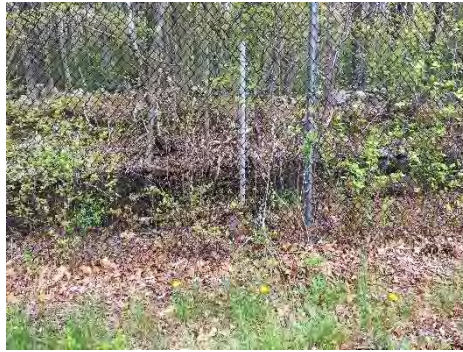
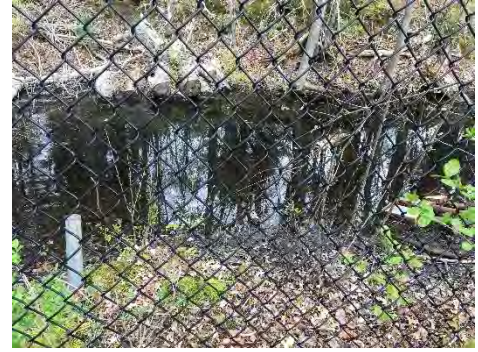
- Standing water sits the area just behind the fence, in the low spots between the fence and the abutting woods. This is likely what has caused the trees to fall in

the back, as the soils are saturated. The standing water also attracts mosquitoes. A wetland assessment of the area should be conducted, and if possible, drainage should be installed in the area to alleviate the standing water problem.

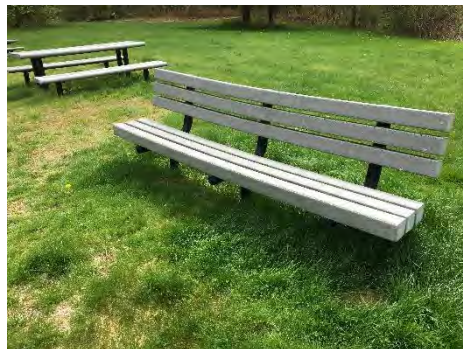
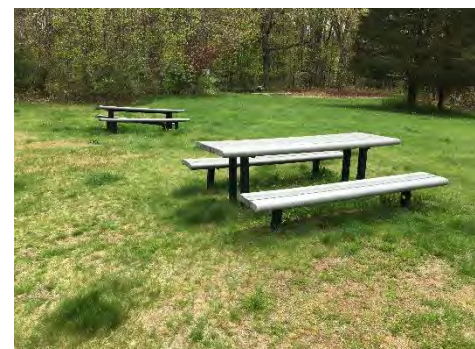
- There are picnic tables near the basketball courts, in the grass. They are not ADA accessible.
- One in-ground bench is also located near the basketball courts – just off the former tennis court area. The bench is in good condition but not well-located, as the tennis courts do not appear to be used anymore. It also is a maintenance nuisance, as it is difficult to mow around. The bench should be relocated to a more suitable location.

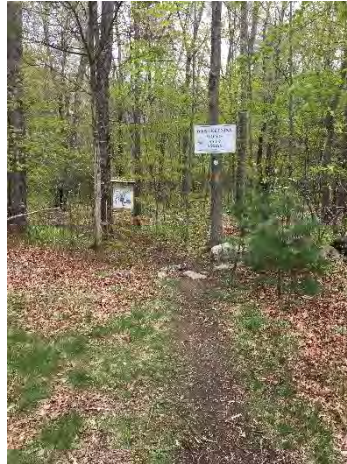
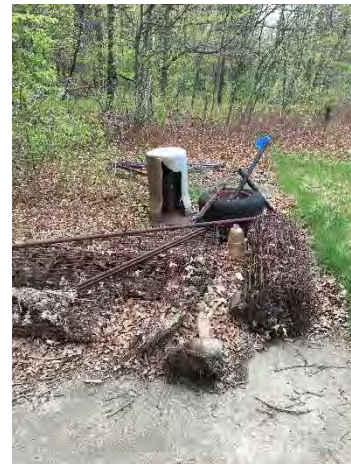
Better wayfinding signage should be added to the site to help visitors know the trail exists and where it is located.

- The garbage and debris near the trailhead should be cleaned up and hauled away.

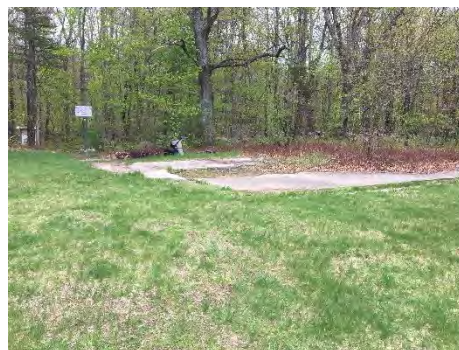
- A potential use for the old concrete slabs is to convert them into ADA accessible picnic table areas. An ADA accessible path would have to be installed to the picnic area as well.

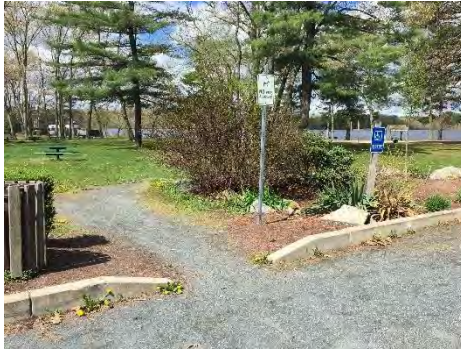
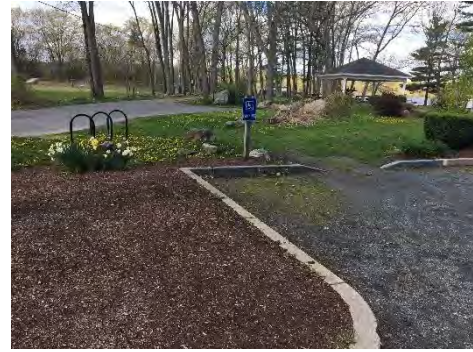
- The access drive down to the parking lot is paved, and the parking lot itself consists of compacted gravel. Concrete curbing surrounds the gravel parking lot, and is painted with white tick-marks, delineating the different parking stalls. Overall, the parking lot is in very good condition.

- The parking lot has four (4) handicap parking spaces. There are curb cuts in the center of each of the parking stalls (two sets of two spaces); however, neither has an accessible route to any of the park's amenities. Both paths dead end into the grass.

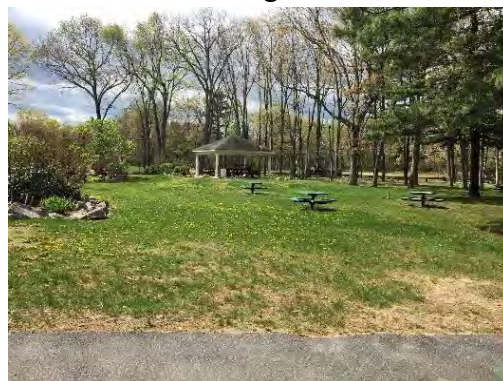
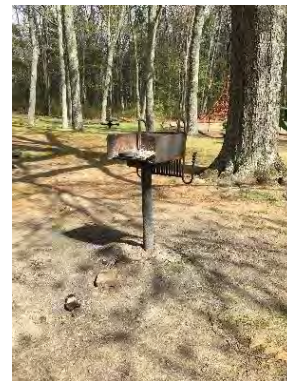
- There are approximately a dozen picnic tables scattered throughout the grassy area between the parking lot/playground and the beach area. The tables are all in good condition, and most are accompanied by a barbeque.
- The area is landscaped nicely, however the grass is sparse and compacted due to foot traffic coming across it down to the beach area.

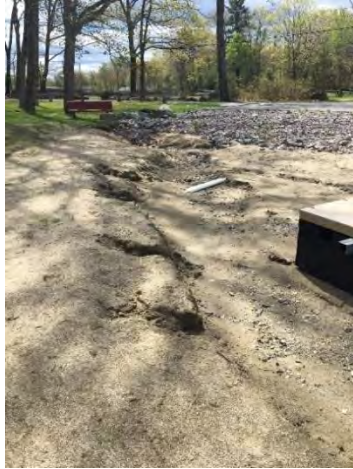
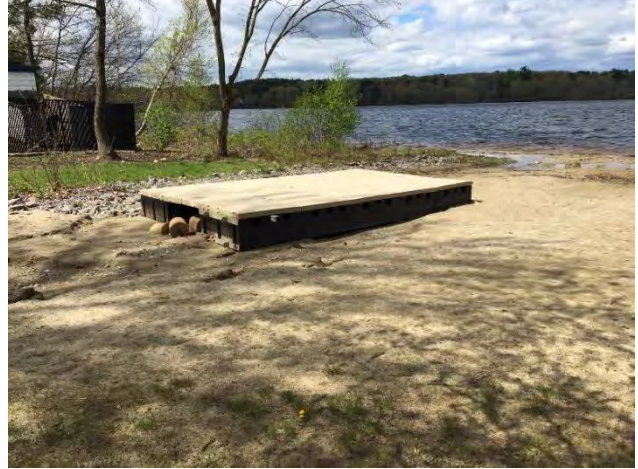
- This area should be repaired and armored with rip-rap, to prevent further degradation to the beach and surround area.

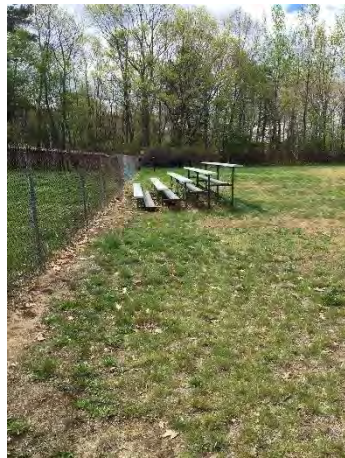
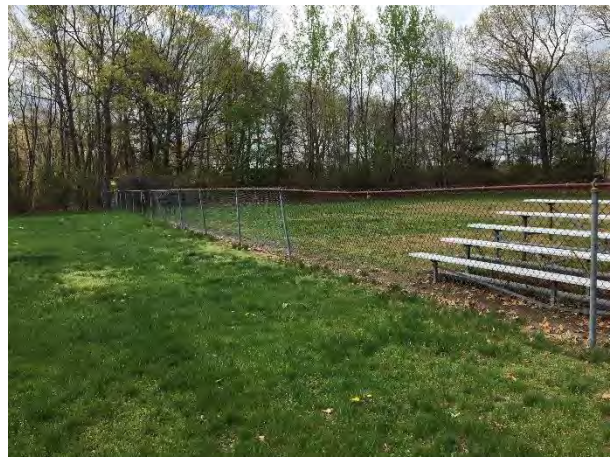
#### One (1) 65' Softball Field

- The turf is in good condition overall, despite having a dandelion issue. There are a few, very minor bare patches and other areas where the grass is lumpy and uneven.
- Spectator seating is provided along the first base line but is not ADA accessible.
- The fencing along the first-base line is rusting and bent. It is missing a number of posts/stringers. The fence could use replacement.

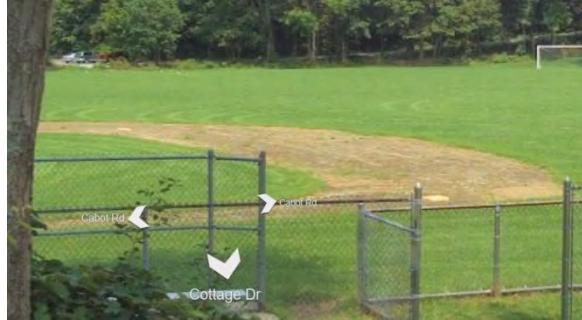
- There are two soccer fields (striped according to use but can fit an approximately 180' x 125' field and a 300' x 200' field side by side), as well as a 60' baseball diamond in this area.
- The turf is in good condition overall, with the same issues mentioned above for the softball field.

- Weeds are present within the infield. The stone dust and clay mix base paths, pitcher's mound and home plate areas should be re-graded, supplemented, and repaired to eliminate lip, infield mix migration and weeds.

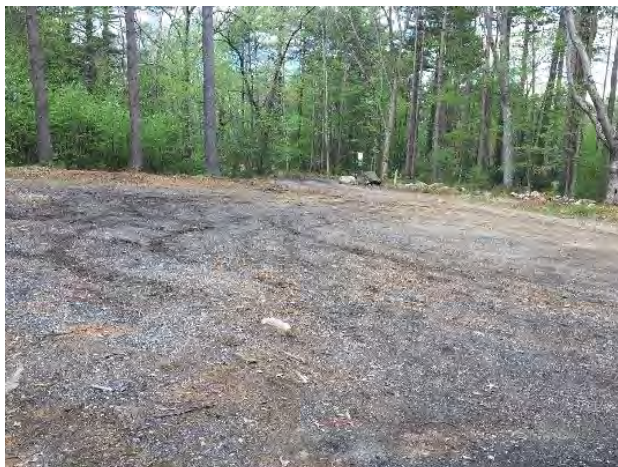
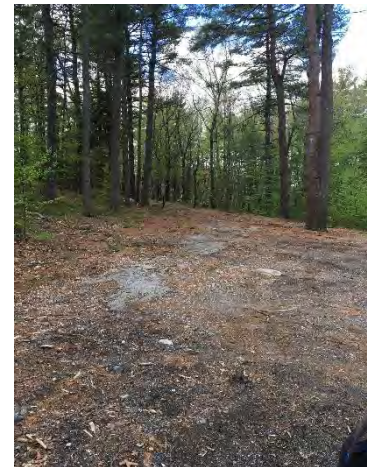
##### Parking Lot/Access Road

- The site is accessible via a dirt road that comes off Norfolk Street.
- Parking is very limited and/or restricted near the first entrance to the ball fields, which is a problem during baseball games. More parking and/or delineated parking areas should be better marked in this location. Another option is to install a sign that notifies visitors that there is more parking located further up the road.
- A larger, dirt parking area is located about 300 yards further up the dirt road. It is an informal parking lot, meaning there are no delineated parking spaces. The terrain is rough, with many washed out areas, potholes, rocks and tree roots exposed. The parking is not ADA compliant, and there is no ADA accessible route from this parking area to any of the park's amenities.

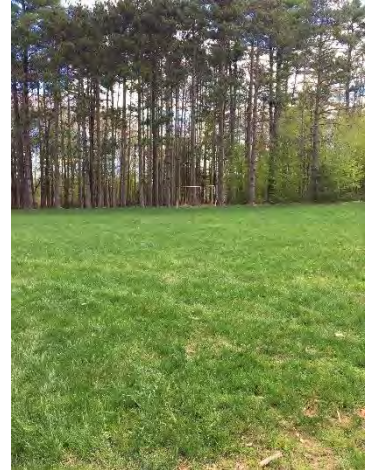
### Two (2) 60' Softball/Baseball Fields

- Both fields are in good condition. The grass as well as the infields are maintained well. They are used for little league games during the spring.
- Part of the field near the northern diamond appears to get inundated with water during storm events. This is evident as there is some rutting and sparse grass in the area, and the soil is softer than the surrounding area.
- There is a storage shed located behind the backstop at the northern field.
- It appears that the field is also used for soccer on occasion – as there is a goal stored on site.

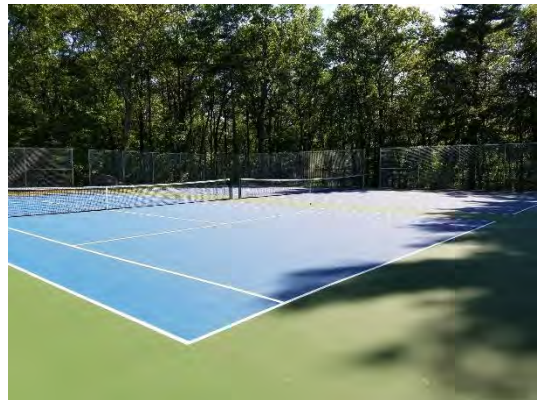
### Two (2) Tennis Courts and Basketball Court

- New tennis courts and a basketball court were constructed in 2017 and are in very good condition.
- The nearest parking lot, currently, is the dirt overflow lot mentioned earlier. This parking lot, nor the access down to the tennis courts, is ADA accessible. At least one accessible parking space and an accessible route should be added for the new tennis facility.

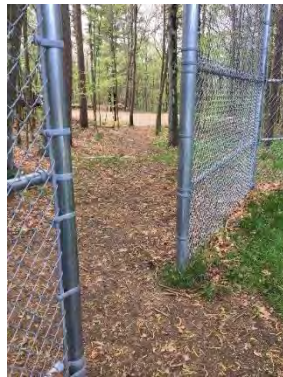
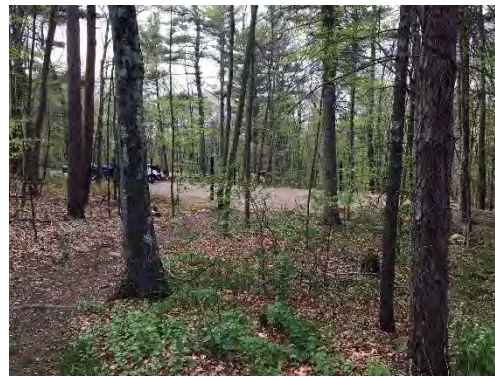
Paths

- Footpaths connect the ball-fields to the tennis courts. These unofficial paths meander down to the tennis court area, as well as between the parking areas and the fields/courts. Again, there are no ADA accessible routes to any of the park's amenities, and therefore some should be installed to make the site ADA compliant.

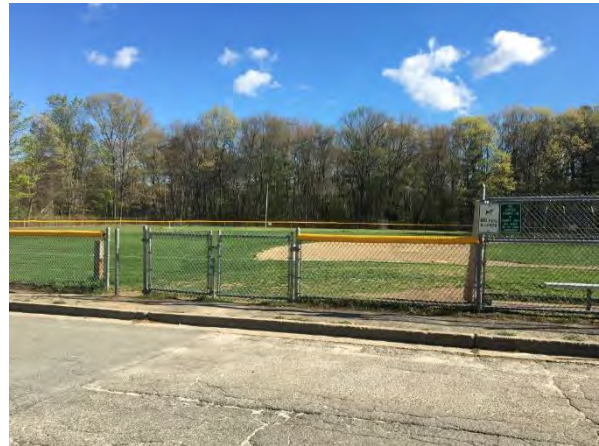
### 4.7.2 Topography

Overall the site is relatively flat as the facility consists primarily of the existing baseball field and outer practice area. Beyond the maintained field area, lies wooded and wetland areas.

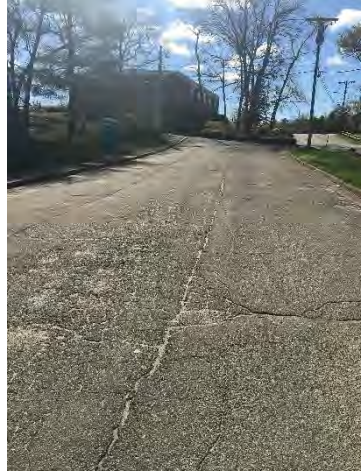
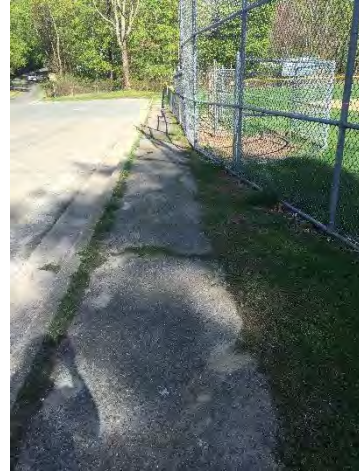
- The paved parking lot is in poor condition. The pavement is cracked, heaved, and disintegrating – along with the asphalt walkways that abut to it.

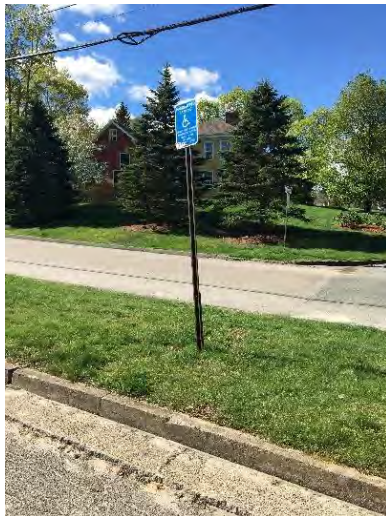
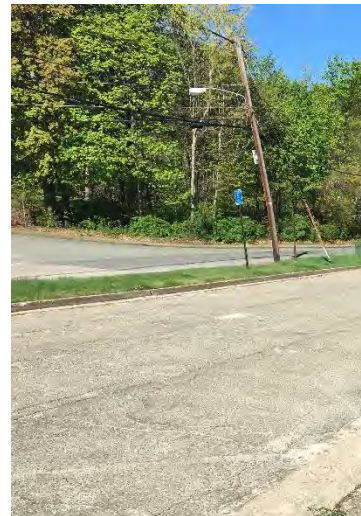
- There is one handicap parking space but is not well delineated. There is no parking lot striping, and only the one sign indicating an accessible parking space. Because the stall is not striped, this would be hard to reserve the spot properly on a busy game day. It appears that the signed accessible parking space does not meet grade requirements either, due to the heaving, rutting and cracking of the pavement surfacing.

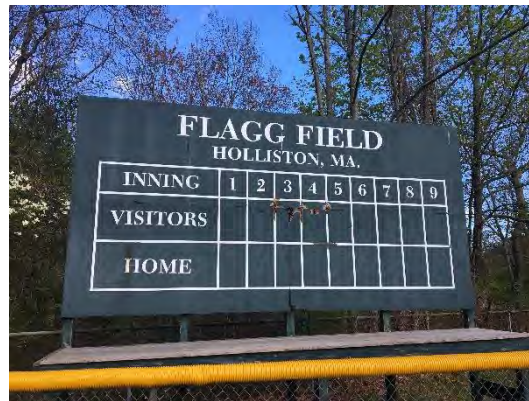
- The field appears to have an irrigation system, as there are valve boxes located on site.
- A wooden score board is located beyond the left field fence. Although useable, the scoreboard is in disrepair. Where the boards abut to one another, the edges are rotten and therefore a hole in the center of the scoreboard has developed. The scoreboard needs repair due to general weathering and wear.

The old score board could be removed and replaced with a new scoreboard.
