From: James Keast - Facilities Manager

Date: April 8, 2020

Re: **Facilities Review 269 Central Street (DPW Foundry Buildings)**

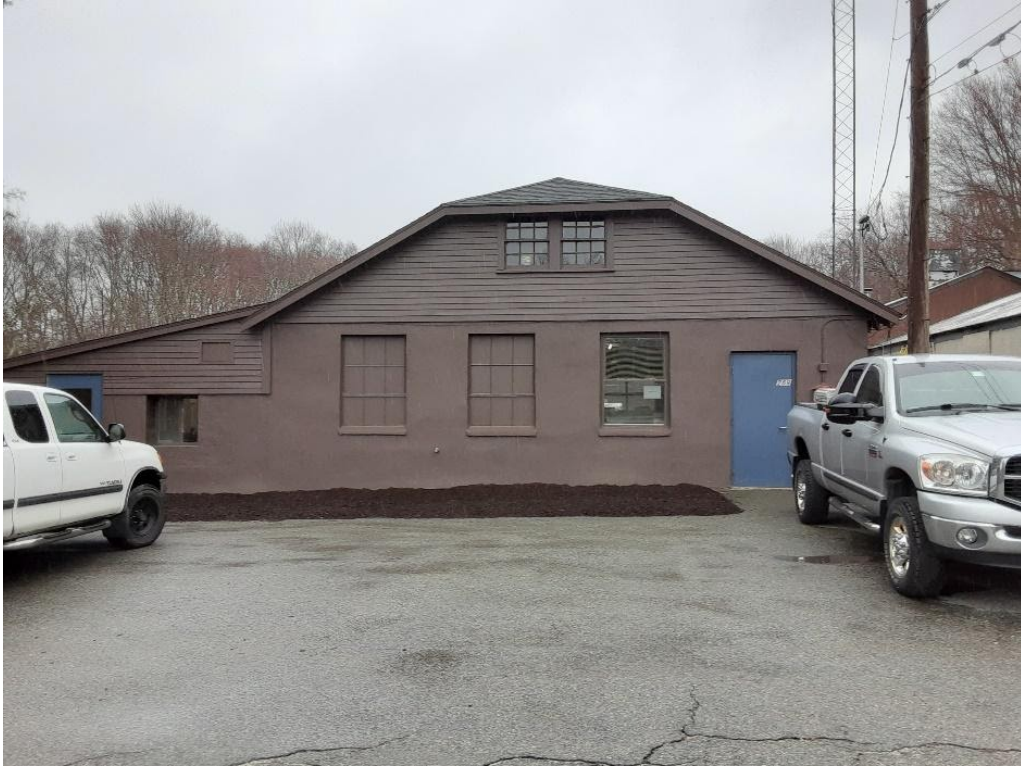
Office/Admin front

The exterior of the Office/Admin building was recently painted. There are no signs of peeling paint or significant rotting of wooden areas. It was noted that there is a stucco layer added to the exterior block wall. The wall section next to the driveway leading to the rear of the building has large sections of stucco missing and covered up by the recent painting. Some cracking in the block wall is also noted. However, this is not a structural concern.
