From: James Keast - Facilities Manager

Date: April 10, 2020

Re: **Facilities Review 63 Arch Street (DPW Highway Buildings)**

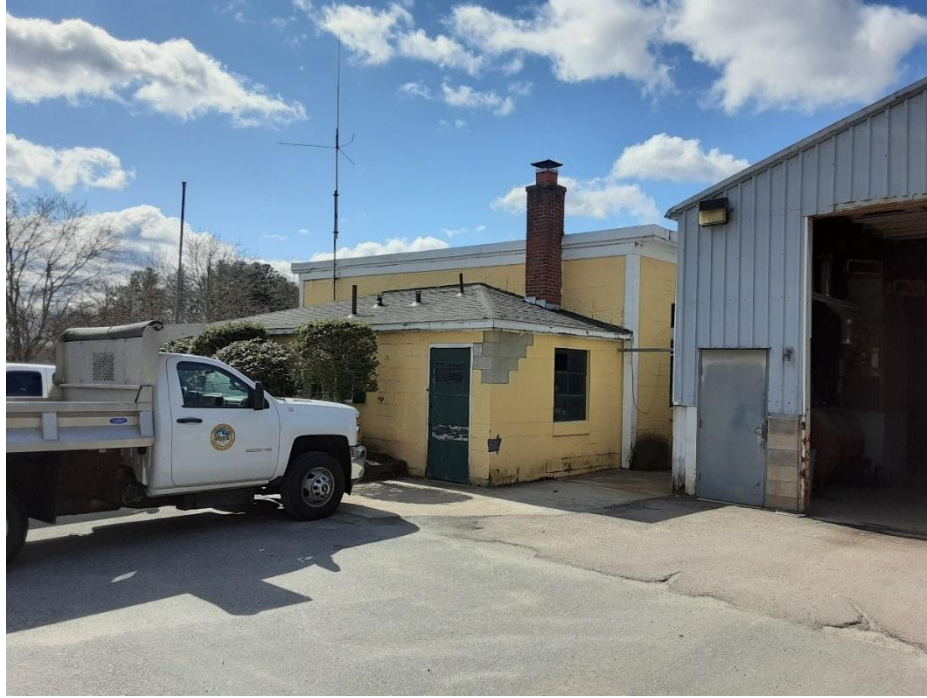
*Office/admin side*

The concrete block walls are damaged in various areas around the building. There is significant damage located at the side entrance to the service shop. This damage is a result of a roof drainage issue. It was noted that the connecting roof area between the original Office/Admin and Service shop and the Vehicle Storage addition collects a significant amount of water from both roofs channeling it to this area of the building.

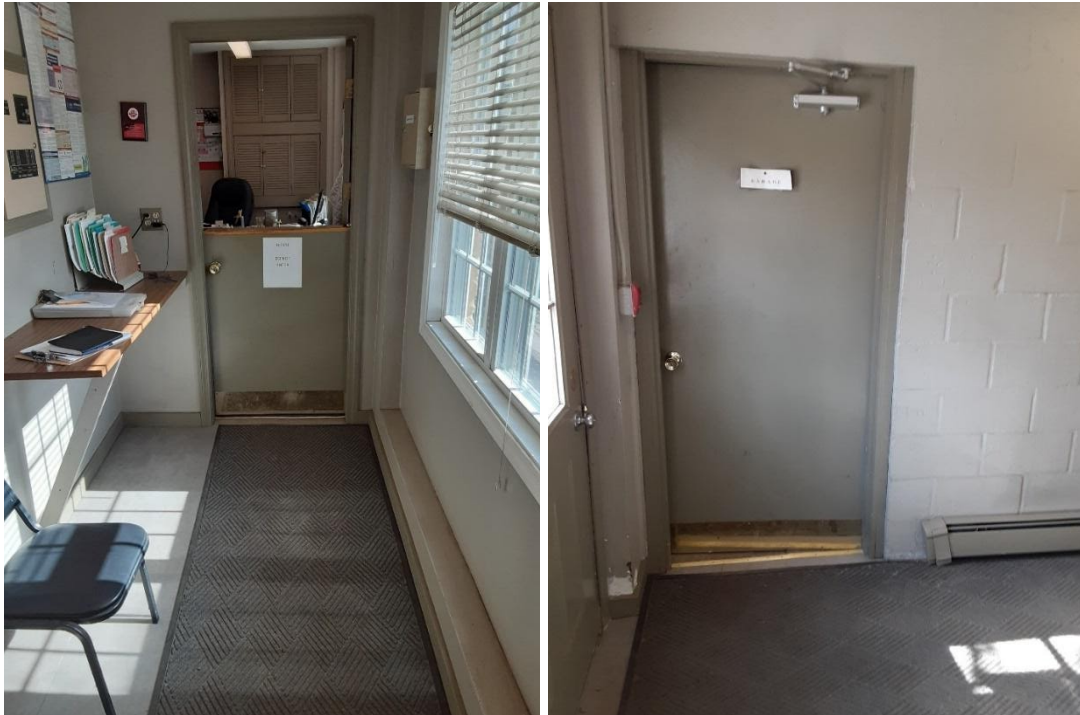
The interior of the Office/Admin area is well maintained and good condition. Through-the-wall window A/C units were observed along with baseboard heat. The lighting is functional and was

*Office/Admin entry*

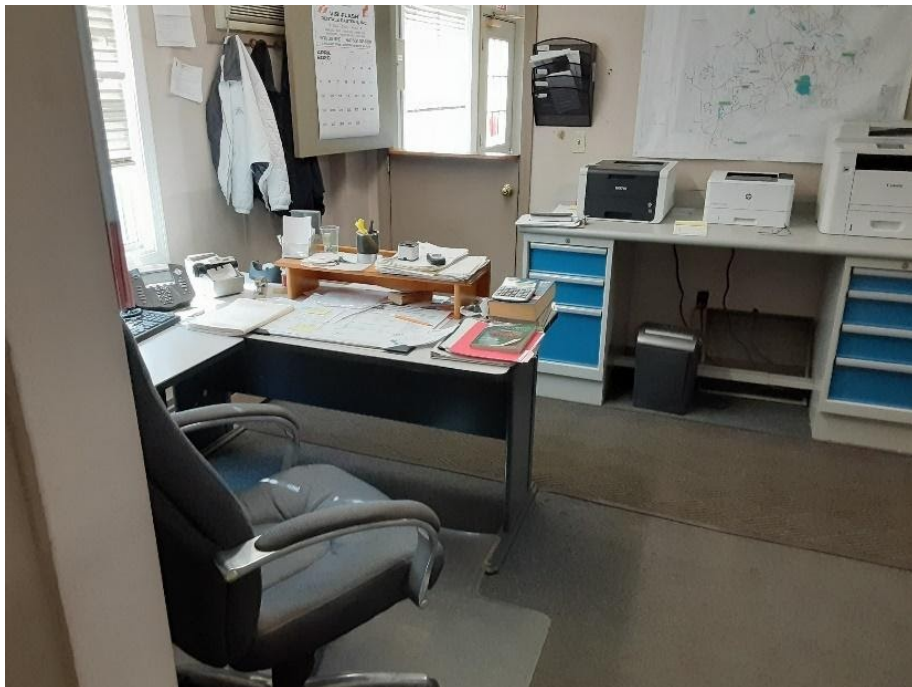
*Office area*

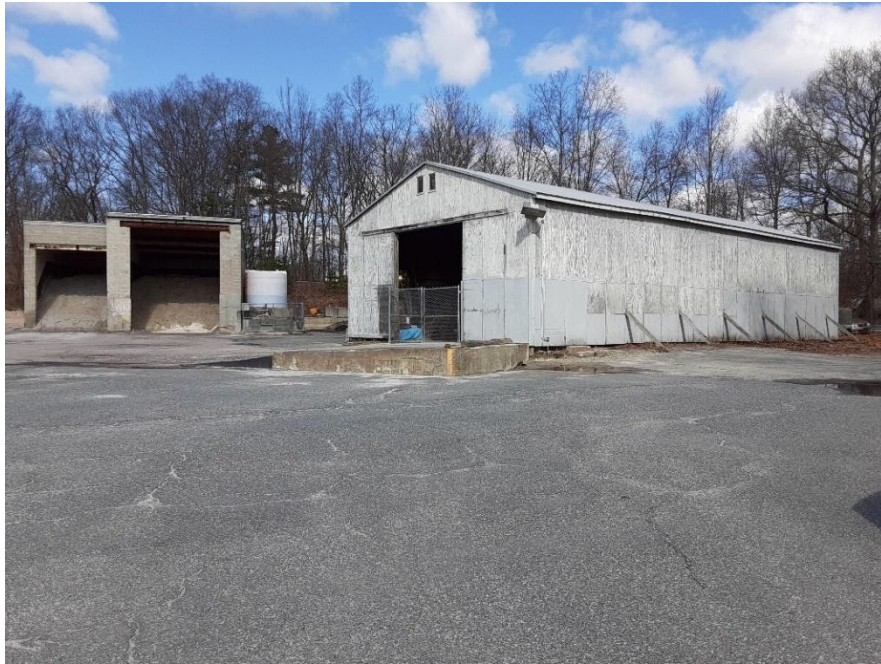
Storage building 1 is unconditioned and constructed of wood with a metal roof. It stores material used to treat roadways in the winter. At the time of my review vehicles were being stored in this space along with the material. This building was secured with a gate. This building is in poor condition with the side bowing out from the road-treating material piled against the interior walls. Side bracing is installed on the outside parameter of the building.

*Storage buildings 1 and 2*

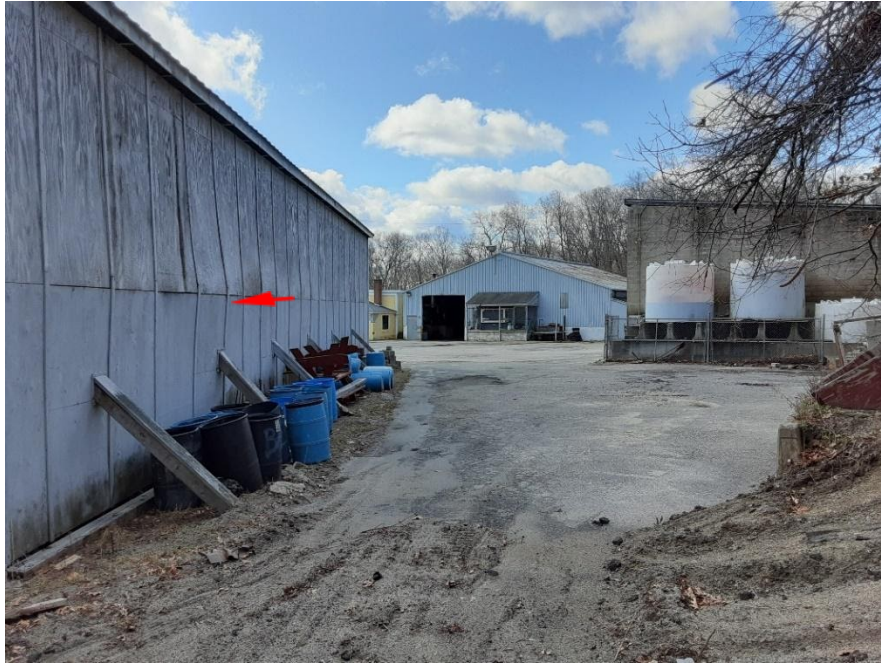
*West side of Storage 1 and north side of Storage 2*

Storage building 2 is unconditioned and stores material used to treat roadways in the winter. This building is open in the front and not secured. This building is constructed from concrete block with a wooden roof structure and rubber roof. This building is in fair condition.
