From: James Keast - Facilities Manager

Date: Aug 18, 2023

Re: **Facility Condition Assessment - Holliston High School 370 Hollis Street**

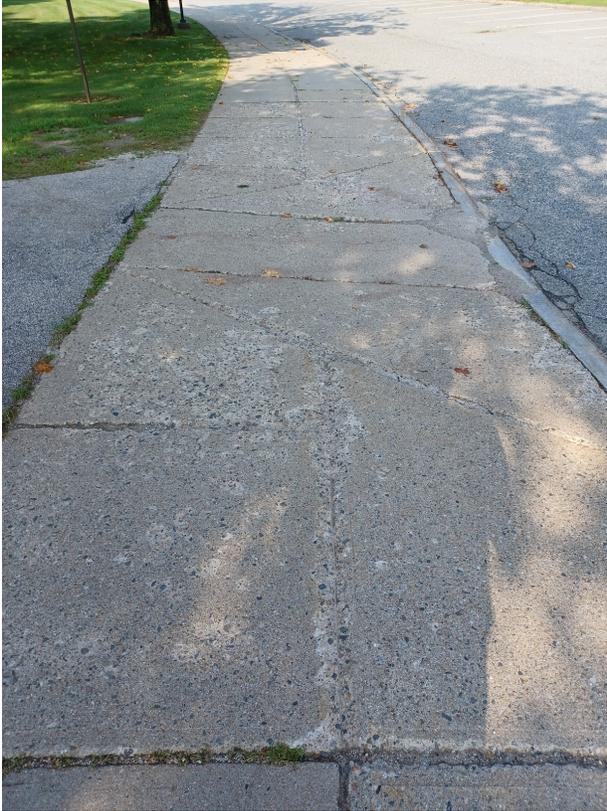
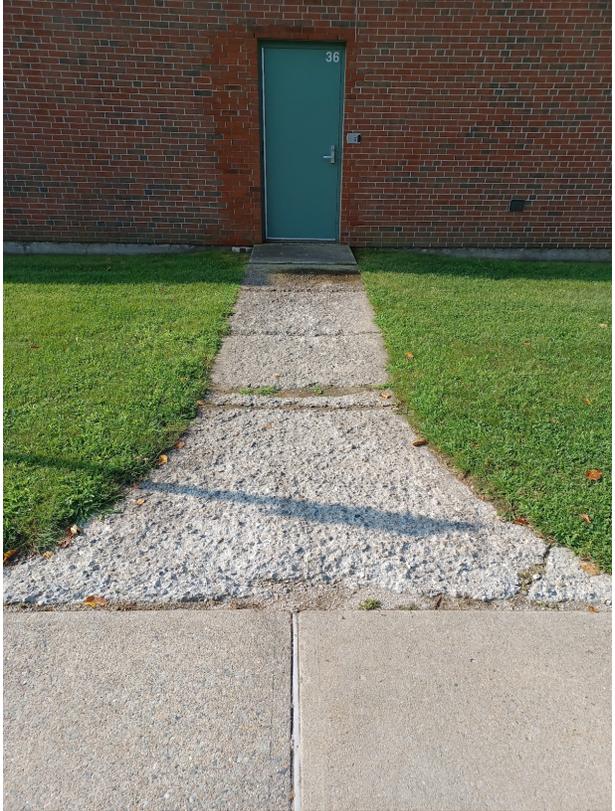
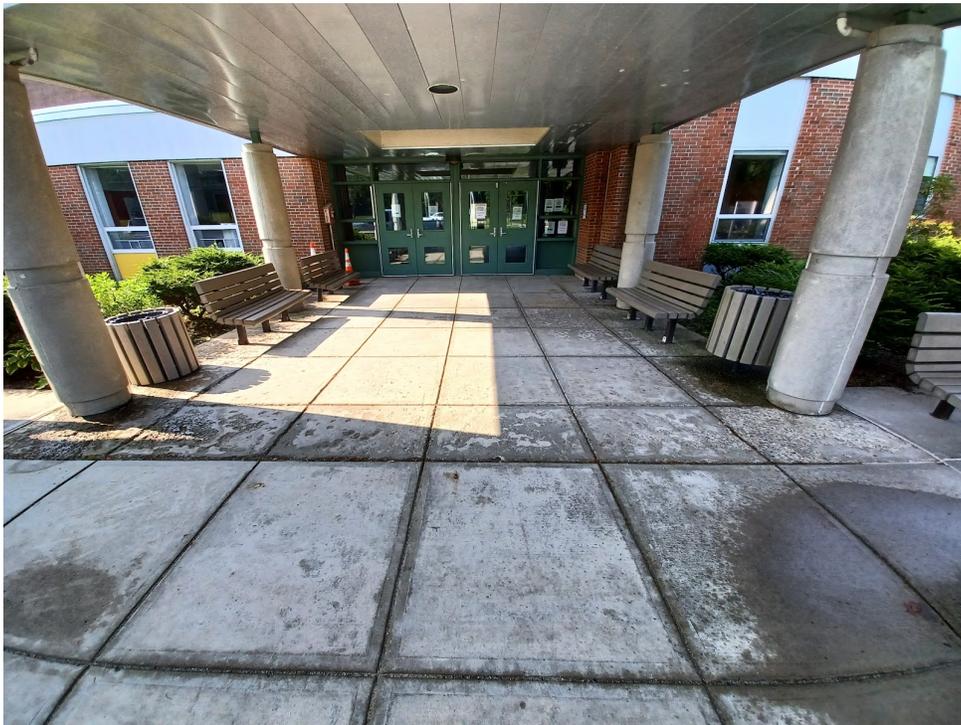
Sidewalks and Pavement- Some sidewalks are in critical condition and are a safety hazard to users. Many sidewalks have shifted at the joints resulting in a raised edge which creates a tripping hazard. Some of the surfaces have deteriorated so much that the concrete has broken apart as shown below. Other sidewalks have a deteriorated surface which traps water, ice and debris further accelerating the deterioration process.

Critical ADA Ramp, Sidewalk, Main Entrance

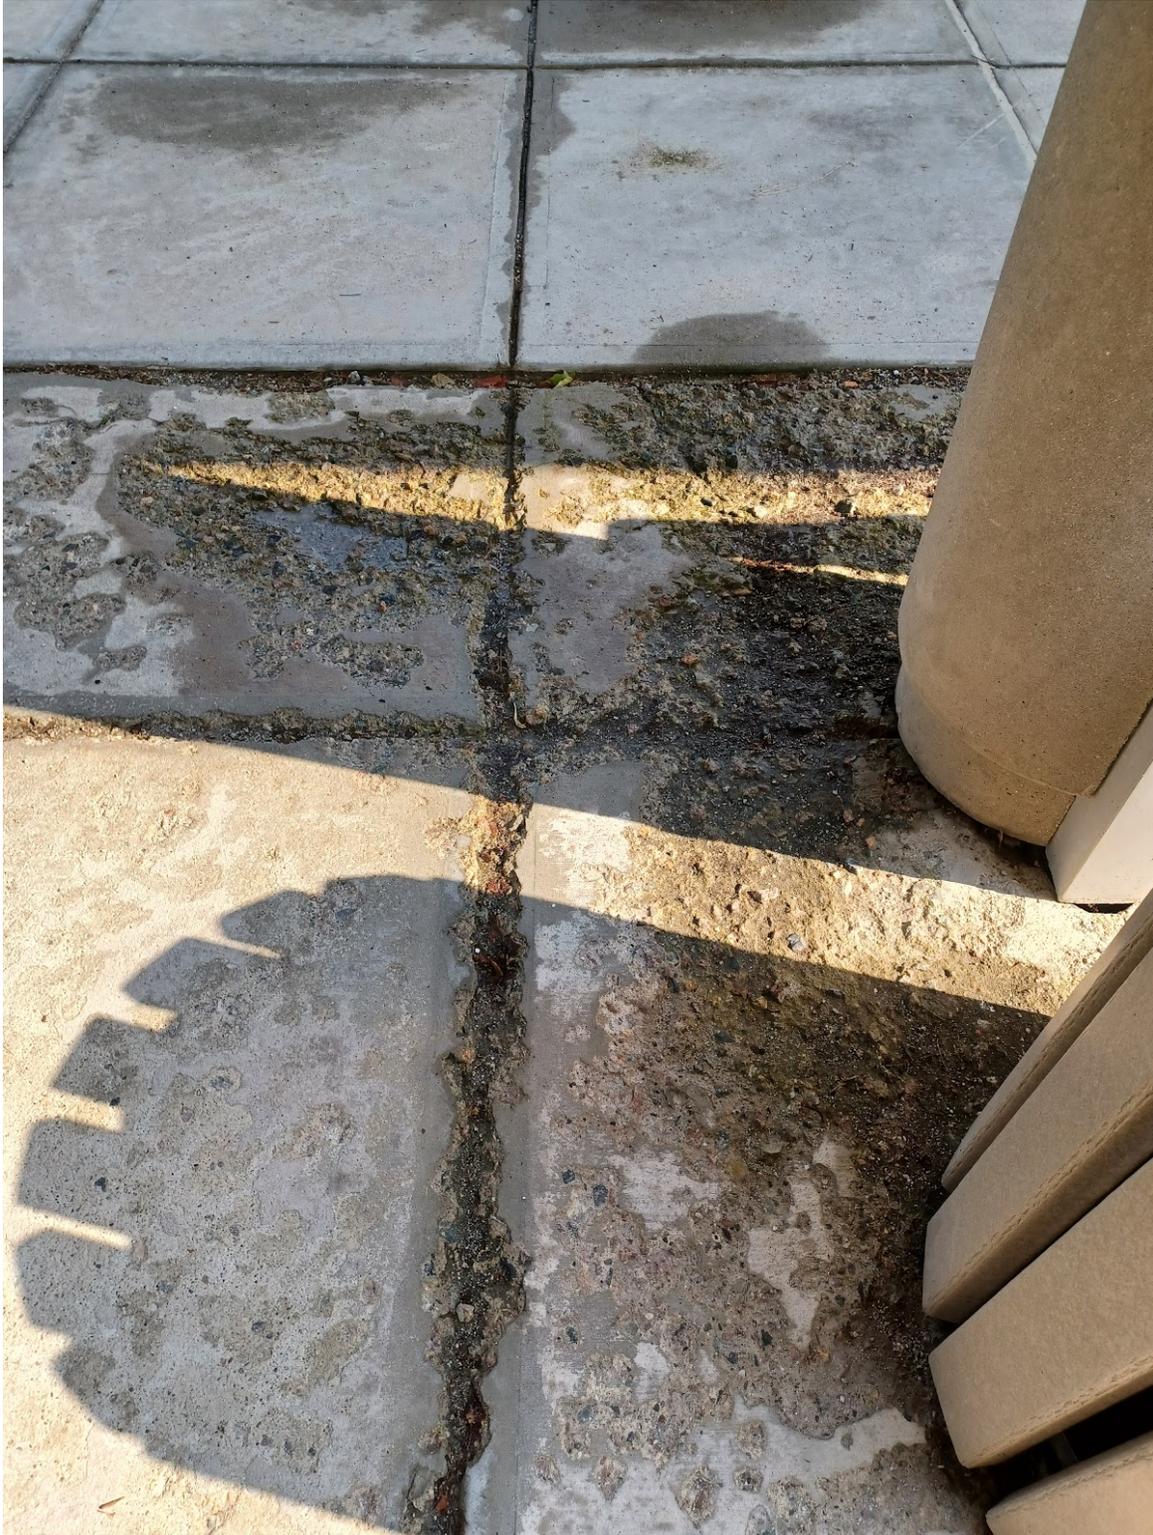
Critical Main Entrance

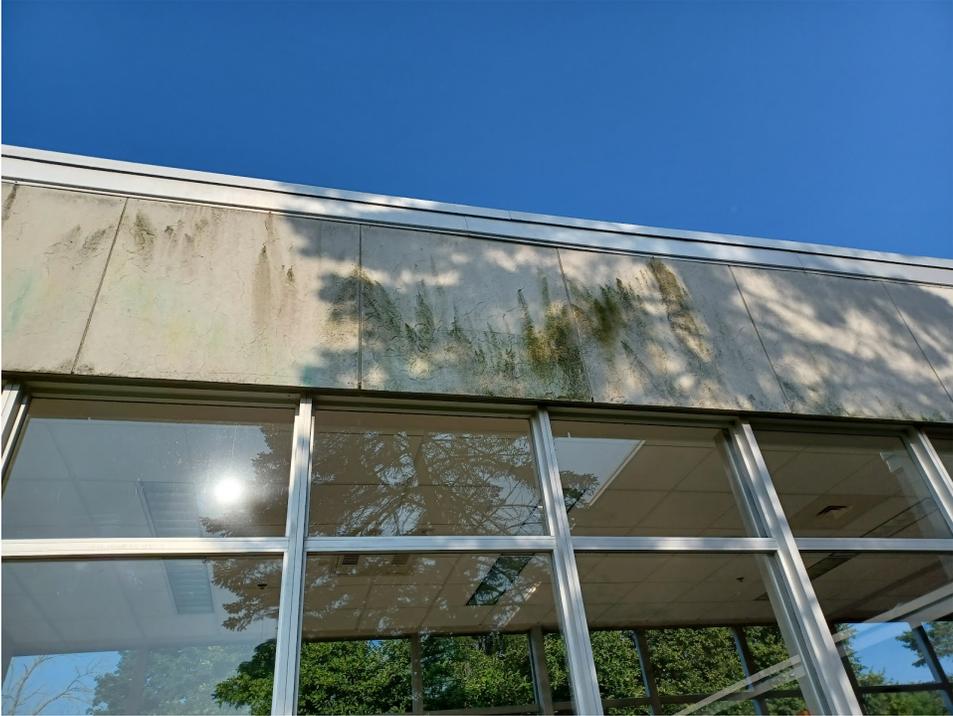
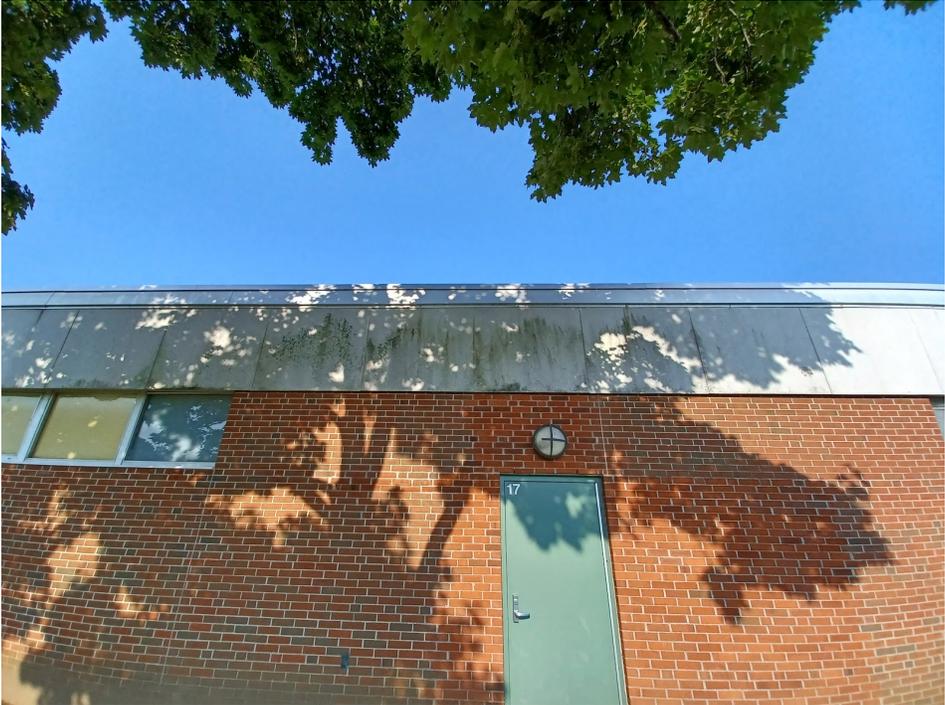
The facias are masonite panels approximately two feet tall and wrap around the perimeter of the building. These panels are generally in Fair to Good condition. It was noted that several panels were cracked. The panels in the shaded areas were also covered with organic materials like mold and algae.

Masonite Panels

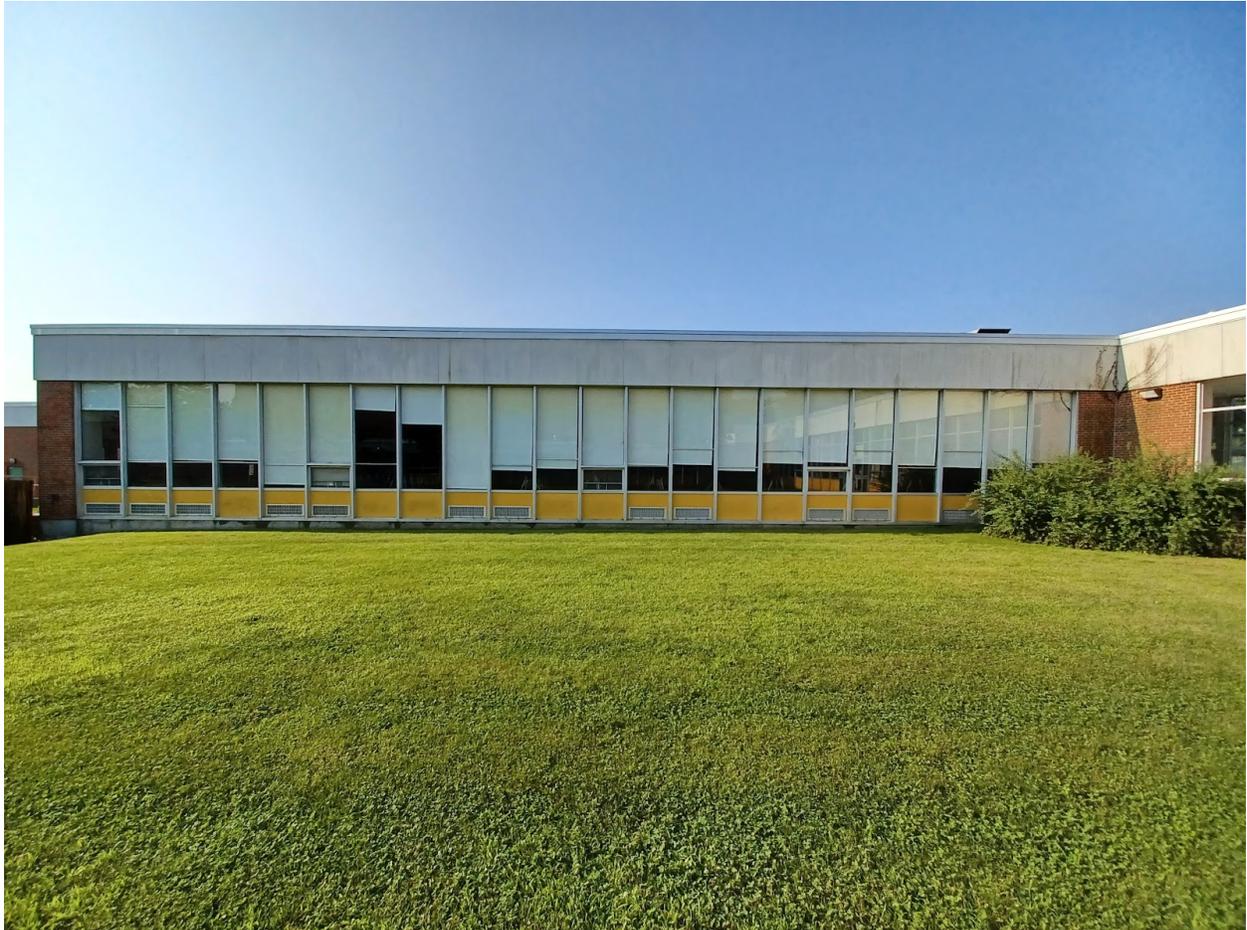
Typical Window Wall Panel System

In general the panel wall system is in Fair condition with some repairs that have taken place over the years. Glass that required replacement was done with more energy efficient double pane units. However, the window glazing used to hold the window into the frames has failed and in critical condition. The glazing has deteriorated to the point where moss and other organic growth has filled the gaps allowing for water and air infiltration.

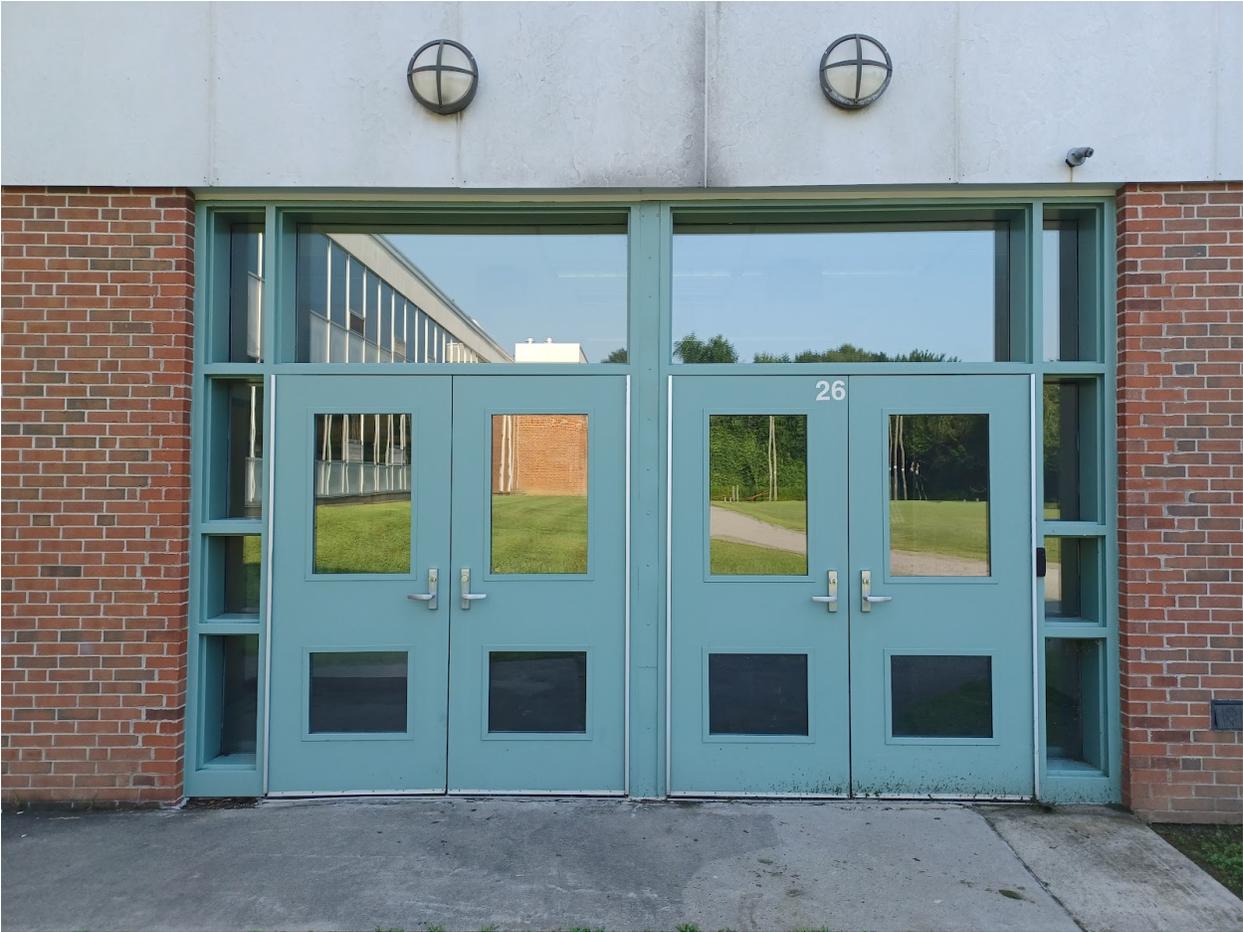
The doors are in Fair condition with only some minor rust forming on the frames. All exterior doors operate well and the main entrances have remote access control allowing for all doors to be locked during school hours.

Typical Door System

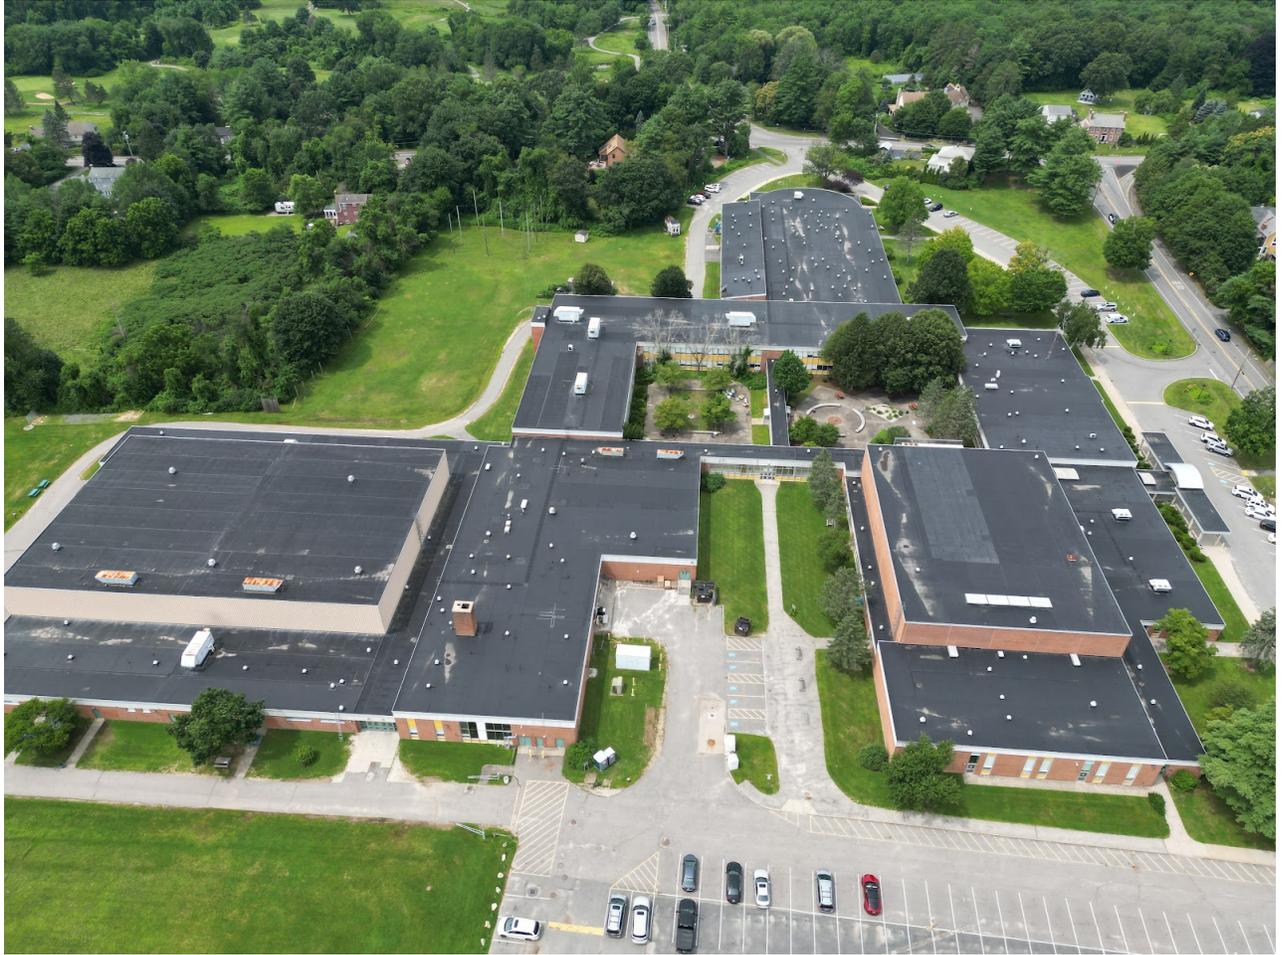
Roof - The flat EDPM roof was replaced in the 2001 building renovation and is in Fair condition. With the exception of the area of the covered over brick wall drain holes, as mentioned previously, there are minimal leaks. (Confirm with Keith). The roof is approximately 22 years old and should last another 10 years. This roof is a good candidate for restoration whereby a new liquid layer, along with a fabric reinforcing mesh, can be applied over the existing roof to extend its life for another 20 years. It should be noted that there are approximately 100 roof penetrations for various HVAC and plumbing systems. The flashing around these areas typically only lasts 20 years. It is highly recommended that a roofing expert come out and survey the roof to identify areas of concern and outline a plan for replacement of the flashing around the roof penetrations. It was also noted that water is running off the roof and along the exterior wall due to blocked or poorly channeled water drainage.

High School Roof Sections

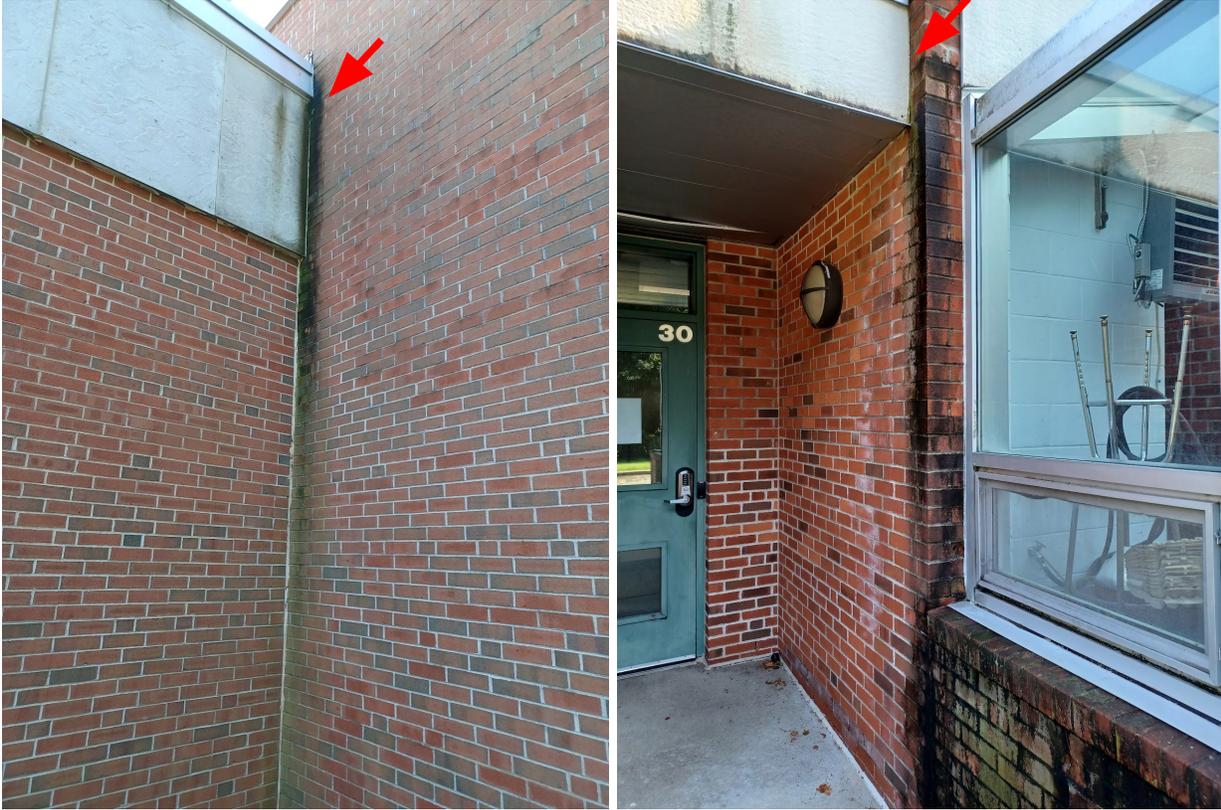
Water Draining Off The Roof

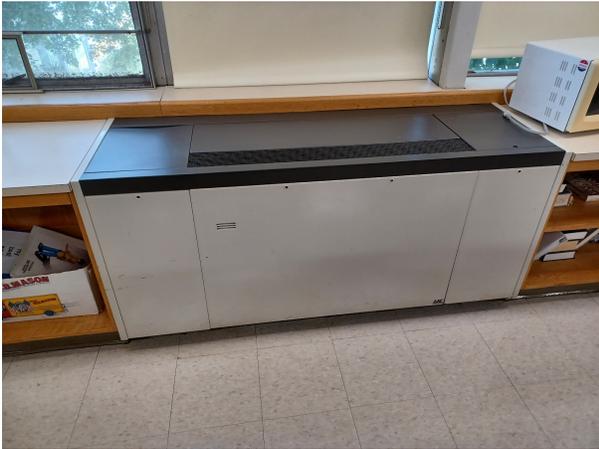
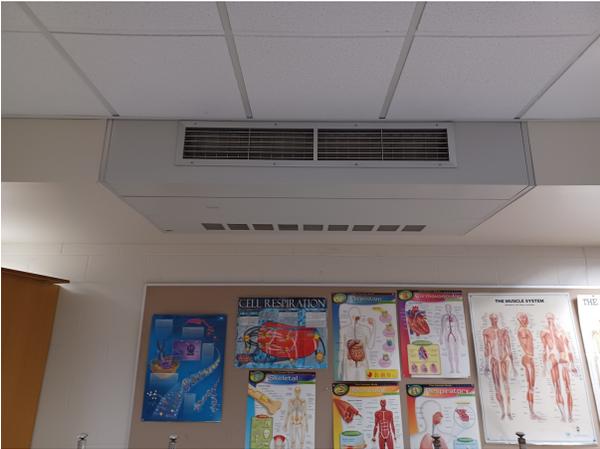
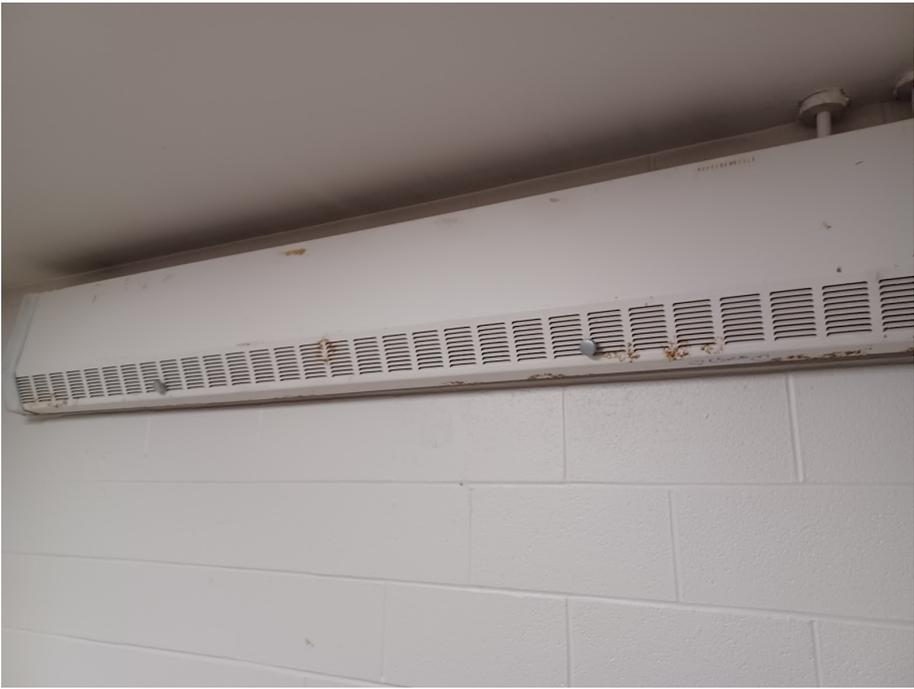
All classrooms have unit ventilators that exchange circulated air with the outside. During the heating season hot water from the boilers circulates through the units to provide heat. There are over 100 of these units in the building requiring individual maintenance on the blower

motors, zone valves and air filters. Many of the blower motors have already been replaced. Due to the age of these units it is getting more difficult to obtain parts for repairs.

Examples of Classroom Unit Ventilators and Radiator

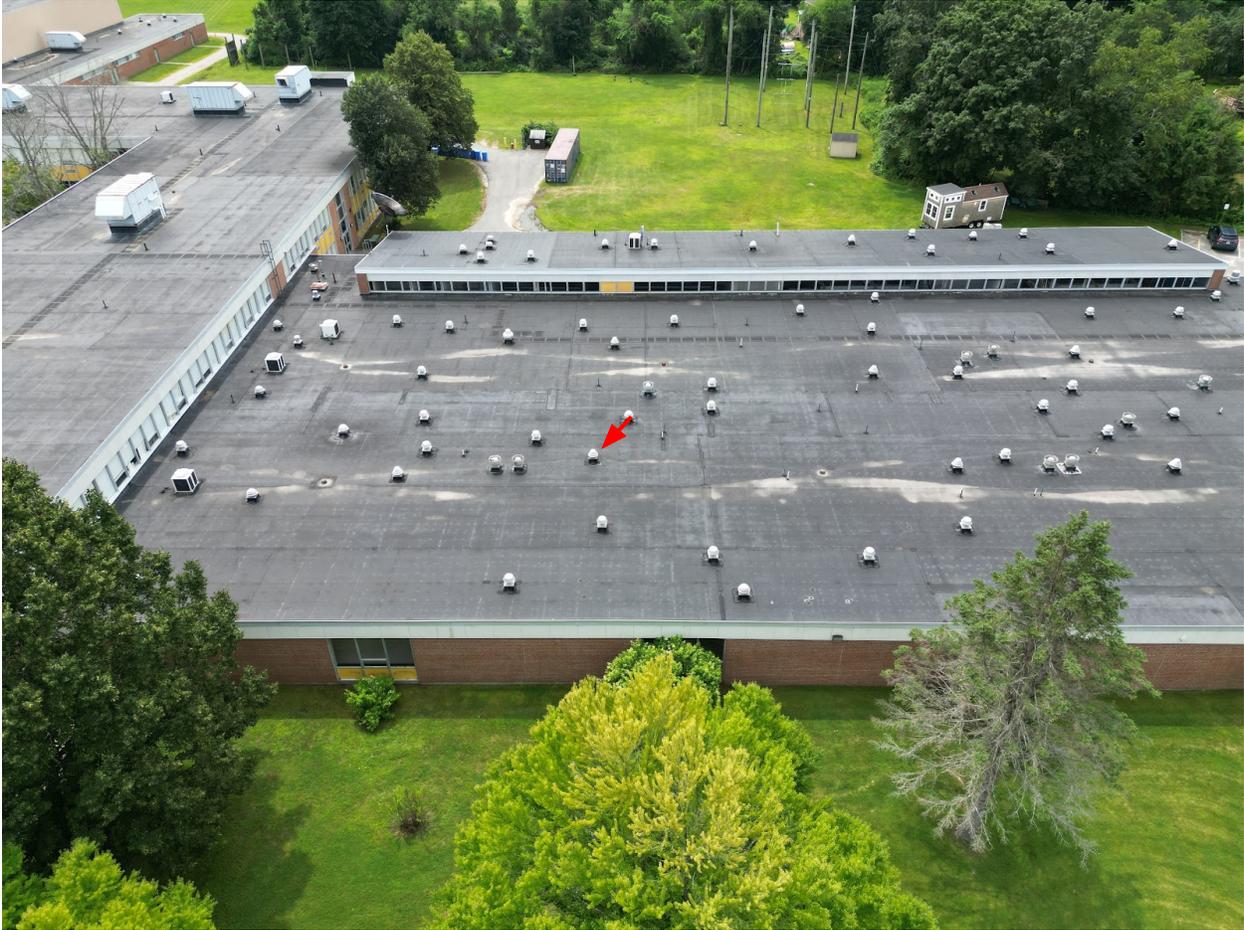
To manage the air quality in the building there are over 100 roof top exhaust fans. All of these fans were replaced during the 2001 renovation. All have had internal components (motors, belts, bearings) replaced over the past 20 years. The condition of these units are fair due to continual replacement of worn parts. It should be noted that using this type of ventilation system is very inefficient in the winter months since the air being removed needs to be heated (via the make-up units). There are more efficient ways to exchange the air in the building.

Exhaust Fans

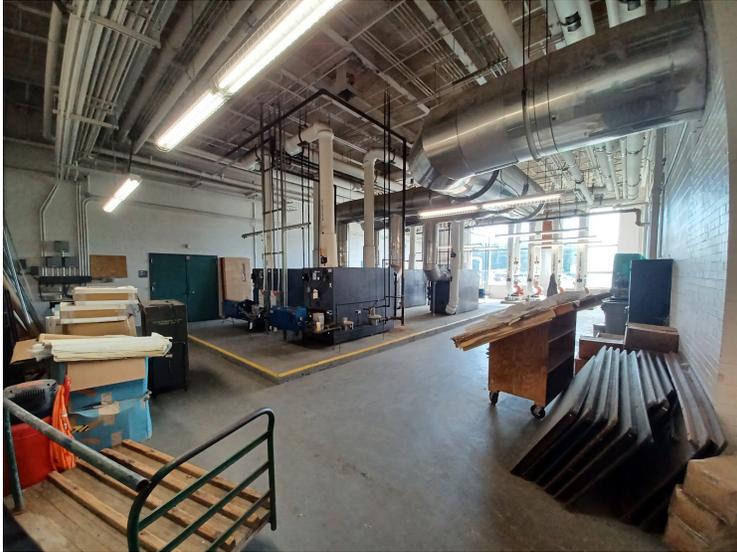
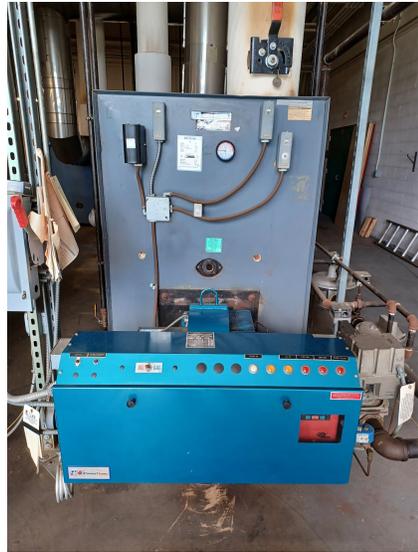
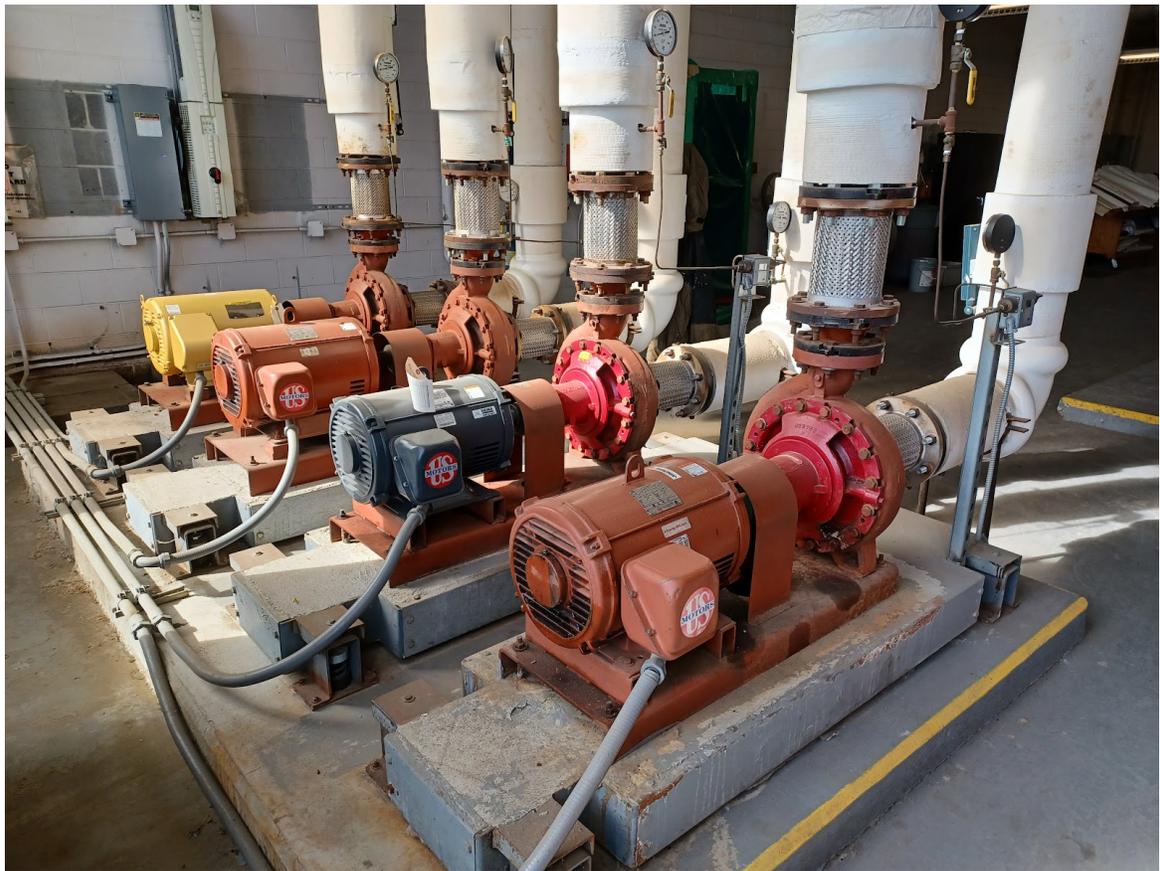
The majority of the heat for the building is generated by four Weil-McLain oil fired boilers. These boilers are 80% efficient with a 2.5 Million BTU/Hr output. All boilers have a Power Flame Burner that is capable of running on Oil or Natural Gas. The hot boiler water is circulated throughout the building with four 30 HP electric motor driven circulator pumps. All of these components were installed in 2001. The boilers and burners are past their useful life. The manufacturer rated serviceable life is 15 years. These units are over 20 years old. Two of the four pumps are original with two others having replacement motors and pumps. These circulator pumps are past their useful life as well. Replacement parts for the motors and pumps are still available, however parts for the Weil-McLain boilers are getting more difficult to find.

Boilers and Circulator Pumps

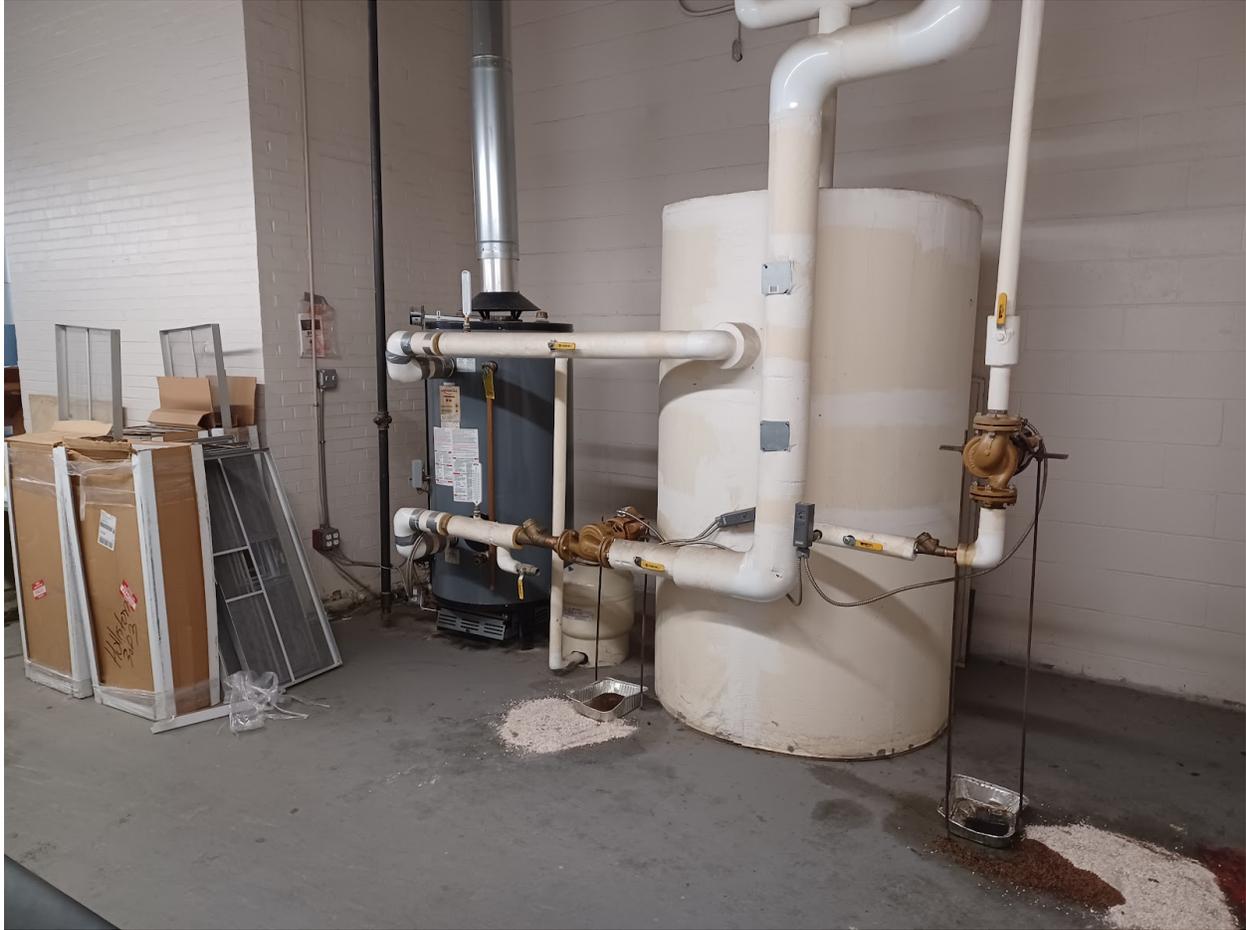
Domestic hot water is primarily provided by gas fired tank style water heaters. These heaters are in fair condition and still have useful life remaining.

Gas Fired Hot Water Heater

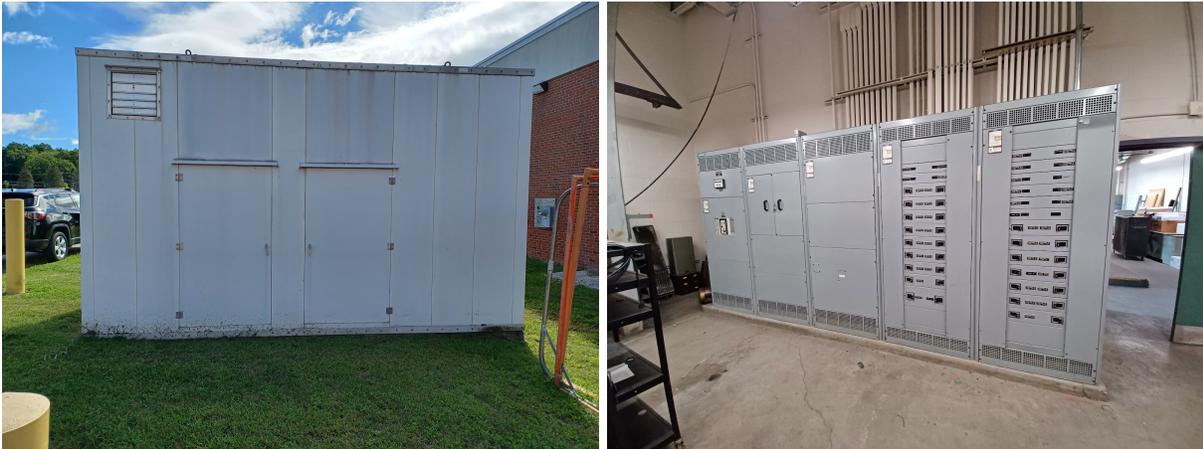
Overall the electrical systems throughout the building are in good to fair condition with no significant signs of degradation. There are some minor issues associated with exposed junction box wiring and broken outlets. Back power for critical building operations and safety is provided by an onsite diesel generator that is in fair condition with useful life remaining.

Backup Generator and Major Electrical Breaker Panel

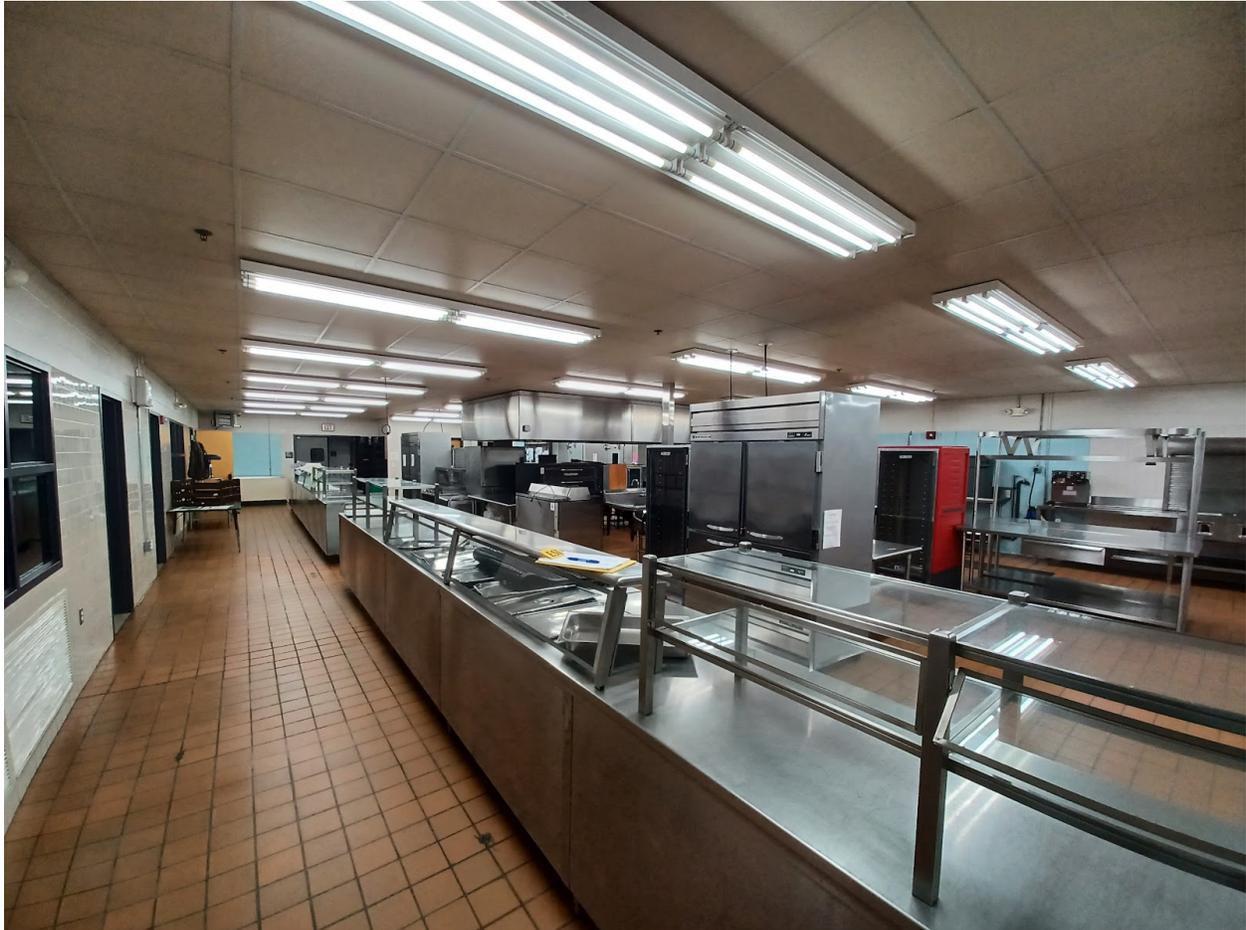
Kitchen - The kitchen is in fair condition and clean. Most of the equipment was installed in 1968 and is technically beyond its useful life but is still functional. When equipment does break it is difficult to find replacement parts. It should be noted that minimal food preparation is done on site which puts less wear and tear on the equipment.

Kitchen

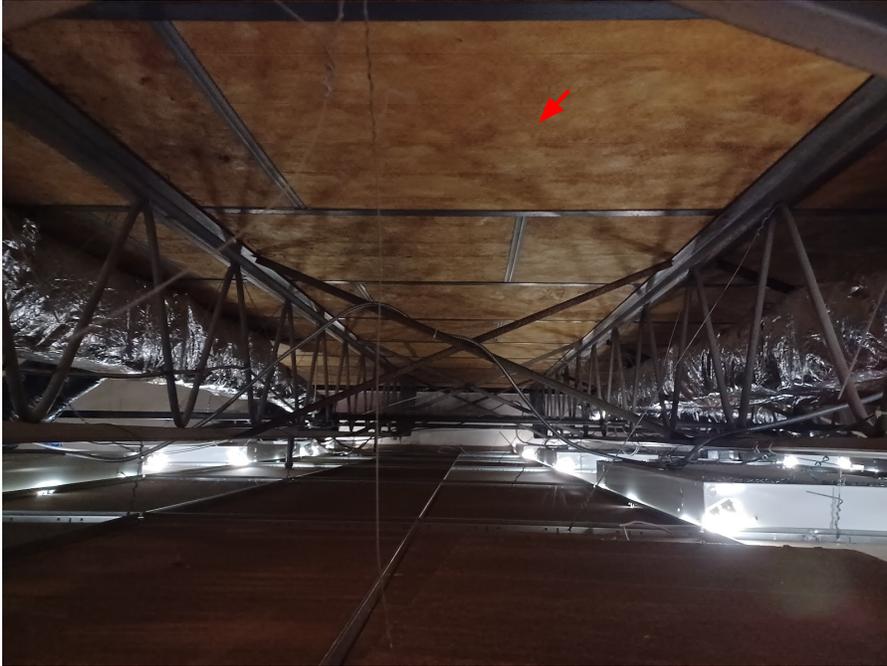
Insulation - Overall the building insulation is minimal due to the style of construction. The flat roof sections have insulated panels that do provide a moderate level of insulation. The concrete block walls have no insulation and the store-front style panel systems have no insulation. The window glass is single pane and also provides very little insulating value. In fact some of the upper class rooms that have windows above an adjacent lower flat roof section become unusable due heat radiating off the roof through the windows and into the classroom.

Roof Insulation Panels

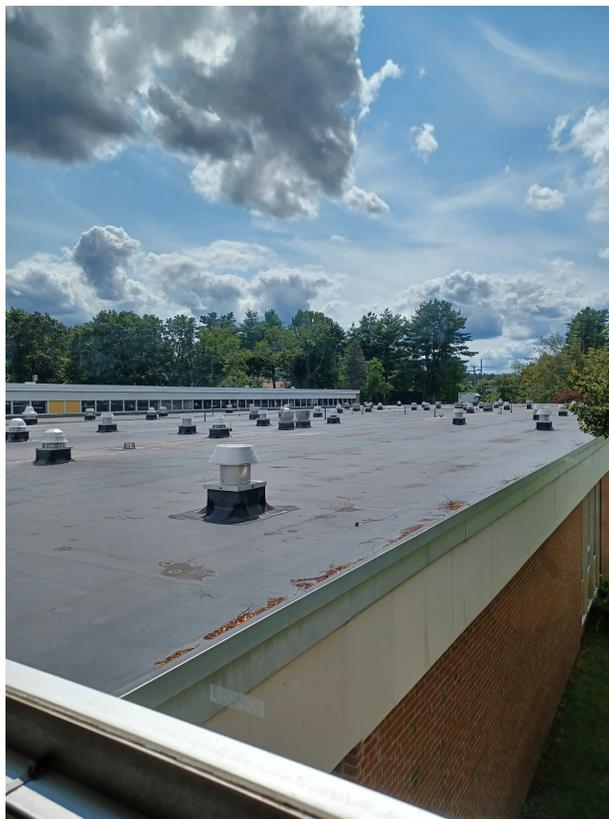
Flat Roof Below Upper Classroom Windows
