**RE: Response to BWC Bogastow Brook, LLC BESS Project Stormwater Design Peer Review #1
Proposed Battery Energy Storage System – 600 Central Street, Holliston, MA**

Inspection: *Documentation of Site and Drainage Pre-Development Conditions*

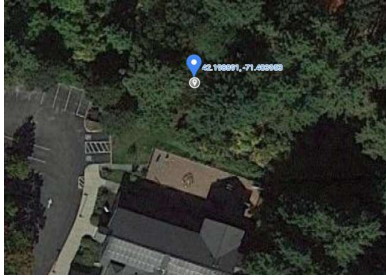
Photo No. 3

Debris including rusty metal, old cans of paint, and shards of glass in the vicinity of the Project Site. Could pose a physical hazard.

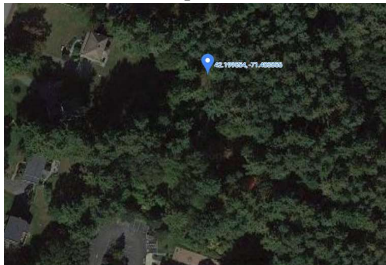
Photo No. 4

Blue and green survey flags mark the proposed battery location within the Project Area.

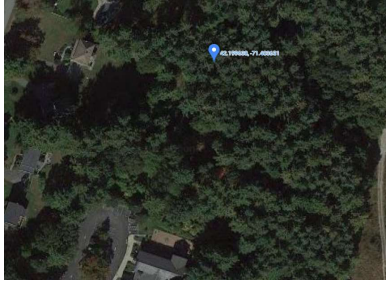
Photo No. 5

Corner of the parking lot with the drain manhole (DMH) and catch basin.

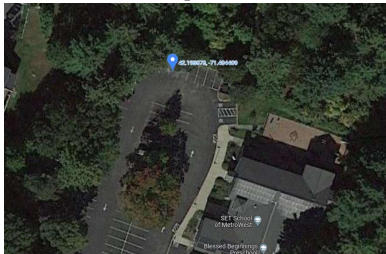
Photo No. 6

View inside drain manhole. CJD measured water levels 48 inches below the rim and a sump of 61.5 inches below the rim. Tops of inlet and outlet pipes were visible.

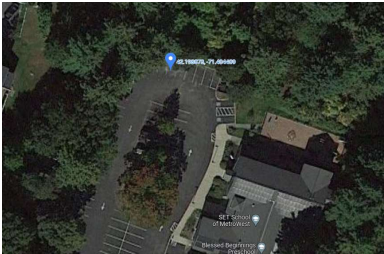
Photo No. 7

Concrete cover to water quality tank, located approximately 10 to 15 feet north of the drain manhole. CJD was unable to open.

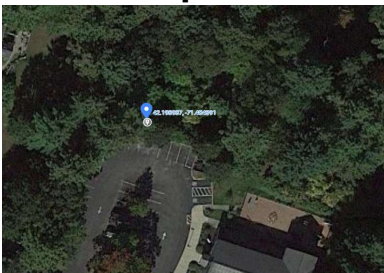
Photo No. 8

View from inside stormwater basin, view towards drainage outfall.

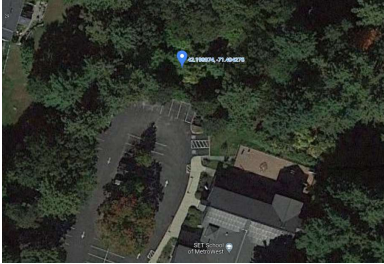
Photo No. 9

The sediment forebay for the drainage outfall observed in good condition.

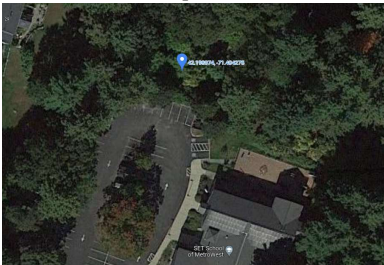
Photo No. 10

Looking inside the drainage outfall. No standing water present, pipe observed in good condition. Inside of water quality tank is visible.

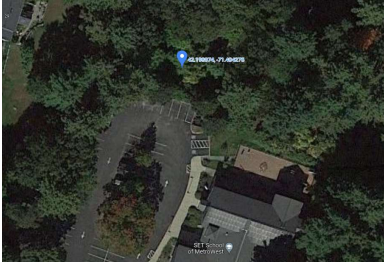
Photo No. 14

View of outlet pipe from outlet control structure. No erosion observed around the area.

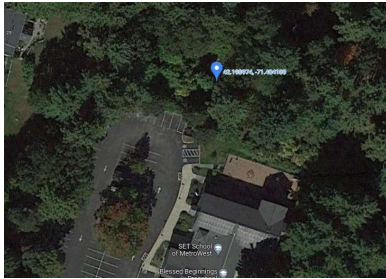
Photo No. 15

View of drainage channel downstream from the outlet control structure discharge pipe. The channel is observed not eroded and is in good condition.

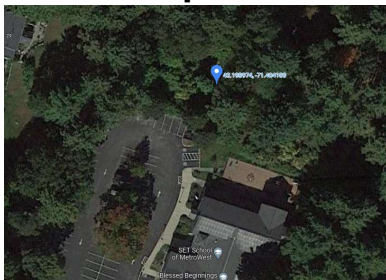
Photo No. 16

View of pond embankment observed in good condition. There is no evidence that water overtops the embankment of the basin during storm events.

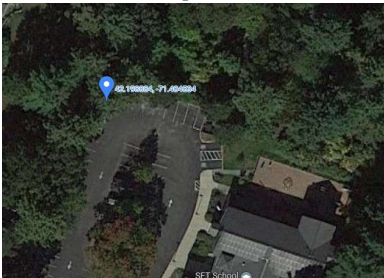
Photo No. 18

View of bare ground adjacent to parking lot area. The ground being free of pine needles may indicate that water has flowed in this location recently.

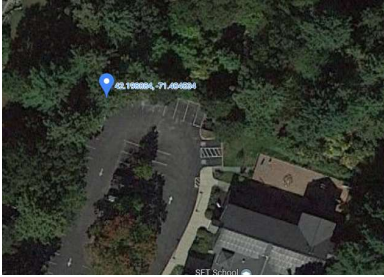
Photo No. 19

View looking down an embankment from the subject parking spot. An abutter shed is located adjacent to an area where stormwater may flow.
