MAKRIS FIELD REPORT**Date of Field Visit/Observations: 1 March 2019****Project: Holliston Library****Date of This Report: 3 March 2019**

1 March 2019, Chris Bromley of RebuildEx and I checked in with Leslie McDonnell and conducted hands-on inspection and layout measurements of the roof trusses. We also reviewed the basic steps necessary to jack the trusses into their original configuration; this requires more specific planning.

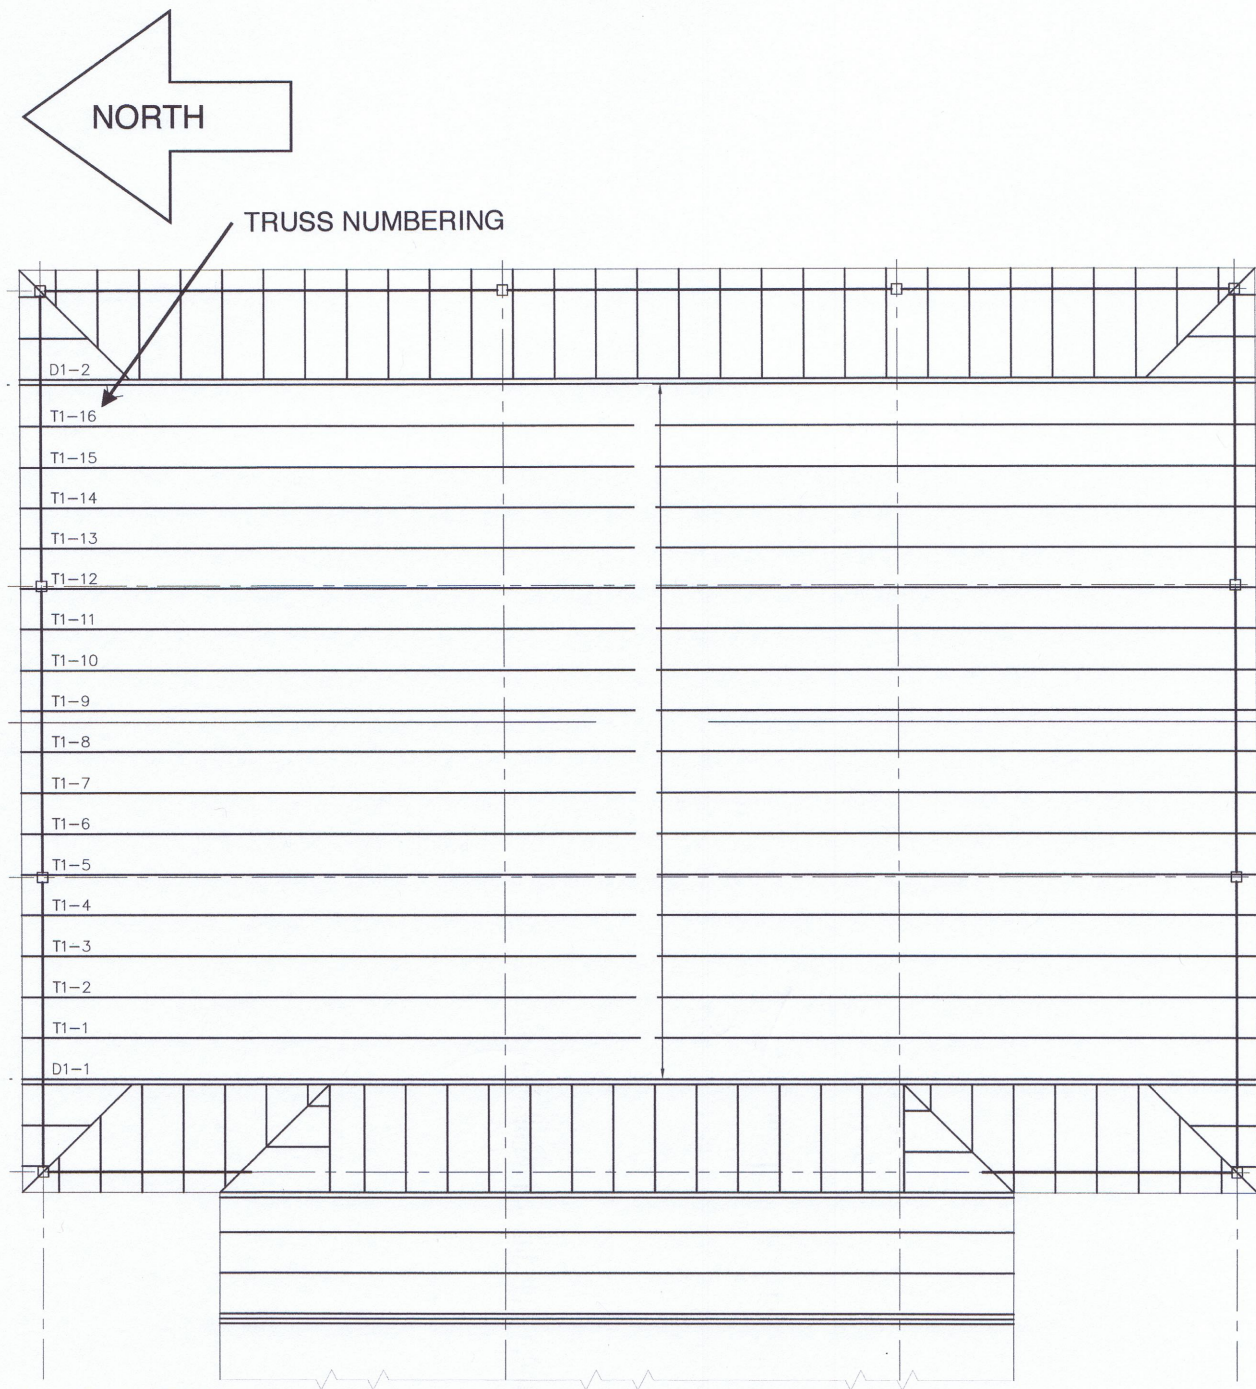
Figure 1 - General Plan of Trusses (Linework Copied from RussoBarr Drawing)

1. Note, for compass point orientation, the “front” entry of the Library facing Washington Street is assumed to be west elevation. See Figure 1 for the truss orientation plan.
