October 20, 2022

Re: **Notice of Intent – AnyFence Co., 1485 Washington Street, Holliston MA,
DEP File#: CE 185-0931**

CDW has reviewed the comments by McClure Engineering, Inc. (McClure), dated September 27, 2022, regarding the Notice of Intent Stormwater Management Design for AnyFence Co. The Site Plan Set have been revised to address the comments from the McClure letter and have a revision date of October 18, 2022, and offer the following responses to the comments. The McClure comments are in bold. Additionally, the Conservation Commission requested additional plan revisions listed at the end of the comments.

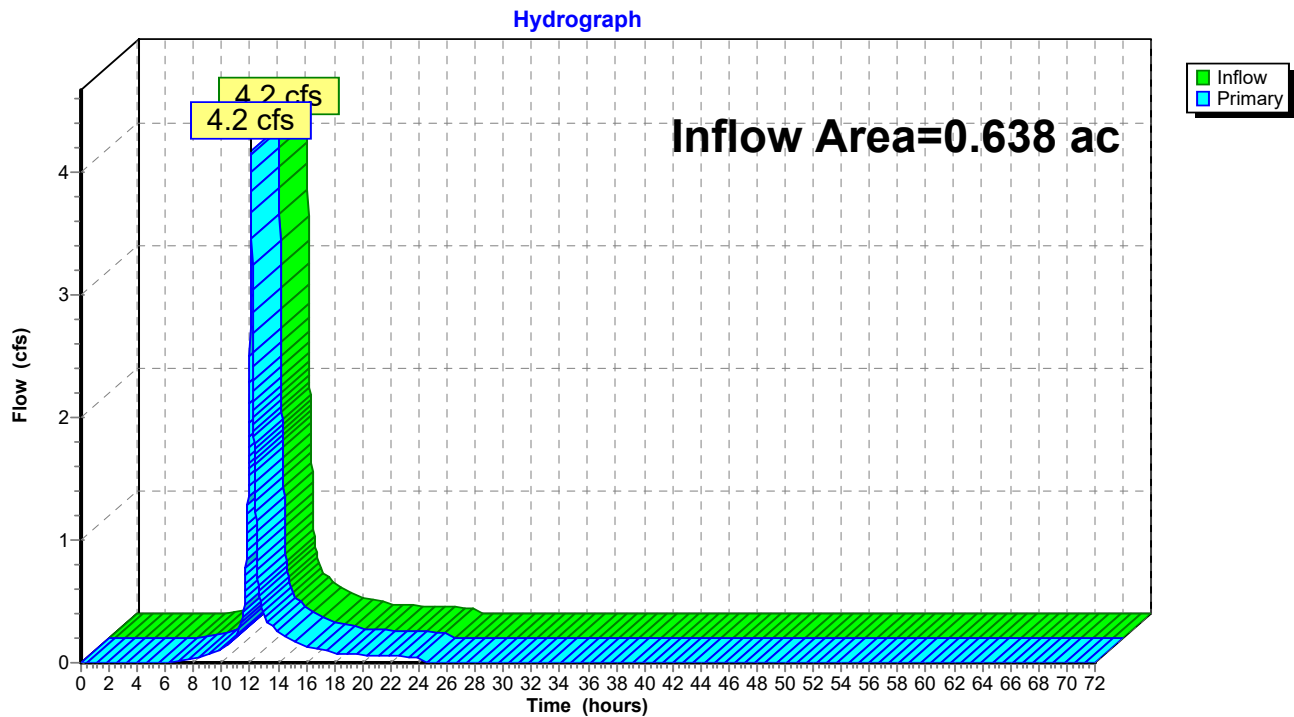
Pond DP-2e: (new Pond)

Routing by Stor-Ind method, Time Span= 0.00-72.00 hrs, dt= 0.01 hrs

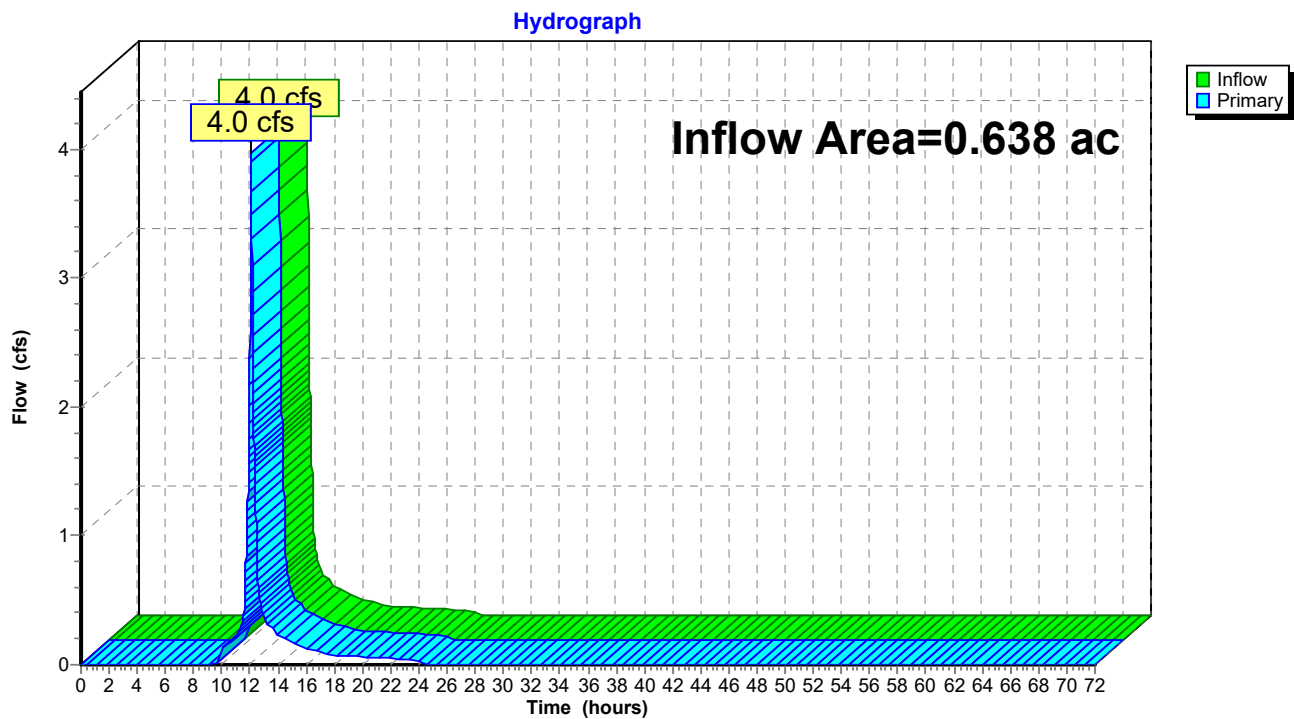
Pond DP-2p: (new Pond)

Routing by Stor-Ind method, Time Span= 0.00-72.00 hrs, dt= 0.01 hrs

Type III 24-hr 100-YR Rainfall=8.27"

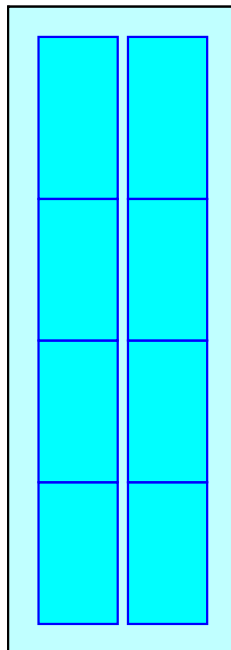
Summary for Pond UGI: Underground Infiltration System

43.1 cy Field

30.1 cy Stone

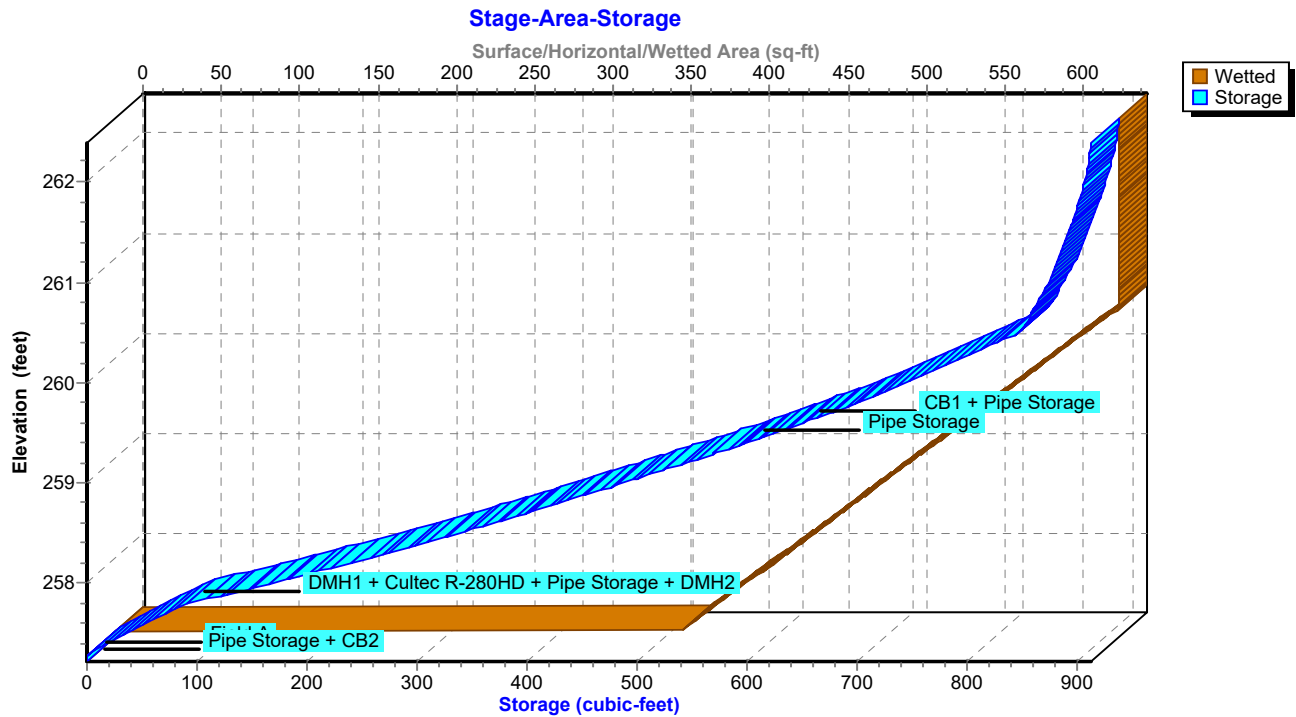
Pond UGI: Underground Infiltration System

Pre&Post flow R20.17infil rate check*Type III 24-hr 100-YR Rainfall=8.27"*
